Survivors among the Ruins: Traditional Houses in Earthquakes in Turkey and India

RANDOLPH LANGENBACH

Many traditional timber and masonry houses defied today's conventional wisdom about the safety of masonry by surviving the great Turkey earthquakes of 1999 and India's Bhuj earthquake of 2001 that felled many modern buildings.

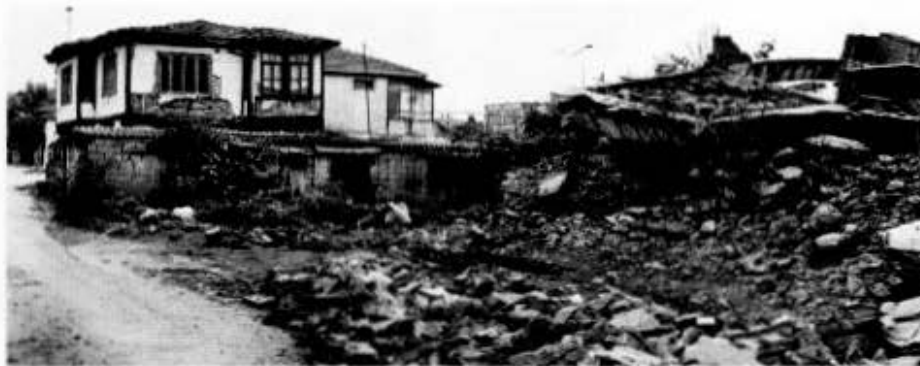
Not often seen on television, however, were the many old and seemingly rickety timber and masonry vernacular buildings that remained standing, often unscathed, next to the collapsed modern buildings (Fig. 1). These old houses defied today's conventional wisdom about the safety of masonry. Many of these survivors resemble Tudor cottages, with lightweight timbers laced into the masonry. They are clearly different from the masonry construction in India that proved to be unsafe when the Bhuj earthquake struck that country in 2001. It would seem that the record created by the surviving buildings in Turkey should be worthy of study, but most of the visiting engineering researchers who combed the earthquake-stricken areas paid little attention to them.

Fig. 1. A timber and masonry house in Adapazari, Turkey, remains standing, having lost only its stucco, next to a collapsed reinforced-concrete apartment house. All photographs © the author.

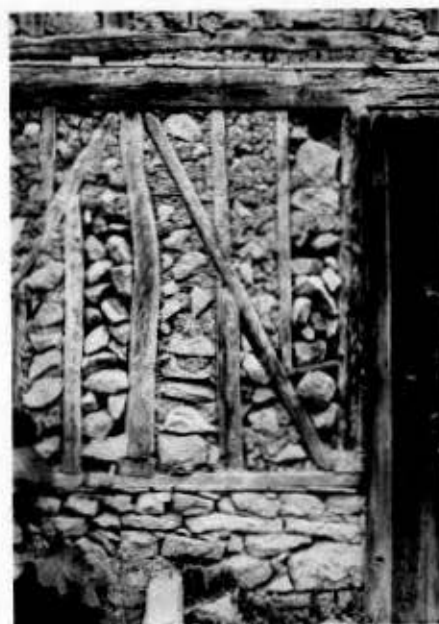
Fig. 2. *Hıms*-style wall with stone infill laid in mud mortar, in Safranbolu, Turkey.

The upper story is almost always constructed with a timber frame infilled with a single wythe of fired brick or stone masonry, referred to in Turkish as "*hıms*" (Fig. 2). This construction utilizes a weak mortar of mud or lime to hold a single wythe of masonry into a timber framework of studs rarely more than two feet (60cm) apart. The studs themselves are tied at midstory height by other timbers. Because the masonry is only one wythe in thickness, the walls are light enough to be supported on the cantilevered timbers.

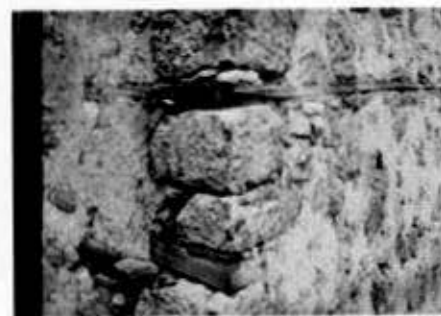
The multi-wythe masonry bearing walls of the first story are often laced with horizontal timbers, (in Turkish: "*hatıl (s) hatıllar (pl)*").⁵ These are often very thin timber boards laid into the wall like a course of masonry, at vertical intervals of about 3 feet (1m). They are

placed so that they overlap at the corners (Fig. 3). They thus serve to bind the stone layers together without interrupting the continuity of the masonry construction. This method of construction, with its heavy walls below the lighter walls resting on the cantilevered floor joists, together form the technical underpinning of the Ottoman vernacular architecture with its characteristic jetties overhanging the narrow streets (Fig. 4).

Fig. 3. Detail of lower-story walls showing *hatıllar* imbedded in wall, and lapping at the corners, in Safranbolu, Turkey.

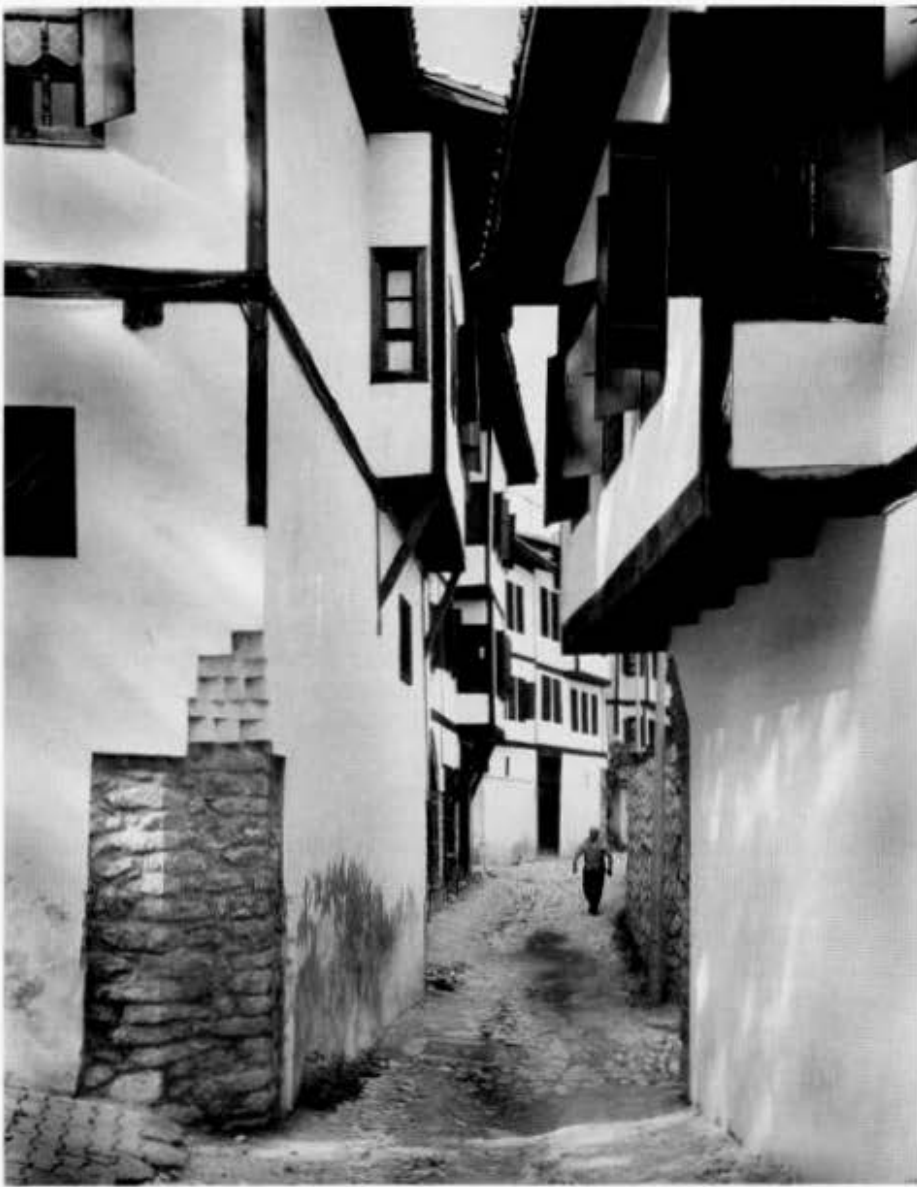
Fig. 4. Street with overhanging jetties, in Safranbolu, Turkey. The cantilever of the upper story over the lower story helps to hold the masonry walls together. The timber lacing is hidden by the plastered surface.

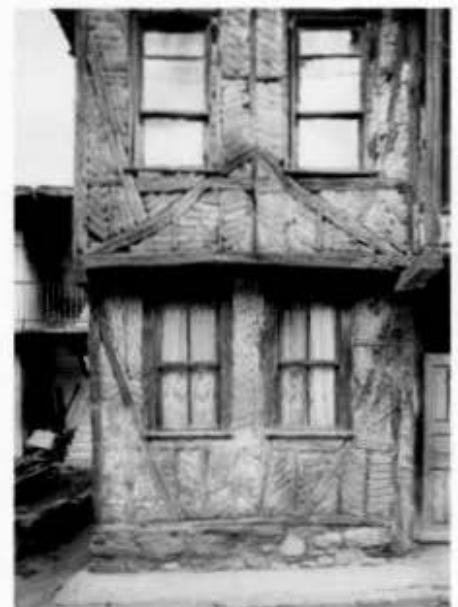
There were clusters of *hıms* buildings in the heart of these districts. These houses, mostly dating from the early part of the twentieth century, pre-dated the ruined reinforced-concrete apartment blocks nearby (Figs. 5 and 6).

Fig. 5. This house was constructed in 1955 by the father of the two brothers who currently live there with their families. It survived with only cracks in the interior plaster just a few blocks away from rows of new reinforced-concrete apartment houses that collapsed.

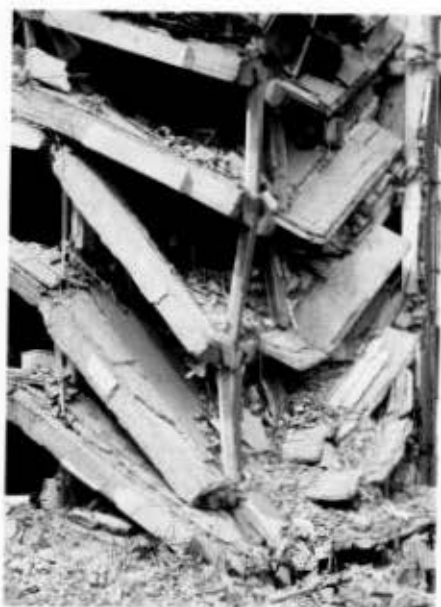
Fig. 6. Gölcük. Partially collapsed reinforced-concrete apartment house.

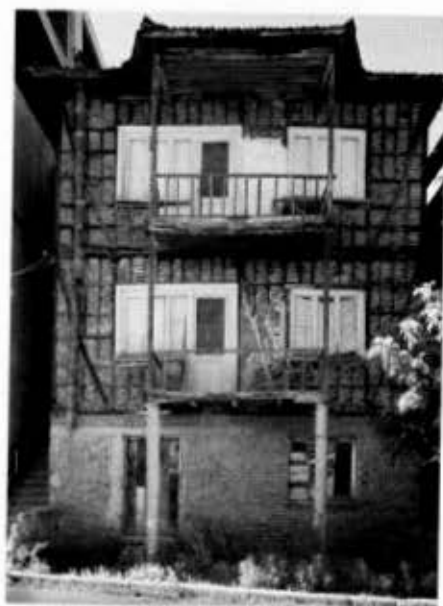
In Gölcük, within 100 meters of the *hıms* houses, a surface trace of the fault was visible. The land had dropped 2.5 meters, dragging some buildings and their sleeping occupants into the sea. Some of the *hıms* houses near there were damaged, but they survived (Fig. 7).

Fig. 7. *Hımış* house that survived the earthquake with no visible damage to its exterior in the heart of the damage district in Gölcük, Turkey.

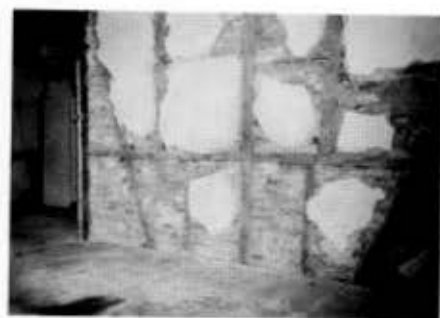
interior plaster along the walls and at the corners of the rooms, revealing the pattern of the timbers imbedded in the masonry underneath. This level of damage was evident in every house (Fig. 8).

Fig. 8. Damaged interior wall exposing an undamaged brick infill wall behind, in Düzce, Turkey. The plaster cracking and falling at the edges of the panels, where the wood intersects with the brick, is characteristic of the damage to the *hımış* style of construction. This is a more extreme example of plaster shedding.

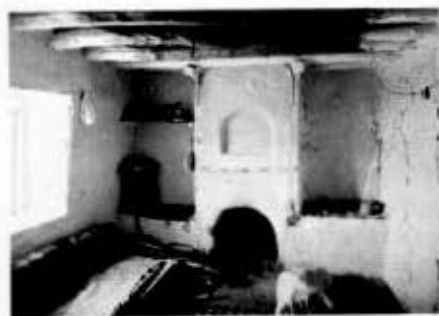
Fig. 9. This photo of a farming family's living room was taken after the earthquake. The house is in a village near Orta.

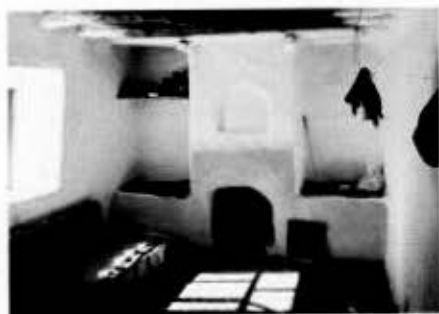
Fig. 10. This view of the living room was taken six months after the earthquake, after the family had repaired their house and moved back in.

The local people in a nearby village, who were mainly younger farmers still actively farming, responded differently. They did not wait for the government handouts but instead repaired their houses and went on with their lives. It was thus the younger, rather than the older, people who showed more confidence in and understanding of the stability and restorability of the timber-laced system of construction. Farm families living in tents the day following the earthquake in June had by November migrated back into their repaired houses (Figs. 9 and 10). They had done the work themselves in the traditional manner, with mud and plaster instead of concrete.

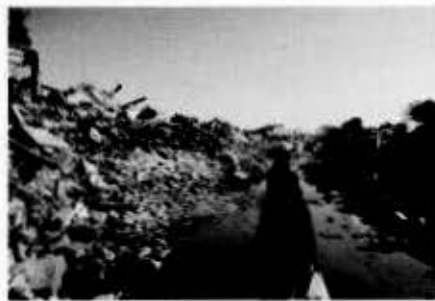
Fig. 11. The ruins of Anjar town center in western Gujarat, India, a month after the earthquake.

A year and a half after the earthquakes in the Marmara region of Turkey, an equally devastating earthquake struck a largely rural area of the western Indian state of Gujarat, on January 26, 2001. The devastation was appalling. Unlike the damaged districts in most recent earthquakes, this earthquake left many villages and the small city of Bachau completely leveled.¹⁵ As far as the eye could see, both modern and premodern buildings were either partially or totally collapsed into piles of rubble (Fig. 11).

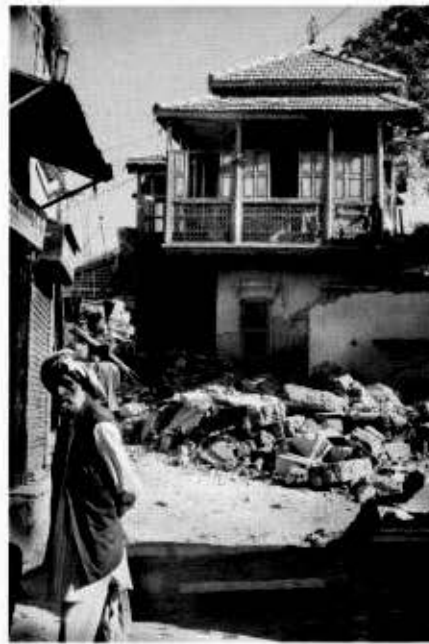
Fig. 12. This house has survived at least the most recent two major earthquakes that otherwise devastated Anjar’s old town center. The balconies on two walls helped to keep this house standing while most buildings around it fell.

Among the surviving buildings in Kutch, however, one thing did stand out. Of the masonry buildings that survived, many had timber floor joists that extended through the walls to support balconies. On partially collapsed buildings, there were often balconies on the parts of the building that did not collapse. This observation suggests that the effect of having the joists continue through a wall to support a balcony was significant. Balconies resting on joists that extend through the masonry walls increase the resistance of the structure, restraining the walls from falling outward. Without a balcony, the joists most often terminate in shallow pockets in the masonry wall without any anchors. This is an important point because balconies may be considered primarily an architectural element rather than an integral part of the structure, and yet, as was also seen with the projecting bays in Turkish Ottoman architecture, this one element can help protect against collapse (Fig. 12).

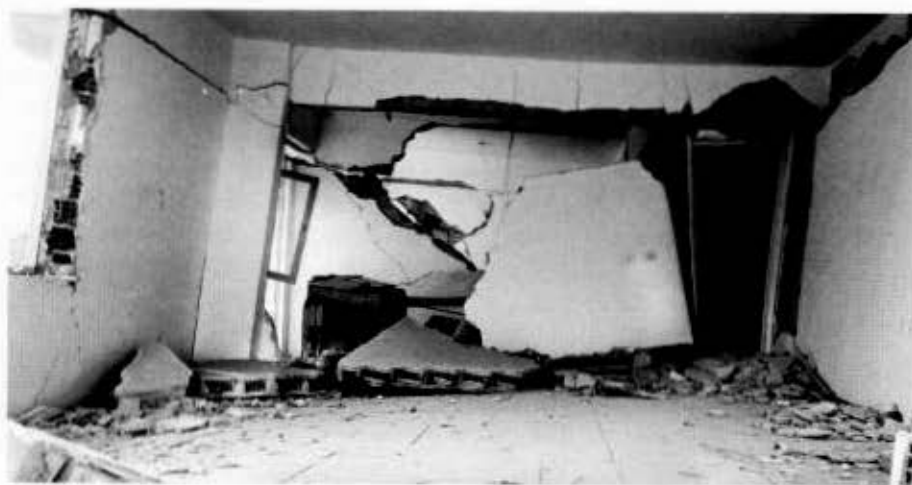
Fig. 13. The infill wall in this reinforced-concrete building in Turkey offered little resistance once it began to crack in the earthquake, unlike the timber-laced walls of the *hımış* construction.
