## THE EARTHQUAKE RESISTANCE OF TRADITIONAL TIMBER AND MASONRY DWELLINGS IN TURKEY

Polat GÜLKAN<sup>1</sup> and Randolph LANGENBACH<sup>2</sup>

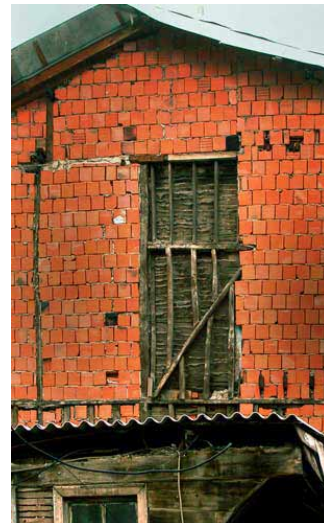
**Figure 8:** RIGHT: Detail of a timber house in Istanbul where the timber studs remain in only one portion of the wall and the rest have been replaced with hollow clay block creating a condition dangerous for earthquakes.

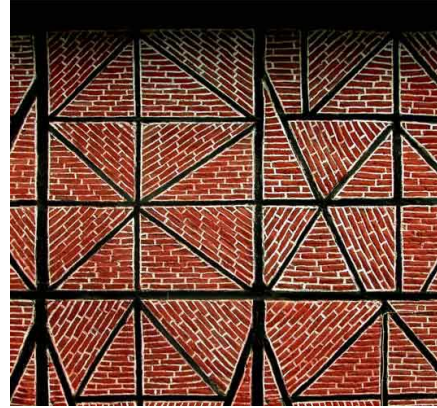
**Figure 10:** RIGHT: Detail of ornate variation of *himış* construction near Duzce. Despite their locations, the 1999 earthquakes did not damage these buildings.

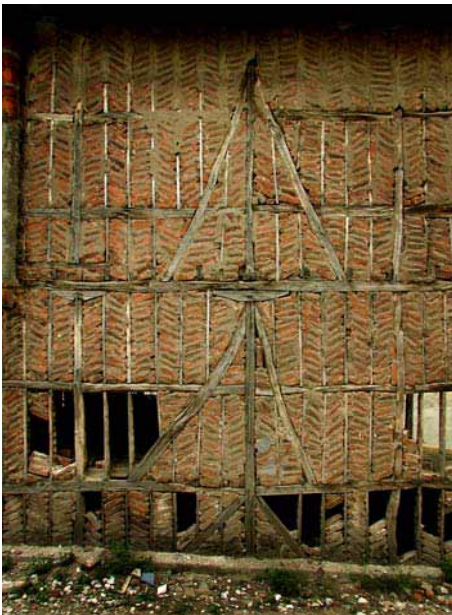
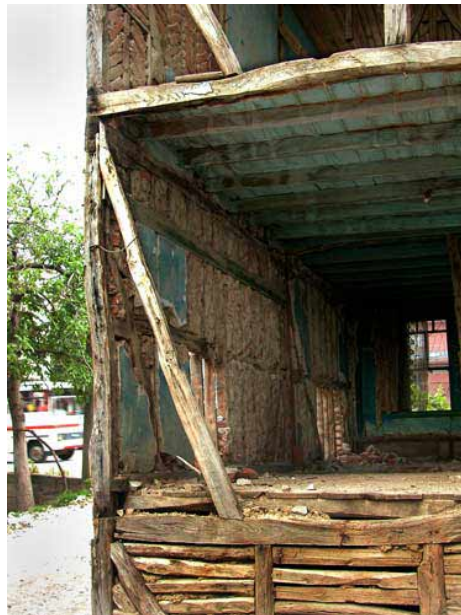
**Figure 11 & 12:** Partially demolished house in Golcuk showing the single brick wythe thickness of typical *himış* wall. On the LEFT is the exterior and on the RIGHT is the interior face of the same wall.

This house was abandoned and partially demolished at the time of the earthquake. Despite its condition, the earthquake had little affect on it. It was photographed in 2003.

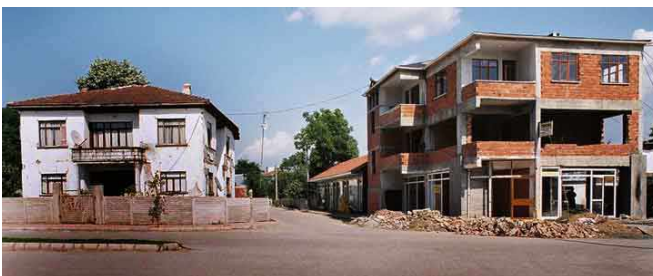
**Figure 17:** Three story RC building next to a 2½ story *himiş* house near Düzce showing the repair of severe damage to the RC building (notice the size of the ground floor columns). The *himiş* structure has lost only stucco on the side. Almost all of the hollow clay block on the RC building has been reconstructed after the earthquake. This shows that even low rise RC buildings sometimes suffered more damage than nearby traditional buildings.

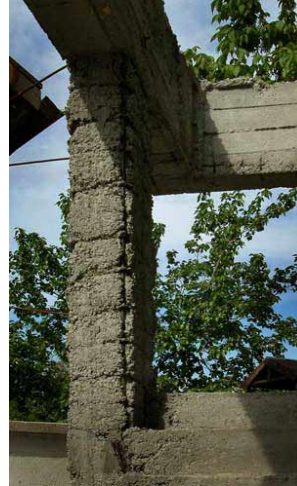
**Figure 19:** RIGHT: Concrete column in new mosque being constructed on site of building destroyed in Afyon Earthquake showing rock pockets leaving re-bar exposed. Vibrators are not used in most Turkish construction.

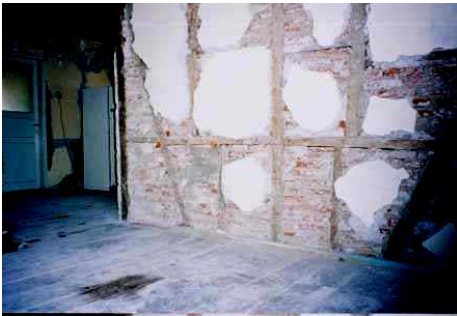
**Figure 20:** *Hımış* interior wall in house in Düzce earthquake damage district showing “working” of wall that caused loss of plaster.

The problem is not just an academic one. The evaluation of older structures after earthquakes can lead to broadly divergent views on the significance of the damage, and the reparability of the structures. This can have profound consequences for the owners and for the economic and social dislocation of the disaster as a whole. Dusi and Langenbach [6] It can also result in the unnecessary loss of buildings of historical and cultural value. This is a problem that can affect archaic and modern buildings alike. Earthquake damage has often been looked at with little understanding of what it represents in terms of loss of structural capacity. The standards applicable to reinforced concrete, where a small crack can indicate a significant weakness, are applied to archaic systems where even large cracks may not represent the same degree of degradation, e.g., a masonry building with cracks in the walls with fallen plaster, and a reinforced concrete building with only hairline cracks at the beam/column intersections do not correspond to the same level of degradation. It is the reinforced concrete building that may be closer to collapse than the masonry building. In the case of masonry, it is the friction of the moving and cracking materials that produces damping, thus helping to reduce the structure’s response to an earthquake. Disruption of plaster or stucco over a significant portion of a wall area can represent a beneficial performance. (Figures 13, 20, 22, 23)

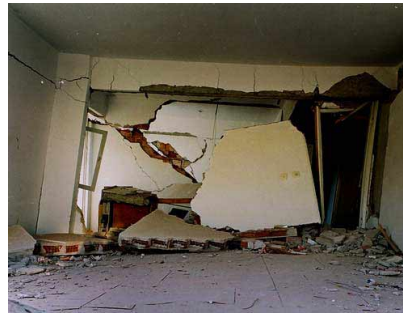
**Figure 21:** Collapse of a brittle interior hollow clay block wall illustrating typical failure pattern for such walls lacking subdivisions.

this fails to take into account the essential mechanism by which the traditional construction is able to resist earthquakes – flexibility and energy dissipation, rather than strength and stiffness. Its survival in the much larger and longer earthquake illustrates that the *hımış* is capable of maintaining stability over many cycles. To do this, however, the deflection of the structure and friction in the infill must begin at the onset of shaking. Thus the shedding of the plaster and stucco in both the large and small earthquakes was similar. By comparison, although only lightly damaged in this and other smaller earthquakes, the non-engineered concrete buildings often suffer from a rapid and sometimes catastrophic degradation of strength in larger earthquakes because they are inflexible and lack the reserve capacity that is found in the *hımış* construction. The brittle hollow tile block infill walls in the concrete frame buildings are initially stiff, and then, once cracked, tend to collapse (Figure 21). Langenbach [13]

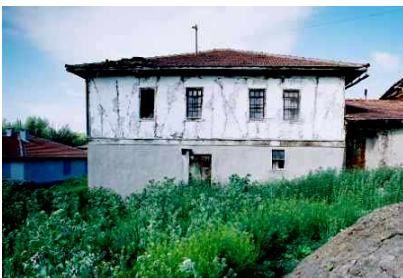
**Figure 22:** LEFT: House in Orta, Turkey one day after the 2000 Orta earthquake – showing plaster cracking that reveals the timber frame.

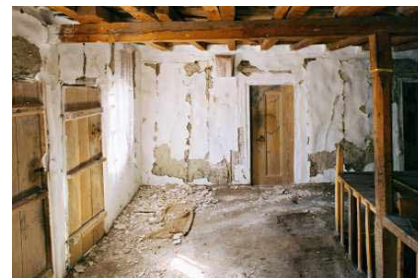
**Figure 23:** RIGHT: Interior of *hımış* house after the Orta earthquake showing the “working” of the masonry panels.
