‘Earthquake Resistant Traditional Construction’ is Not an Oxymoron* :

**The Resilience of Timber and Masonry Structures in the Himalayan Region and
Beyond, and its Relevance to Heritage Preservation in Bhutan**

**By Randolph Langenbach
USA**

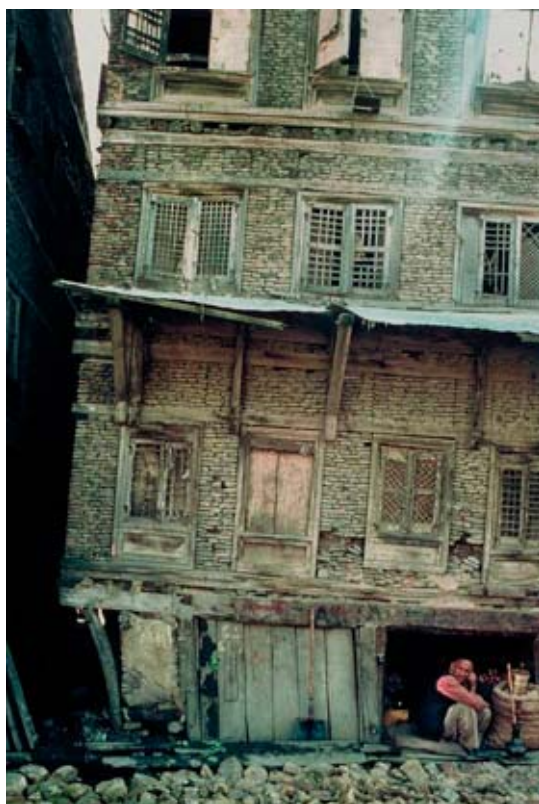
Fig. 1: How is it possible to consider this building as “earthquake-resistant construction”? This photograph was first published by the author in 1989, and has since become symbolic of what is counter-intuitive about the findings that such timber-laced masonry construction is earthquake resistant.

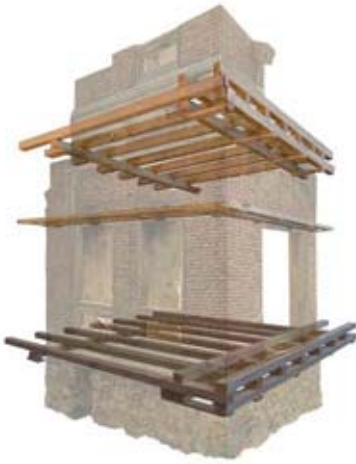
Fig. 2: A model showing the timber-lacing in Kashmiri *taq* construction. Only horizontal timbers are placed, and timbers on the inside and outside faces of the wall are tied together like ladders. The joists are secured to the wall by the weight of the masonry above.

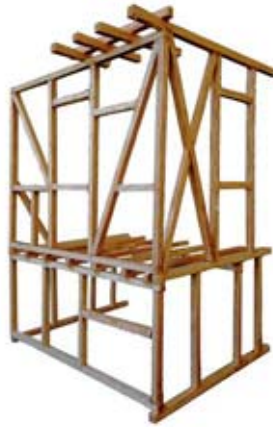
Fig. 3: A model showing the timber elements in traditional Kashmiri *dhajji dewari* construction. To form the exterior and interior walls, a single layer of stone or brick (fired or unfired) masonry is laid into the walls within the timber frame.

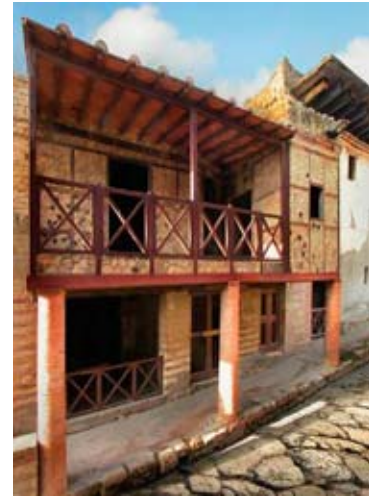
Fig. 4: 2,000 year old Roman house in Herculaneum, Italy with timber frame and infill wall construction revealed after having been buried by the ancient eruption of Vesuvius.

When archeologists dug up the port town of Herculaneum that had been buried in a hot pyroclastic flow from Mount Vesuvius in 79AD, they found an entire two story half-timber house which he identified as one of the masonry construction typologies described by Vitruvius as "*Opus Craticium*" (Figure 4). This example in Herculaneum may provide us with the only surviving example of the form of construction that had been used in ancient Rome for the seven or eight story tenements (*insulae*) that filled that city of a million and a half people. Masonry bearing walls would have been too thick at the base to fit on the known footprints of these ancient buildings with space for rooms left over, so it is likely that the Romans constructed many of these tall buildings with timber frames and infill masonry.

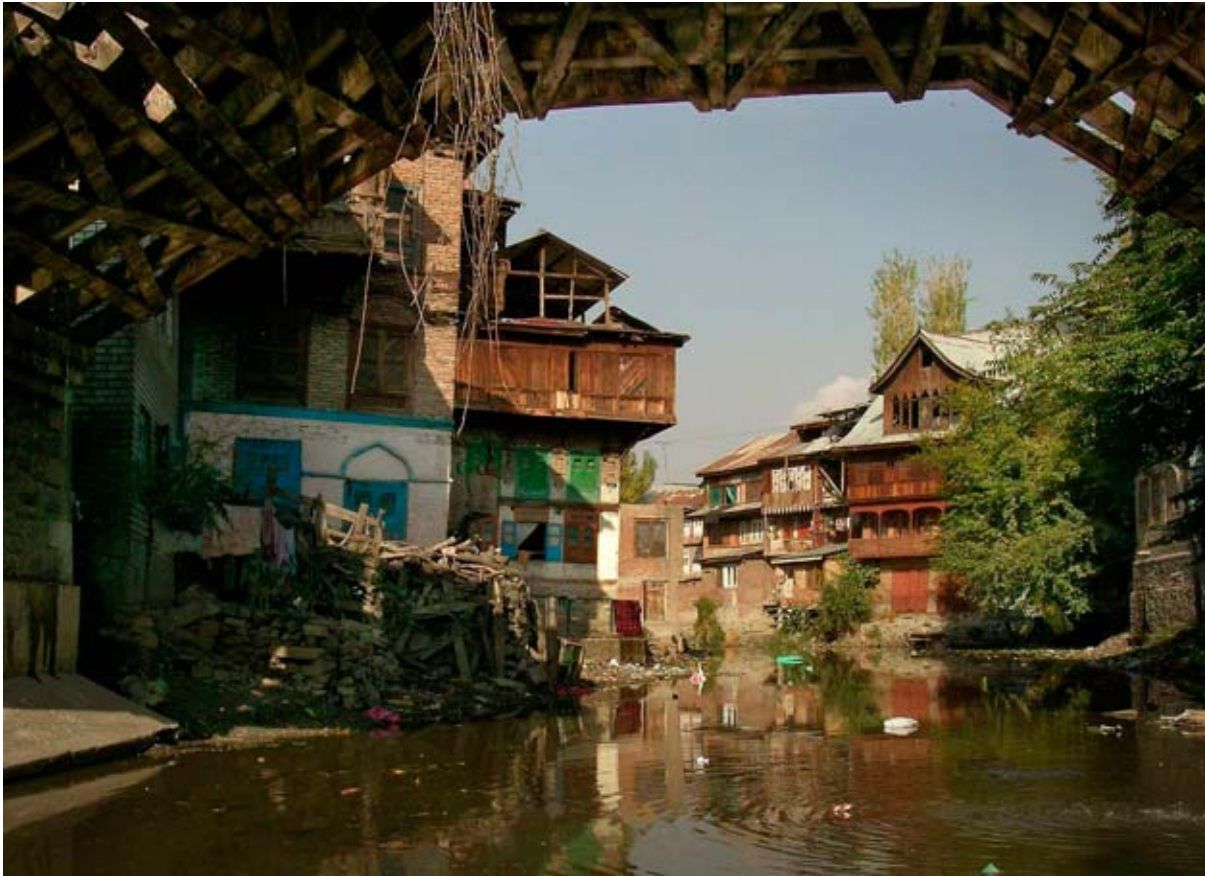
Fig. 5: Srinagar, Kashmir was famed in the 19th century as a water-borne wonderland of canals and shallow lakes. Only one of these famed canals still exists – the Rainawari Canal, shown here in 2005. Many of the buildings tilt and lean seen here on the left because of the soft water-laden soils making the evolution of the timber-laced construction necessary for structural survival. It is this timber lacing of the masonry that has proven also to provide earthquake resistance.

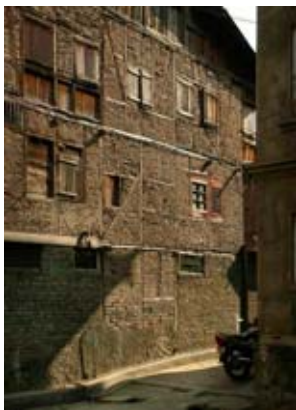
Fig. 7: *Hıms* construction in Srinagar, Kashmir, India.

Most of the traditional buildings in Srinagar can be divided into two basic systems of construction. The first system, sometimes referred to as *taq*, consists of load bearing masonry piers and infill walls, with wood "runners" at each floor level used to tie the walls together with the floors, all of which is locked together by the weight of the masonry overburden (Figure 1,2 & 6). The second system, known as *dhajji-dewari*, consists of a braced timber frame with masonry infill. With its thin, one-wythe thick walls, it provides an efficient and economical use of materials, which helps to account for its use even for new construction until about two decades ago (Figure 3,7 & 9) (Langenbach, 2009)

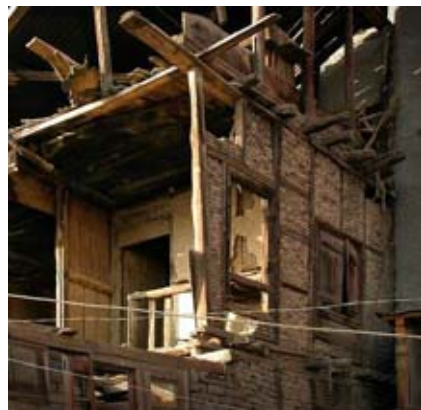
Fig. 8: Partially demolished *dhajji dewari* house in Srinagar showing the timber frame with the single thickness brick walls.

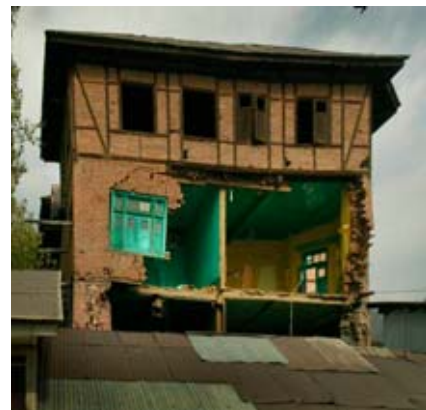
Fig. 9: In the 2005 Kashmir earthquake the unreinforced masonry front wall of this 4 story building collapsed, while the *hıms* wall above bridged over the collapse holding the side walls together, and thus prevent the complete collapse of the building.

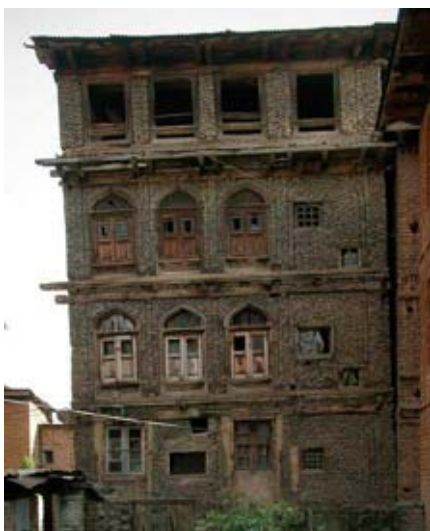
Fig. 10: Four story house of *taq* construction in Srinagar on soft soils showing foundation settlement. The timber lacing has served to hold the building together.

Another example is the difference between Kashmir and Nepal. Many masonry buildings in Kathmandu, including the Palaces, temples and houses were severely damaged in a large earthquake that struck the cities and towns in the Kathmandu Valley in 1934 (Figure 33–35). Comparing the photos and accounts of this with the descriptions of the 1885 earthquake in Srinagar, Kashmir does reveal a difference, a difference born out by the author’s inspection of traditional building construction in Kathmandu in 2000 and 2005. (Compare figure 10 to figure 36).

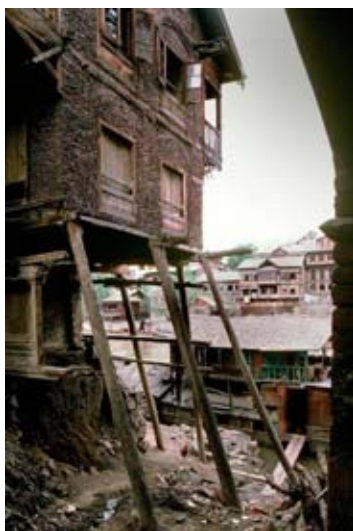
Fig. 11: The resilience of *taq* construction is demonstrated by this building here held up with widely spaced timbers even though it is of brick in mud mortar bearing-wall construction.

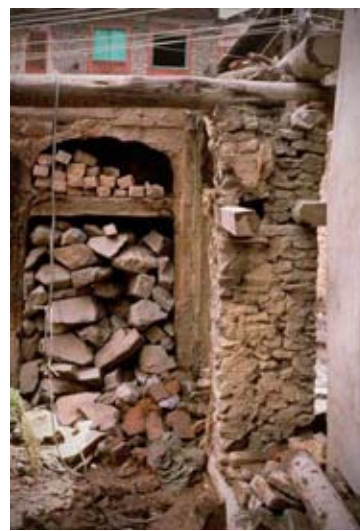
Fig. 12: Partially demolished *taq* house in Srinagar showing the timber framing members which encircle the building at the floors and above the windows.

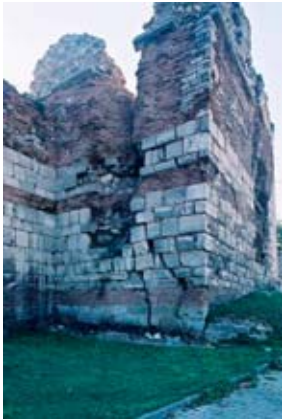
Fig. 13: Original section of Theodosian City Wall, Istanbul after 1999 earthquake. The visible damage to these walls is from well before the earthquake.

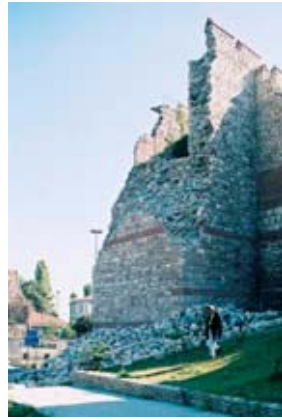
Fig. 14: This tower is a modern reconstruction that collapsed in 1999 earthquake. The bands were one-brick thick for architectural appearance only.

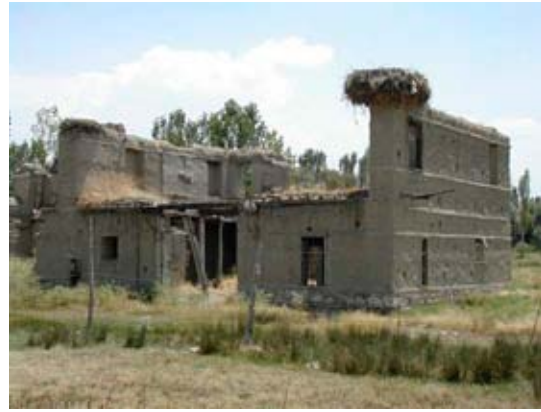
Fig. 15: Abandoned earthen house near Yazıköy, Turkey showing timber hatillar. Notice that the timber bond beams are on the inside as well as the outside of the walls. Photo by Jacqueline Homan (Homan, nd)

The historic origins of timber-laced-bearing wall construction can be found in the 5th Century AD Theodosian city walls of Istanbul, where the belts of red brick are an integral part of the architecture. Modern restorers, who reconstructed a portion of the walls mistakenly treated this only as an architectural element by applying a brick band as thin layer on the surface, rather than as a structural layer extending through the masonry (Figure 14). When the 1999 earthquake struck, this newly constructed section collapsed, while the surviving 1600-year-old heavily deteriorated portions of the wall were little affected by the earthquake (Figure 13). This system evolved into the timber-laced construction found in historic Turkish towns and villages today described below (Figure 15).

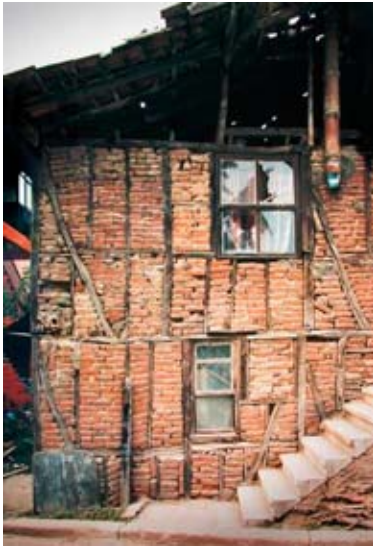
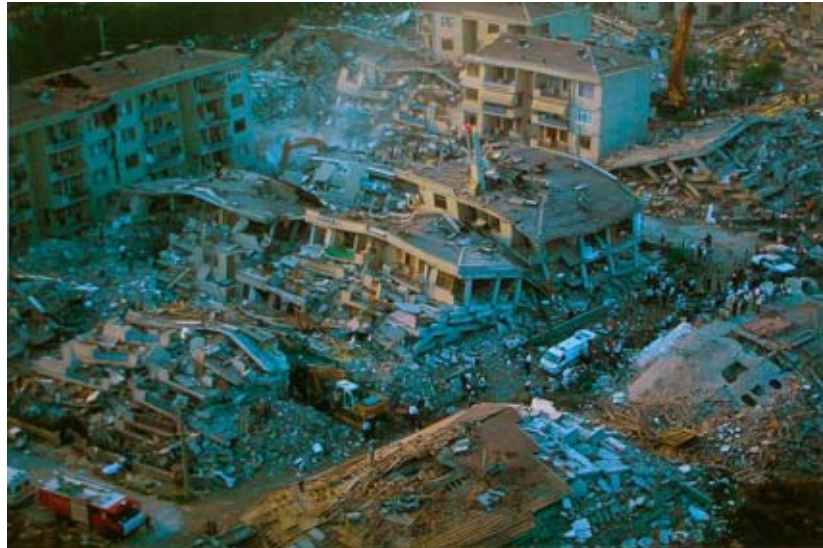
Fig. 16: *Hımsı* house in Gölcük, Turkey after the 1999 Kocaeli earthquake. This house, although old and abandoned, suffered almost no damage while many reinforced concrete buildings nearby collapsed.

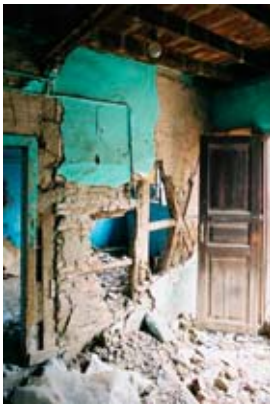
Fig. 18: Interior of *hımsı* house in heart of damage district in Adapazari after 1999. This building was abandoned and in poor condition when the earthquake struck.

performance of the traditional *himiş* buildings shaken by the same earthquakes. The small difference in the damage caused by the smaller and larger earthquakes demonstrates their ability to absorb the much increased shaking with little increase in damage (figure 17 & 18).

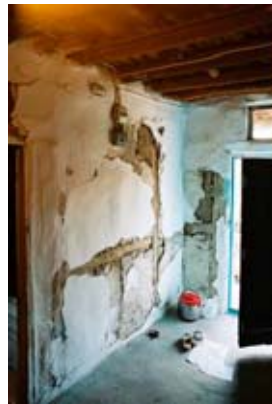
Fig. 19: Interior of *hımsı* house in Orta after 2000 Orta earthquake. This building has been occupied both before, during and after the earthquake.

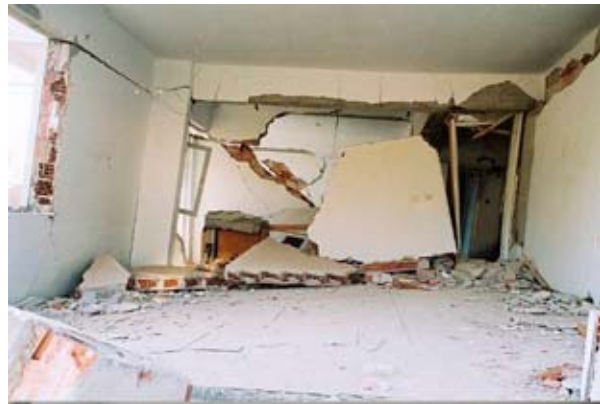
Fig. 20: Interior of partially collapsed multi-story apartment building in Golcuk after the 1999 earthquake showing how the hollow block unreinforced masonry infill walls have suffered a brittle failure contributing to the collapse of the building. This can be compared to the resilience shown in Fig's 17 and 18 of *hımsı* construction.

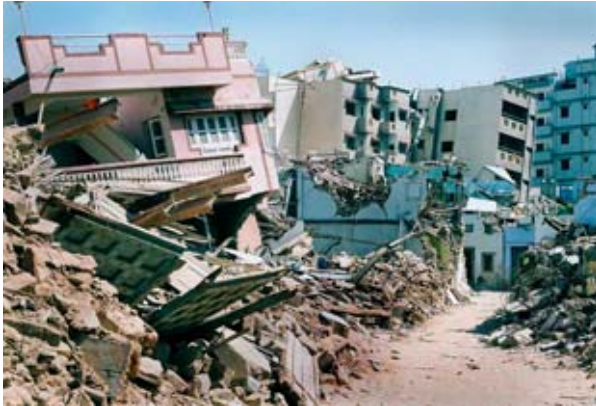
Fig. 21: Widespread collapsed of URM and RC buildings in Bhuj in 2001 Gujarat earthquake.

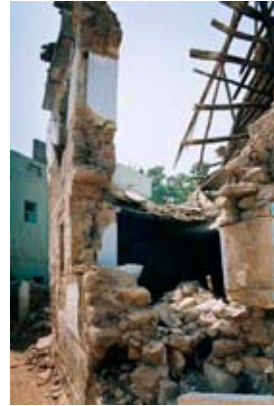
Fig. 22: Typical URM building in Bhuj in 2001.

The masonry consisted mainly of rubble stone laid in mud or weak lime-mud mortar. The newer construction was of reinforced concrete, with infill masonry walls (Figure 22).

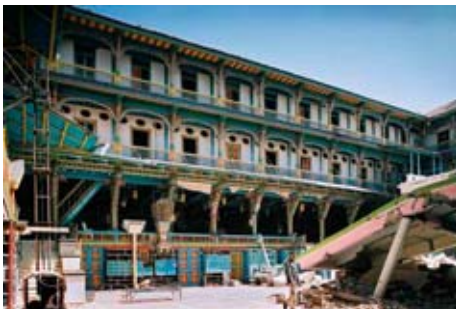
Fig. 23: Swaminarayan Temple in Bhuj after 2001 earthquake with collapsed RC structure in front.

buildings, all of which had weak masonry infill walls. The earthquake shook most of the rubble stone buildings to the ground; buildings with horizontally bedded ashlar performed better, but sections of their walls were often missing. Many of the RC structures appeared to have collapsed just as readily (Figure 21). Timber-reinforced construction, either the bearing wall type with horizontal timbers, or the infill-frame type, was extremely rare in Kutch. The only example found in this survey was a large building within the Swaminarayan Temple complex in Bhuj. This building, which dates from the early 19th Century, was unscathed by the earthquake, while a modern reinforced concrete building right in front of it collapsed (Figure 23).

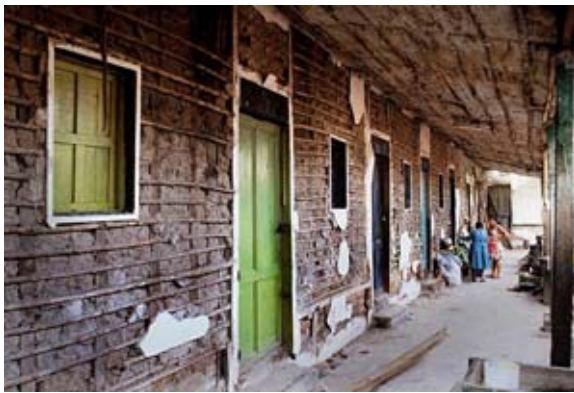
Fig. 25: San Salvador *bahareque* building after 1986 earthquake. The shedding of the plaster is evidence of the flexibility of the building. The infill masonry still in place shows its resilience.

In 1931, Freeman observed that “*the only serious damage was the shaking off of...practically all of the plaster.*” Likewise, in San Salvador in 1986 there were many *bahareque* buildings where the plaster had fallen off with no evidence of damage to the underlying walls (Figure 25). The dislodging of the plaster from nearly the entire surface of the walls is evidence of the distribution of the earthquake stress throughout the wall, which is indicative of good behavior because the earthquake stress is dissipated throughout the wall with small movements between the masonry and wood of what is inherently a flexible structure. As a result, there is no

single major destructive crack, and the energy of the earthquake is dissipated by the friction from the micro-cracking of the substrate which is confined between the studs.

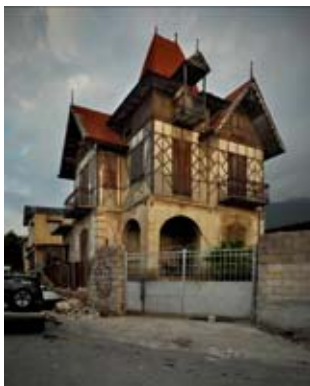
Fig. 26: Late 19th century “Gingerbread” house with a brick masonry ground floor and *colombage* upper floor in Port-au-Prince after the 2010 Haiti earthquake. Less than 5% of the 100 or more year old Gingerbread Houses suffered collapse.

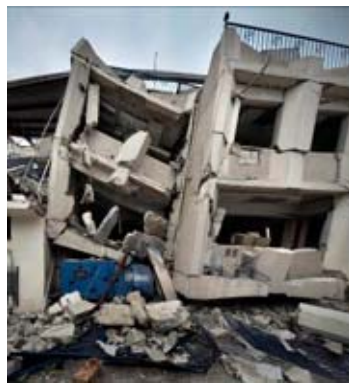
Fig. 27: One of many of the Modern reinforced concrete office buildings in Port-au-Prince that collapsed in the 2010 Haiti earthquake. Approximately 40% of the buildings in the downtown area were partially or totally collapsed – most of which were reinforced concrete.

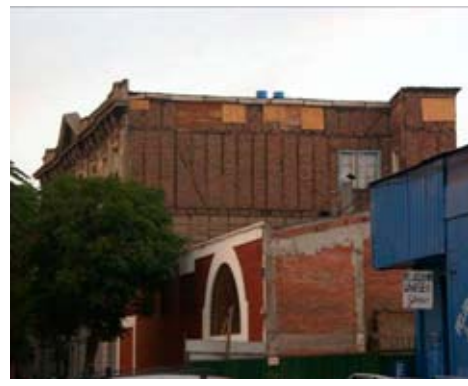
Fig. 28: A timber and masonry infill wall on a three story late 19th century building in Chile after the 2010 earthquake. At magnitude 8.8, the Chile earthquake was much larger than the 7.0 in Haiti, with strong shaking lasting over a minute. *Photo by Luigi Sorrentino*

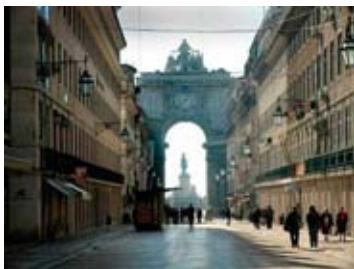
Fig. 29: Lisbon area rebuilt with *Gaiola* walls after 1755.

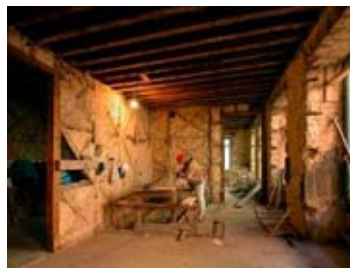
Fig. 30: Typical *gaiola* wall exposed in remodeling project.

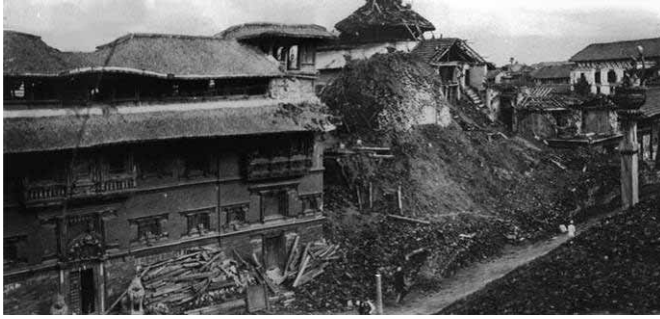
Fig. 33: The Patan Durbar Square with the Keshav Narayan Chowk left and the Degutale Temple right after the 1934 earthquake. The temple is totally collapsed, and the rear wing of the Palace collapsed. Photo credit: www.asianart.com

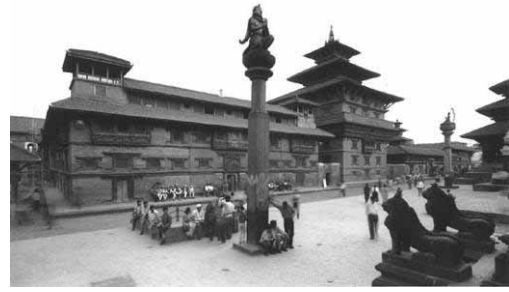
Fig. 34: Similar view of Patan Durbar Square after the 1934 reconstructions. The palace was again in such bad repair by 1980, that it was rebuilt in its entirety as a museum between 1983 and 1992. Photo Credit: (Hagmueuller,2001).

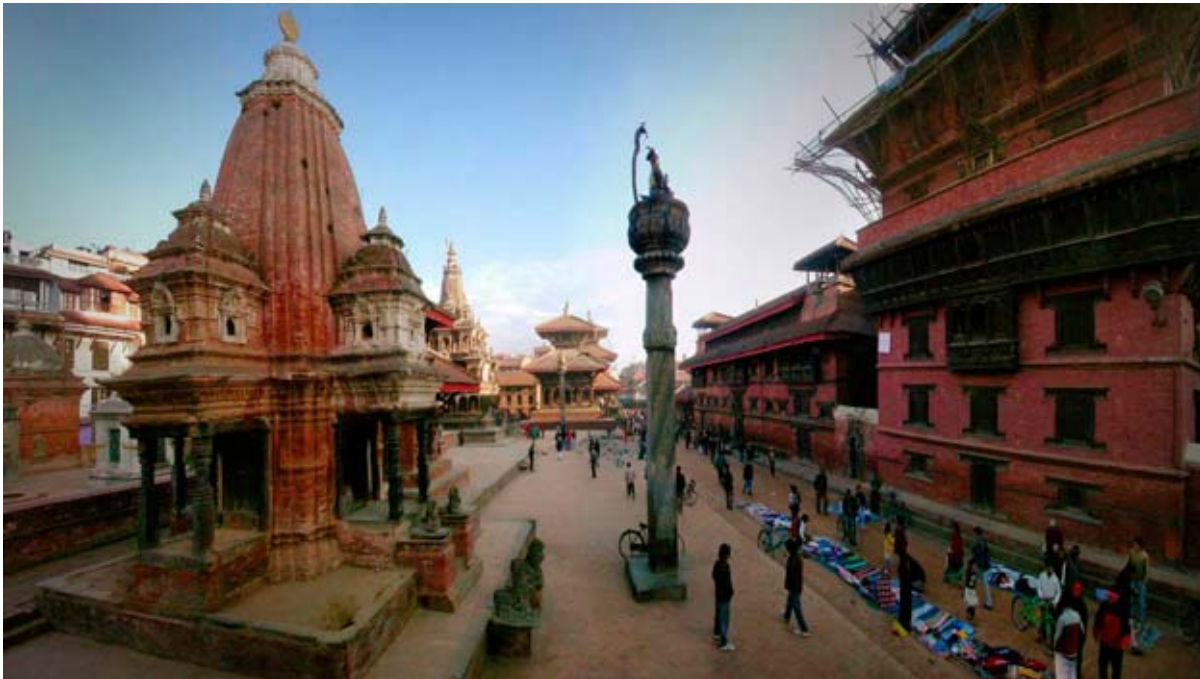
Fig. 35: Patan Durbar Square in 2000, showing the cluster of monuments, temples, palaces and shrines that give character to this extraordinary space. A large stone plaque at the entrance to the square with a lengthy 260-word paragraph history of the buildings on the square describing their construction in the 17th and 18th centuries, which says absolutely nothing about the 1934 earthquake, and the fact that the present structures on the right have been entirely reconstructed. What is important from a cultural heritage perspective, though, is the fact that all of the reconstruction has been done with traditional materials and methods using the original pieces or new materials made in the traditional way, even though in the later restorations, some earthquake hazard mitigation work has been added. Interestingly, the column in the center was not toppled by the earthquake, as can be seen in Fig 33.

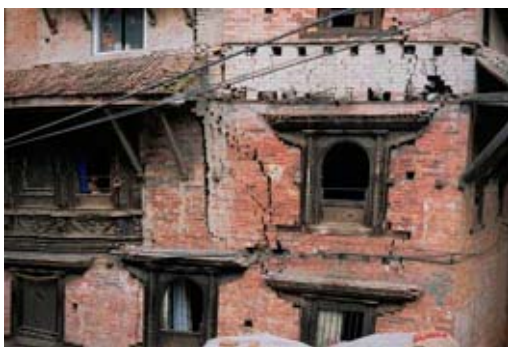
Fig. 36: Lacking timber lacing found in Kashmiri houses, the unrestrained brick walls of this house in Kathmandu are visible coming apart from differential settlement and perhaps some minor earthquake tremors.

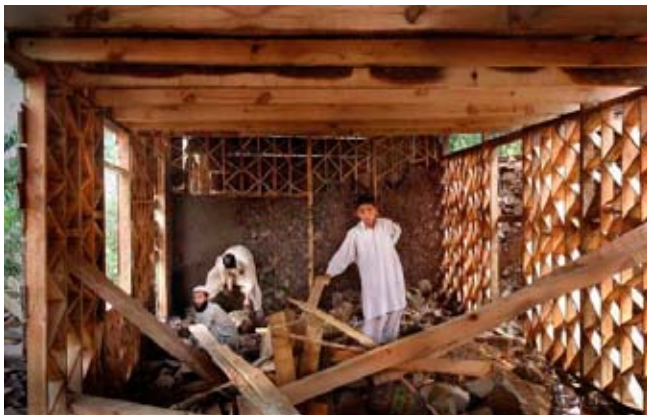
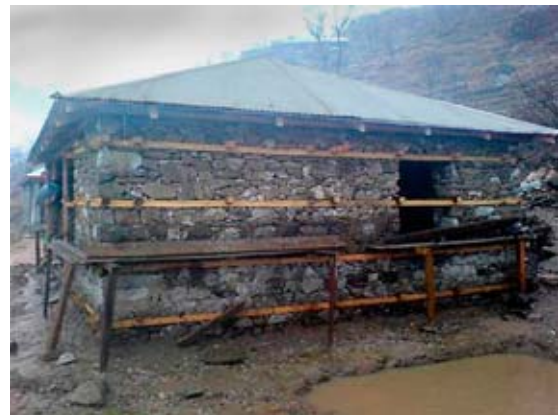
Fig. 40: (left): A rural Pakistan family whose rubble stone house collapsed in the 2005 Kashmir earthquake are rebuilding their house using *dhajji* construction after witnessing that the one building in the village that did not fall down was of *dhajji* construction. The others of both rubble stone and reinforced concrete were collapsed. Photo by Maggie Stephenson, Un_HABITAT. (right) A new *bhatar* building under construction in the northern Pakistan to show government-approved detailing for *bhatar* after this system was approved for earthquake reconstruction. Photograph taken in 2007 by Tom Schacher for the Swiss Agency for Development and Cooperation (SDC).

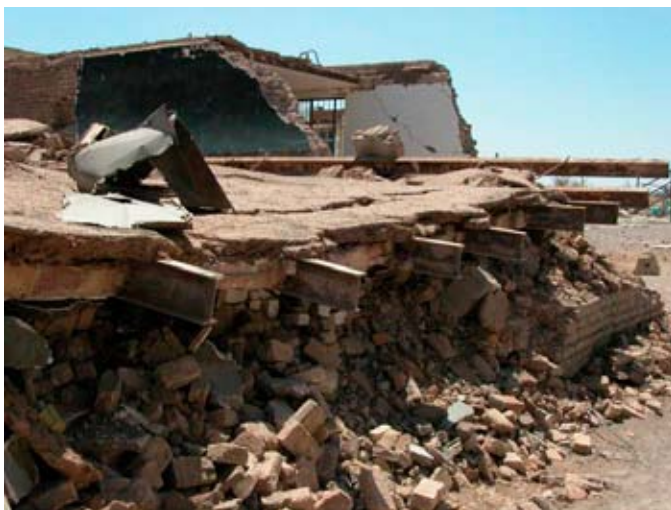
Fig. 41: Earthquake-collapsed adobe (in Farsi known as *khesht*) building in Bam, Iran with roof of steel and fired brick. The buildings with mixed traditional unfired clay brick with steel and fired brick floors and roofs proved particularly vulnerable in the 2003 Bam earthquake.

masonry roofs on adobe walls, rather than those adobe buildings with the older system of adobe masonry vaults. These and other examples of the earthquake failure of buildings where pre-modern and contemporary construction technologies have been combined can serve as a warning of the potential perils of intermingling modern construction in reinforced concrete with existing traditional construction in heritage buildings undergoing repair and seismic strengthening work.

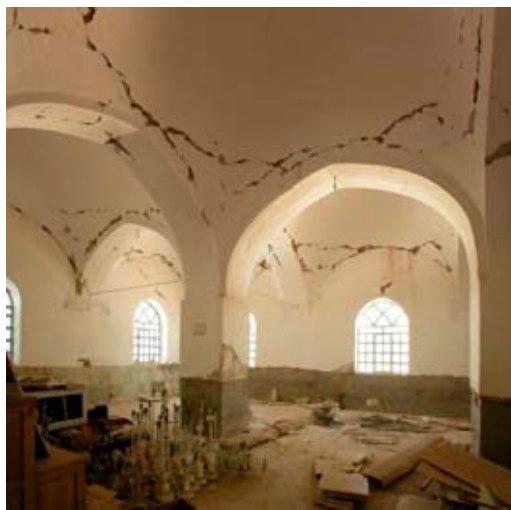
Fig. 42: Interior of a traditional unfired clay brick vaulted building in Bam after the 2003 earthquake showing earthquake damage, but no collapse.

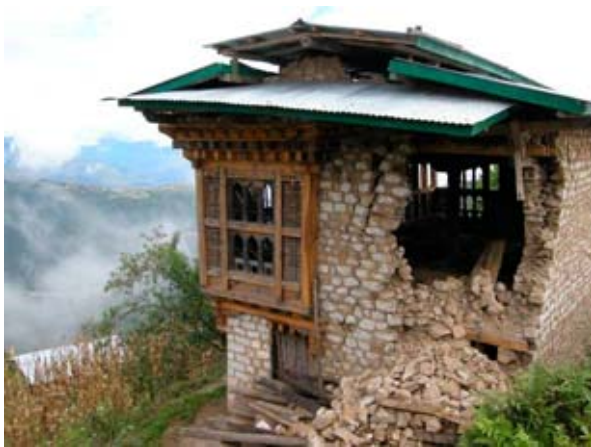
Fig. 43: Damage to a masonry with clay mortar house from the 21 Sept. Earthquake. Photo by Mark LaPrairie for the World Bank

The Bhutanese traditional buildings in the central and eastern part of the country are most often made of unreinforced masonry bearing walls with timber floors, sometimes with roughly shaped stones set in a mud mortar. The conventional wisdom is that such construction is particularly vulnerable to damage in earthquakes, and some indeed were damaged in the 2009 earthquake (Figure 43 & 44).

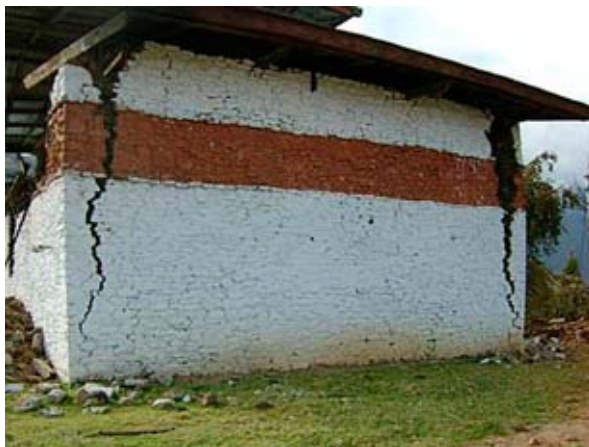
Fig. 44: Damage to a masonry house from the 21 Sept. Earthquake. Photo by Mark LaPrairie for the World Bank

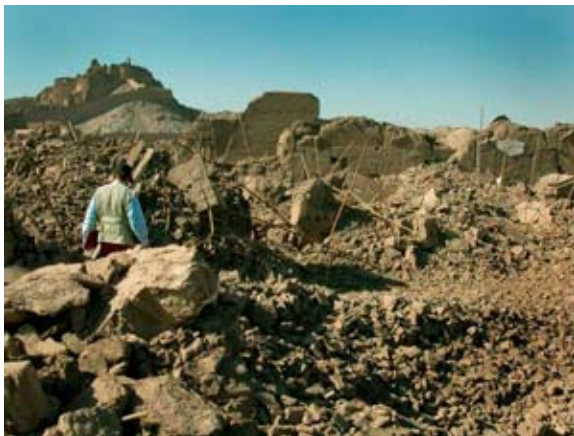
Fig. 45: The Arg-eBam, or Bam Citadel, which includes the walled city that surrounded the governor's palace, almost entirely collapsed in the 2003 earthquake. The parts that collapsed had all been reconstructed or restored from 1950 onwards. Ironically, those parts that had not been restored suffered less damage or remained undamaged.

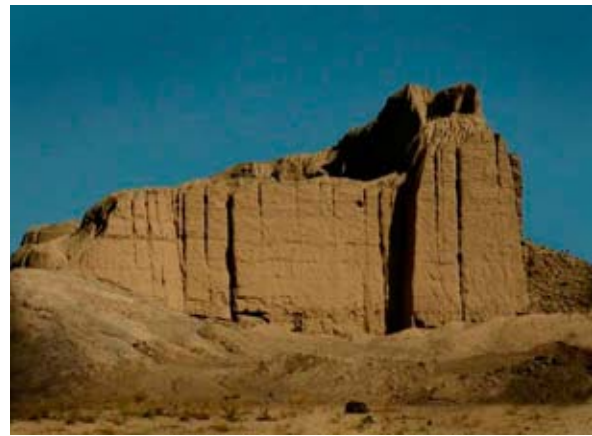
Fig. 46: The Ghal-e-Dokhtar (Castle) in Bam. This earthen structure (*chinnah* in Farsi for built up, but not rammed, earth) survived the earthquake with very little damage. It has not been altered or maintained in over 150 years, providing a remarkable example of earthquake resilience in an ancient earthen structure. (See Langenbach, 2004 for more information)

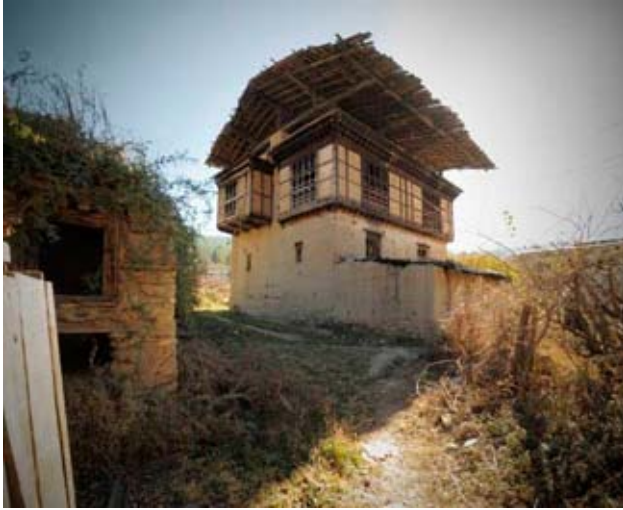
Fig. 47: Historic Rammed earth building in Thimphu now becoming surrounded by the expanding city of concrete multi-family housing. Photo by the author while in Bhutan for the “Living in Harmony with the Four Elements” Conference.

In the western part of Bhutan, the typical historic construction is with 80-100cm walls of rammed earth instead of stone (Figure 47). Earthen construction is one of the most common building systems in the world, but, as the earthquakes in Bam, Iran and in Chile have shown, earthen construction presents significant mitigation challenges to deal with the earthquake risk. However, as seen in Bam after the 2003 earthquake that devastated that city, not all unfired clay structures collapsed. Most revealing was the discovery that many unrestored and unmaintained structures which were even of ancient origin, survived the earthquake in the heart of a damage district that saw the collapse of modern steel frame buildings as well as the earthen structures within the ancient Arg-e Bam that had been restored in the 20th century! (Figure 45 & 46)

Fig. 52: The juxtaposition of houses which are genuinely of traditional timber and masonry construction and ones of reinforced concrete with concrete block can be seen in Thimphu (left) and a village (right). In Thimphu, this genuine traditional farmhouse, also shown in Figure 47, serves to show how the mere use of Bhutanese style windows fails to reduce the alien quality of its outsized neighbor. Had these same accommodations been contained in a cluster of sections of smaller bulk on the same property to form a group, the visual interest and compatibility would have been both more interesting and more respectful of its neighbor – and of Bhutanese cultural heritage in general. The Government's *Traditional Architecture Guidelines* does not address this issue.

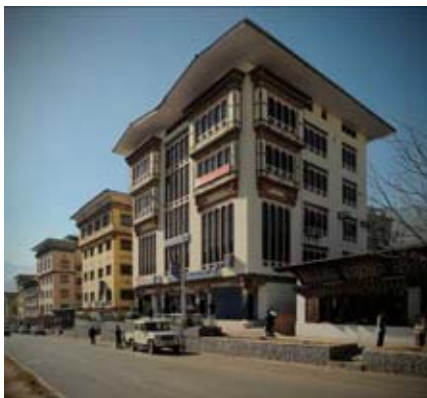
Fig. 48: This building in Thimphu is an example of the use of iconic elements from Bhutanese vernacular architecture on an outsized modern steel and concrete building. The absence of traditional construction materials and methods leads to a conspicuous departure from the essential character that makes traditional Bhutanese architecture so distinctive and of high artistic quality.

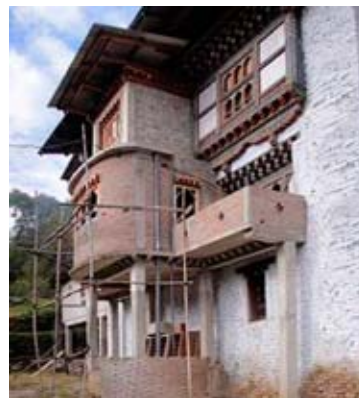
Fig. 49: A Bhutanese traditional masonry and timber house in Rongthong Ngat-shang with modern RC additions attached to it. In the event of a significant earth-quake, these additions, which lack shearwalls, are at risk of collapse. Their weight also increases the risk of damage or collapse of the historic house.
Photo credit: UNESCO Report by Jigyasu & Karanath.

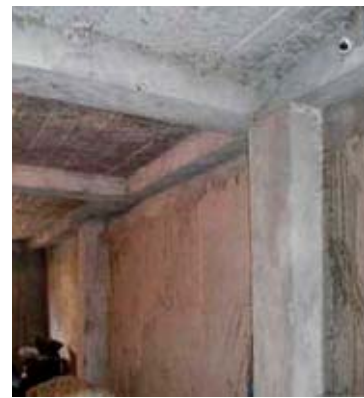
Fig. 50: Interior of traditional house where the timber structure of the first floor has been demolished and replaced with reinforced concrete resting on its own reinforced concrete frame. Notice that the columns do not line up with the beams, which is usually a poor structural detail.
Photo credit: UNESCO Report by Jigyasu & Karanath.

Frequently in Europe and North America buildings made of pre-modern construction of masonry have had their internal structural systems rebuilt with strong modern materials, saving only the facades and architectural features. Vernacular buildings, where the architecture and the structure are one, are effectively destroyed when this happens. For example, the ripping out of a wooden floor and its replacement with concrete, and the insertion of a concrete frame into a stone building is so radical that the heritage completely loses its integrity and thus most of its cultural significance (Figure 50).

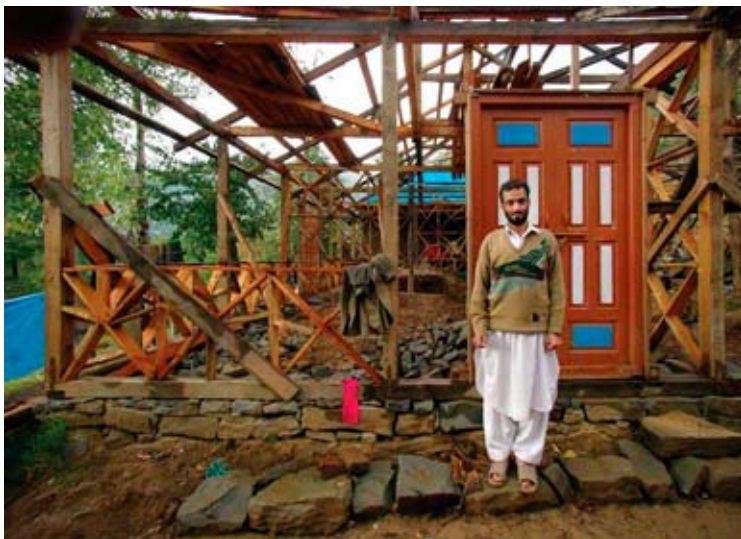
Fig. 51: These rural farmers in remote parts of Pakistan Administered Kashmir lost their rubble stone houses in the 2005 earthquake. They were photographed in 2007 standing in front of the houses they were rebuilding with their own hands using *dhajji dewari* construction. They and many others in these same villages began to reconstruct their houses using this traditional technology well before the Pakistan Government agreed to provide financial assistance for reconstructions in other than the government-approved designs in reinforced concrete. *Dhajji* construction was approved a year after the earthquake, and within about four years after that, UN-HABITAT reported that approximately 250,000 new *dhajji dewari* houses had been constructed within the earthquake damage district.
