Keynote Address  
**Back to the Future:**  
**Lessons from the Past for a more Earthquake-Resistant City**

Randolph Langenbach  
*Conservationtech Consulting*  
Oakland, California, USA

**Abstract**– This Keynote Address focused on traditional construction typologies that have been found to be earthquake resistant. The presentation covered examples found in both Kashmir and Gujarat, documenting their performance in the 2001 Gujarat earthquake and the 2005 Kashmir earthquake. The talk then discussed examples of similar forms of construction in other parts of the world including Portugal, Turkey, Pakistan, and Afghanistan, showing comparisons of the performance of the traditional buildings with that of modern buildings of reinforced concrete. The talk concluded with a review of the urban design issues and development problems that have emerged with the almost universal adoption of reinforced concrete construction in urban areas in India and in other regions around the world.

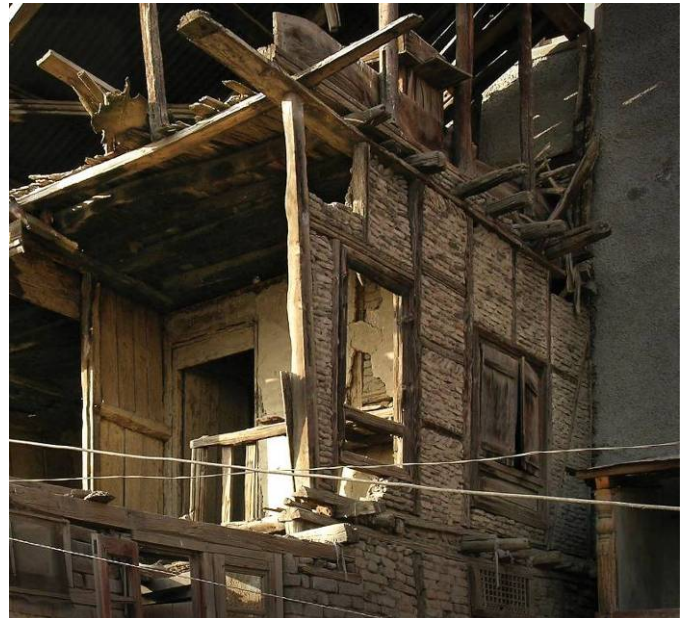
Fig. 2 Detail of *dhajji dewari* construction in a building under demolition in Srinagar, showing the timber frame, with the single-layer brick masonry infill. The walls are thin and light, when compared to bearing wall masonry. Notice how the floor joists are sandwiched between timbers at the floor level. This gives a strong friction connection between the floor diaphragms and the walls.

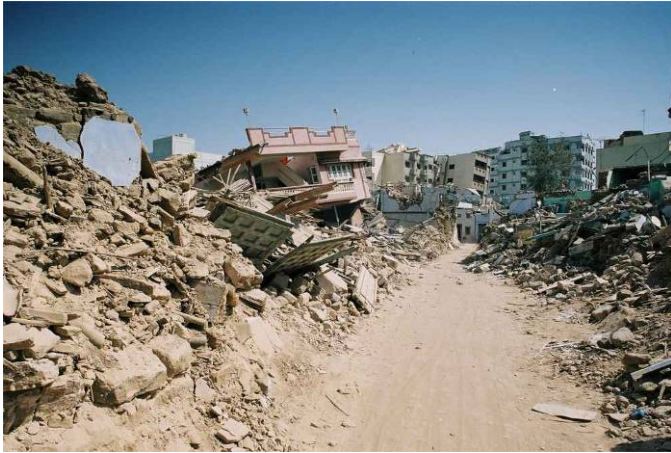
Fig. 3 A view within the historic walled city area of Bhuj after the 2001 Gujarat earthquake. In this area of the city, most of the historic buildings were of rubble stone masonry construction and the modern buildings were of reinforced concrete. As can be seen in the photograph, the earthquake destroyed many of both types of construction.

Particularly relevant in India is the fact that the buildings in the walled city of Bhuj were largely of rubble stone construction, which is particularly vulnerable to earthquake collapse, while almost all of the historic buildings in the walled city of Ahmedabad were of timber-laced bearing wall masonry or timber frame with infill masonry construction. In both cities, by comparison with the pre-modern construction, many modern reinforced concrete buildings collapsed. A comparison of the performance of these two cities, both

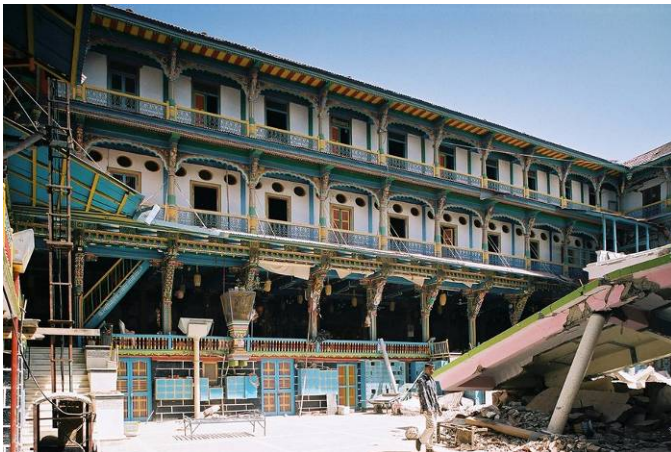
Fig. 4 This building in the Bhuj branch of the Ahmedabad-based Swaminarayan Temple is located in the heart of the walled city of Bhuj, yet it survived almost undamaged, while the modern concrete pavilion seen on the right collapsed. The construction is of timber frame with masonry infill, like that otherwise common in Ahmedabad, but rare in Bhuj.

affected by the earthquake, provides a good opportunity to see the resilience of both timber-laced bearing-wall masonry and timber frame with masonry infill construction.

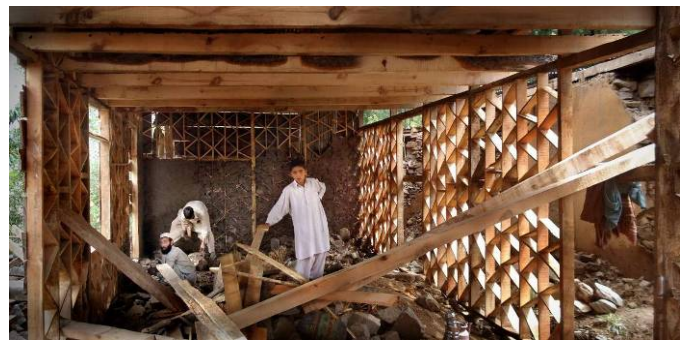
Fig. 5 New house being constructed in *dhajji dewari* by owner-builder in Pakistan Kashmir after the 2005 earthquake destroyed the prior house, which was of unreinforced rubble stone masonry. This family embarked on this construction after seeing that the one house to survive in the village was of *dhajji* construction. At the time they began construction, the Pakistan government would only provide reconstruction assistance for concrete construction, but one year after the earthquake, the government approved *dhajji* construction for assistance.

As can be seen in Figure 5, there were some owners who nevertheless reconstructed their houses using the traditional *dhajji* form of construction after seeing that older houses of this type survived while the newer ones of rubble stone and also even of concrete construction failed. In addition, the cost and difficulty of transporting the materials for concrete construction into the rural countryside made such construction almost impossible to undertake, regardless of the government grants.

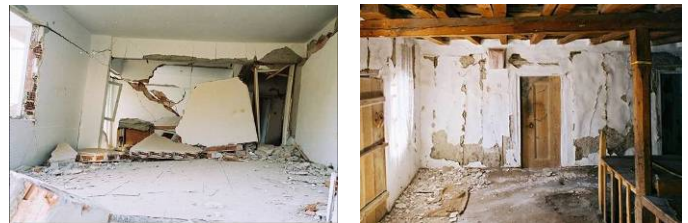
Fig 7 left: A view of a collapsed infill masonry wall in a reinforced concrete building in Gölçük, Turkey after the 1<sup>st</sup> 1999 earthquake, showing how the brittle masonry wall can collapse out of the concrete frame soon after it begins to crack when the frame deforms from the earthquake forces. right: A view of a *humus* construction wall showing how the timber frame has held the masonry panels in place for the duration of the earthquake, despite the shedding of the plaster surface.

Langenbach's research on a comparison between the damage seen in 1999 and that seen in Orta in 2000 provided an opportunity to show why the concrete frame construction is often perceived as more *pucca* (strong) than it often really is. Timber and masonry buildings will often show damage to exterior and interior plaster and to some of the infill masonry at low levels of shaking, while the onset of damage in concrete buildings at that same level of shaking is largely inconspicuous, but ultimately more dangerous, hairline cracking. In the higher levels of shaking experienced in the 1999 Marmara earthquakes, the traditional buildings demonstrated their resilience over many strong-motion cycles, where the slow progression of damage helped to dissipate the energy of the earthquake, while the lack of such energy dissipating capacity was demonstrated by the rapid collapse of many of the reinforced concrete buildings.

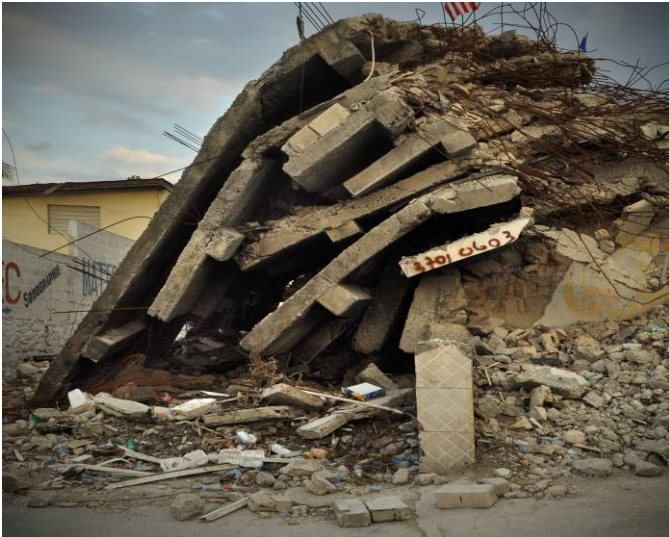
Fig.9 Remains of a collapsed multi-storey building in Port-au-Prince Haiti after the 2010 earthquake that devastated the city. The pancake collapse of reinforced concrete buildings is usually lethal to most of the occupants, and because of the strength of the concrete floor slabs, the finding and extraction of the survivors in time is exceedingly difficult.

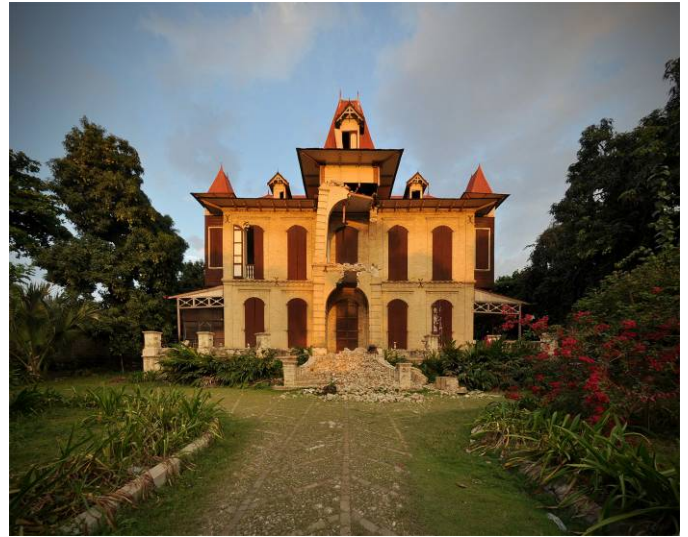
Fig 11 A late 19<sup>th</sup> century house in Port-au-Prince after the 2010 earthquake. The construction of the masonry walls in this house is a combination of brick and rubble stone. Despite the use of extensive internal sections of rubble stone, the house remained standing, although extensively damaged – thus showing a better performance than at least 40% of the reinforced concrete buildings in Port-au-Prince, which collapsed.

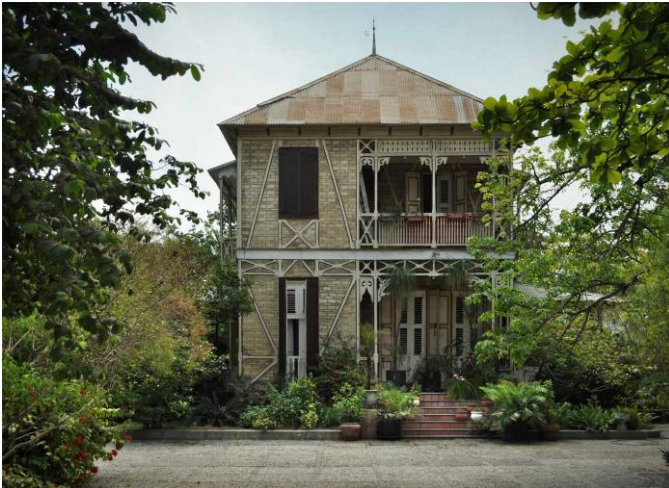
Fig. 10 A late 19<sup>th</sup> century house of *colombage* construction in Port-au-Prince after the 2010 earthquake. This house, despite its age, suffered only minor damage. *Colombage* is the French word for timber frame with infill masonry construction, similar to that found in Turkey, as well as in India in Srinagar and Ahmedabad.

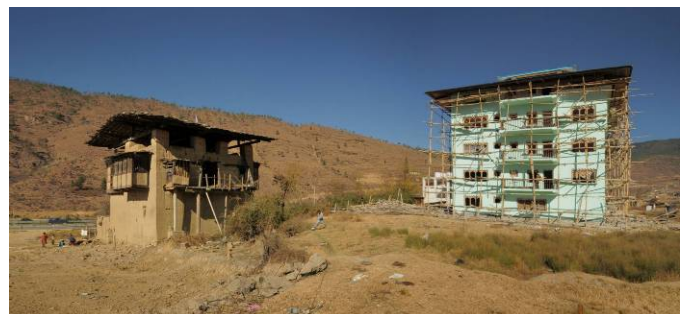
Fig 12 A traditional rammed earth and timber Bhutanese house on the edge of Thimphu next to a new multi-story house of reinforced concrete construction. [4]

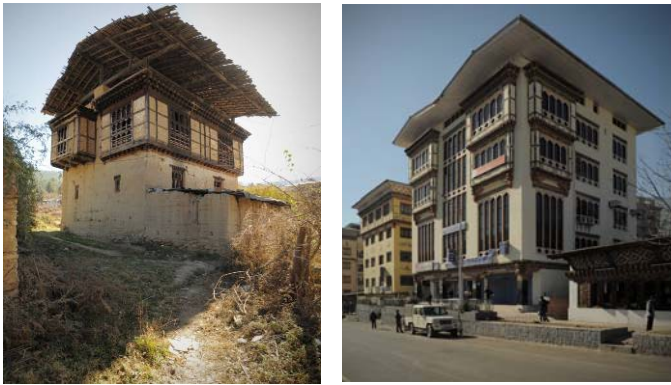
Fig 13 A comparison of a traditional rural Bhutanese house of rammed earth and timber construction (*left*) next to a new hotel in downtown Thimphu of reinforced concrete frame construction. The traditional *rabsel*, or projecting window-wall can be found on both buildings, but it appears tacked onto the side of the modern structure, rather than an integrated and culturally consistent part of its architecture. [4]

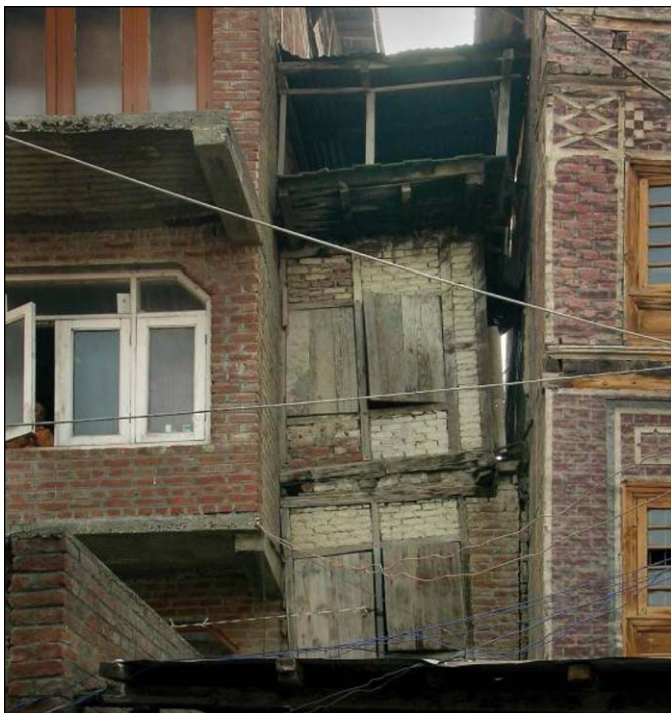
Fig. 14 A view in 2005 of a traditional building in Srinagar, Kashmir where part has been demolished and replaced with a new concrete block, probably after the building was subdivided between two members of the same family.
