A Rich Heritage Lost The Bhuj, India, Earthquake

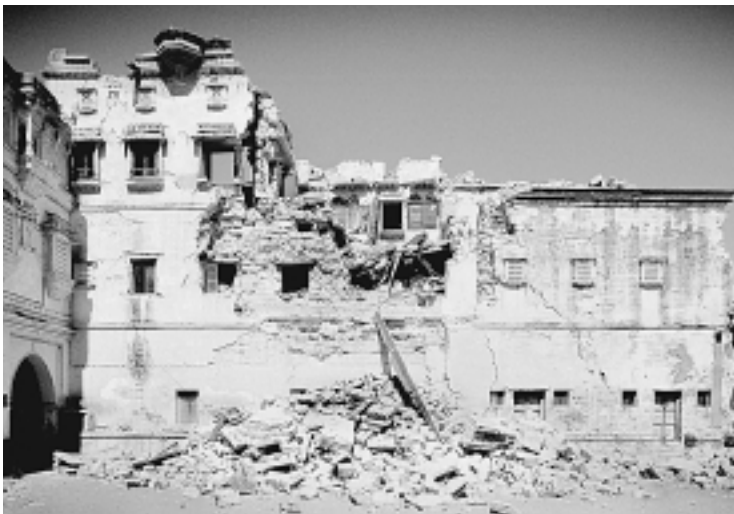
Bhuj, India.

The first view of the inner precincts of the walled city of Bhuj was shocking. In the area immediately inside the city gate, the buildings had almost totally disappeared into rubble piles

that lay along either side of the road like great waves. Riding on these “waves” were the still whole pieces of the upper floors of broken newer concrete buildings.

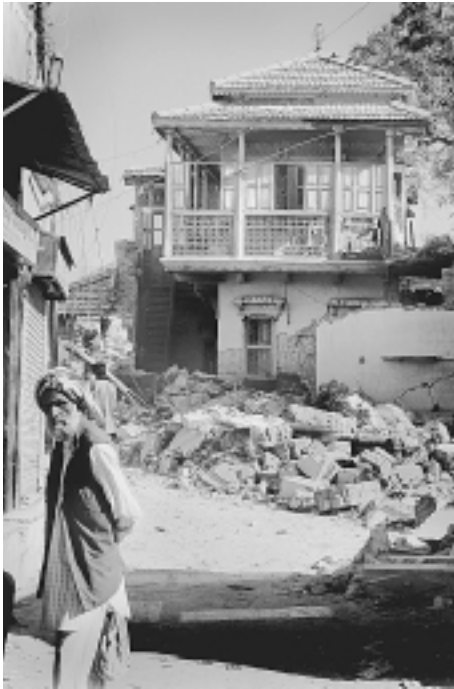
Anjar, India

the now powerless Maharaja families. Despite the fact that they remained full of the art and culture of the region, nowadays they are not under any heritage protection and often they are not maintained. Now, the earthquake has turned many of these former palaces into ruins.
