# **SURVIVORS IN THE MIDST OF DEVASTATION, Traditional Timber and Masonry Construction in Seismic Areas**

Randolph Langenbach<sup>1</sup>

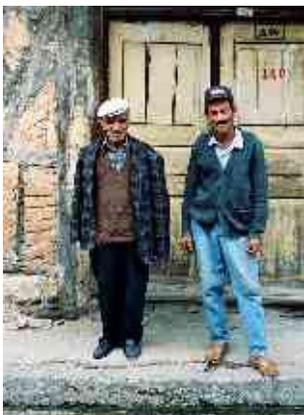
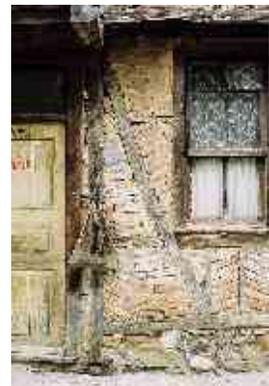
ABOVE & RIGHT: Himis house constructed by the father of these brothers in 1945. It survived the earthquake with only cosmetic damage.

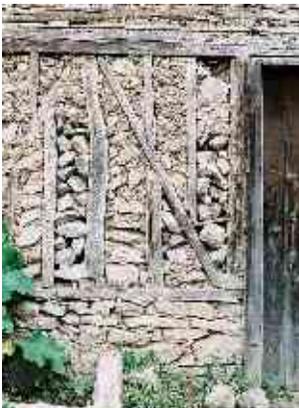
Hıngı construction with stone infill, Safranbolu, Turkey

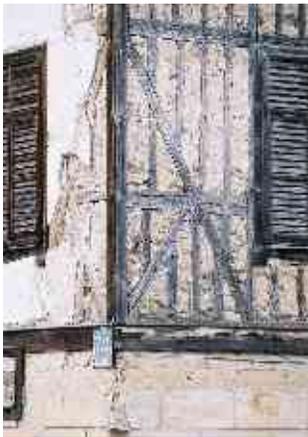
"Hınıs" house with stone infill with mud and lime mortar, Saffronbolu

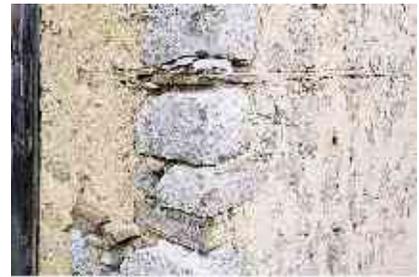
Detail of stone 1st story of house showing "*hatıllar*" imbedded in wall, lapping at the corners.

In the many houses that have the first story of stone bearing walls, the stone is often laced with horizontal timbers, (In Turkish: "*hatıl (s) hatıllar (pl)*"). Frequently these timber reinforcements consist of very thin timber boards laid into the wall like a course of masonry, at vertical intervals of about 3 feet (1m). They are placed so as to overlap at the corners. They thus serve to bind the stone layers together without interrupting the continuity of the masonry construction.

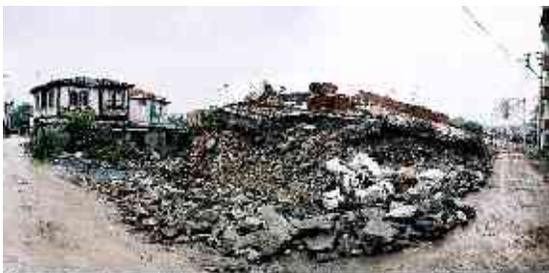
Surviving "*hınıs*" house next to collapsed row of reinforced concrete buildings, Adapazarı

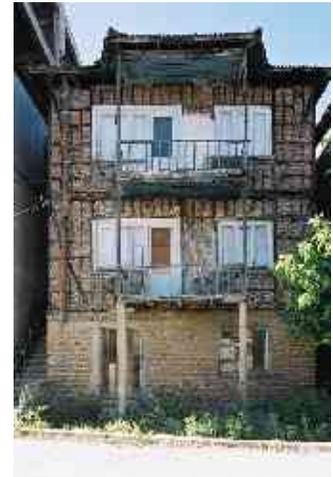
Undamaged, 3 story "Hımsı" style in heart of damage district, Gölcük

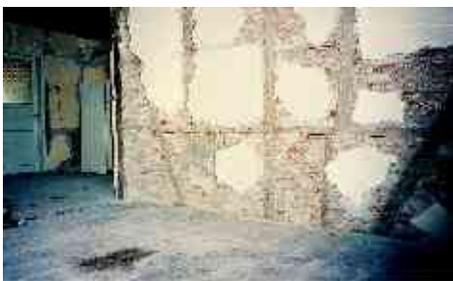
Damaged "Hımsı" house in Düzce showing intact infill wall under plaster shed by the "working" of the wall

The reconnaissance of the damage district included the examination of the interiors of some houses that outwardly appeared to be undamaged. This more detailed survey resulted in the following observations: (1) It was evident that the masonry infill walls responded to the stress of the earthquake by "working" along the joints between the infilling and the timber frame. This was manifested as cracks in the interior plaster along the walls and at the corners of the rooms. This level of damage was evident in every house examined on the

interior. (2) In those cases where the damage was more extensive, small sections of the infilling had fallen out from between the studs near the top of the upper story walls.

(3) In those few observed cases where the damage had compromised the timber frame, this damage was usually manifested as separation of vertical timbers from the sill plate at the base of the structure. (4) Shear 'X' cracks within the masonry panels where the masonry units (in this case always fired bricks) were not observed in any of the examples. (5) The subdivision of each structural bay with a tight network of vertical, horizontal, and diagonal timbers, rather than vertical studs alone, appeared to have been successful in reducing the possibility of the masonry falling out of the frames because of the crushing or shear cracking of the individual panels.

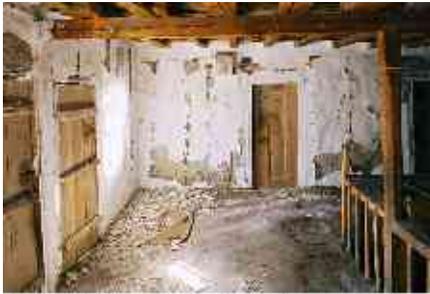
Interior of "huniş" style house after earthquake  
Orta, Turkey

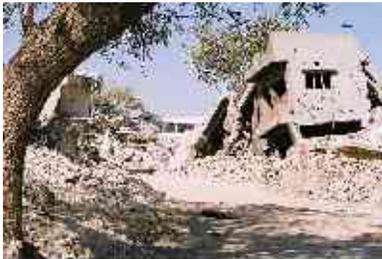
View of the center city of Anjar, India, showing destroyed stone and reinforced concrete buildings.

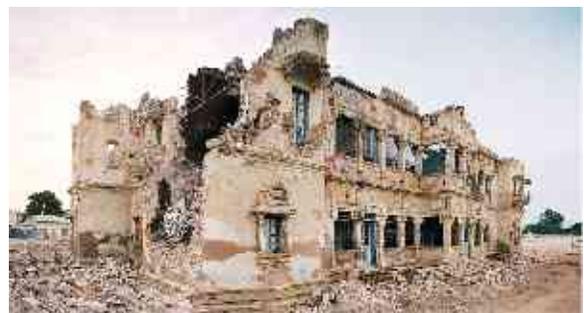
Bhuj Hospital, a masonry building without timber lacing, showing effects of the earthquake

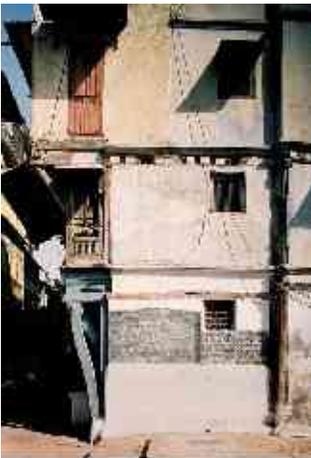
House with timber lacing in Ahmedabad

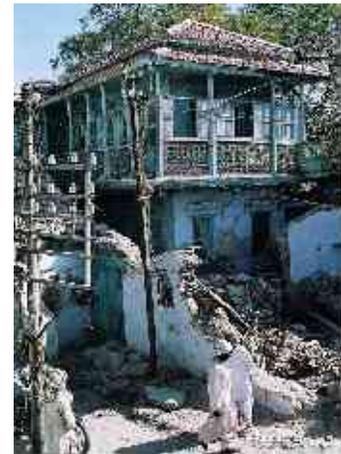
This balconied house in Anjar survived two large earthquakes that destroyed the city.

Among the surviving masonry buildings in Kutch, however, there were a disproportionate number of buildings with balconies. This feature illustrates that, even when the damage in a district was almost total, the differences between whether a building collapsed or not could often be determined by something as simple as having the joists continue through a wall to support a balcony, rather than terminate in shallow pockets. What this observation shows is that even in a profoundly devastating earthquake, the kind of difference in design that can reduce the risk of collapse may be something that is neither rare nor particularly sophisticated. The basic protection provided simply by strapping a building together might be all that is needed to reduce losses substantially – which is exactly what the timber does in the masonry construction in Turkey – and Ahmedabad.

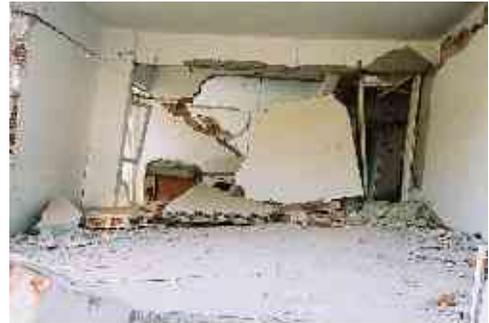
RC construction in Golcuk after earthquake showing collapsed infill wall.

Turkey, India, and many other seismically active areas of the globe, is also a form of infill frame construction. However, in this modern construction, the infill is not considered as part of the lateral resisting system. Rarely are the infill walls subdivided, and sometimes, to avoid damage to the frame from the “diagonal strut” effect, there is even a separation of the infill from the frame. In Turkey, the infill walls are most often constructed using a very thin-walled hollow clay tile that had the strength and brittleness of a dinner plate. In India, solid brick was more often used, but the brick was fired at a low temperature, and thus very weak.

While the infill in modern construction has often performed notably badly, it is the infill in traditional construction that has performed comparatively well. This observation raises two important questions: (1) Is it possible to bring into the reinforced concrete construction arena some of the performance characteristics that have made the timber frame infill construction work relatively well? (2) If such can be done, is the effort worth it? Research and testing is necessary to fully answer these questions, but I believe that from the evidence that already exists there are lessons that can be learned from the traditional construction that can improve modern construction – particularly in those countries where concrete practices are poor, and where the unregulated building development and lack of enforced building codes prevent even a minimum level of quality control.

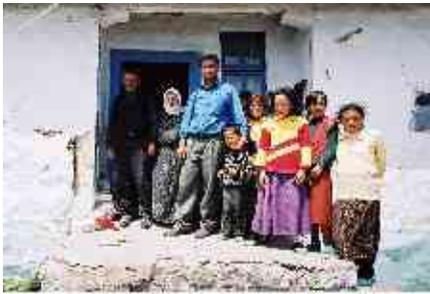
Fanning family in Ordu standing in front of their "birney" house. The working of the masonry is visible as cracks in the stucco.
