**SURVIVORS AMONGST THE RUBBLE:  
Traditional Timber-laced Masonry Buildings that Survived the Great 1999  
Earthquakes in Turkey and the 2001 Earthquake in India,  
While Modern Buildings Fell**

**Summary**

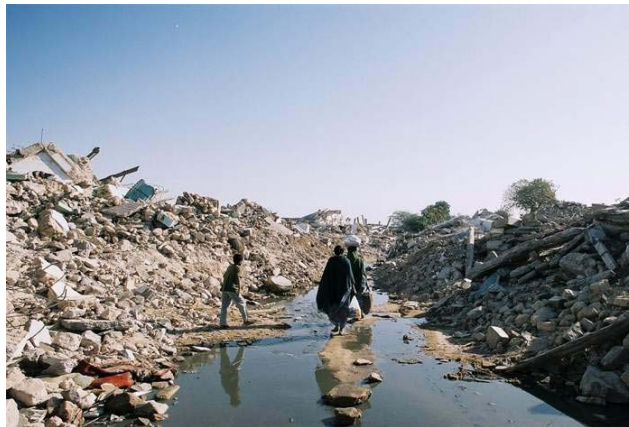
Figure 1: View of Anjar City Center after the Bhuj Earthquake of January 26, 2001.

The Kocaeli and the Bhuj Earthquakes in Turkey and India were devastating disasters, with vast destruction of buildings and countless deaths and injuries in both urban and rural areas. One particular problem unique to urban areas was dramatically illustrated in the recent Bhuj Earthquake when, in the town of Anjar, several hundred school children participating in a Republic Day parade were killed while standing *outside* the buildings. This tragedy occurred because the walls of the surrounding buildings collapsed outward into the narrow street where they were standing, from which there was no escape.

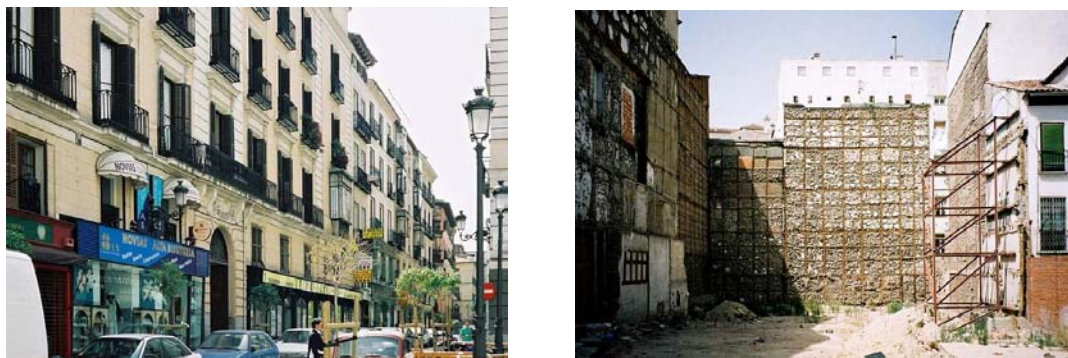
Figure 2 a&b: Timber and masonry infill-frame construction near the Plaza Major in Madrid – hidden in the facades, but revealed by demolition behind.

Timber-laced construction can also be found in both Spain and Portugal. In Madrid, many of the buildings in the historic central area around the Plaza Major which appear today as solid masonry buildings underneath a layer of stucco are, in fact, composed of walls of timber with brick or rubble stone masonry infill (Figure 2). Many of the buildings in Lisbon that were rebuilt after the great Lisbon earthquake of 1755 were constructed with heavy timber frames imbedded in the masonry, in this case a deliberate response to the earthquake risk. In fact, the Lisbon example may have been based on observations of earlier timber-laced buildings that may have done comparatively well in the earthquake, thus encouraging its more elaborate use for earthquake hazard mitigation during the reconstruction.

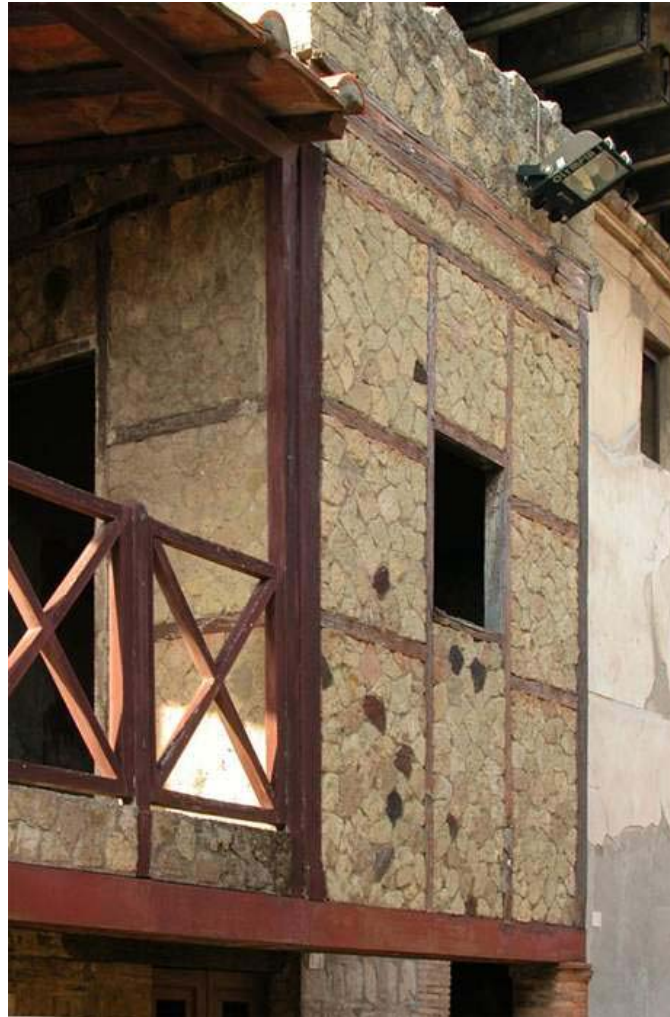
Figure 3: Pre-79AD Infill-frame construction found and restored at Herculaneum.

Because it is rare for the wooden armature of these sorts of buildings to survive as archeological ruins, the chance of finding ancient examples of the infill-frame construction type is low, but the unique burial under volcanic mudflows, and the modern-day archeological uncovering of the Roman town of Herculaneum in Italy has provided the unique opportunity to peer back through 2000 years and find early examples of this type of construction. (Figure 3)<sup>3</sup>

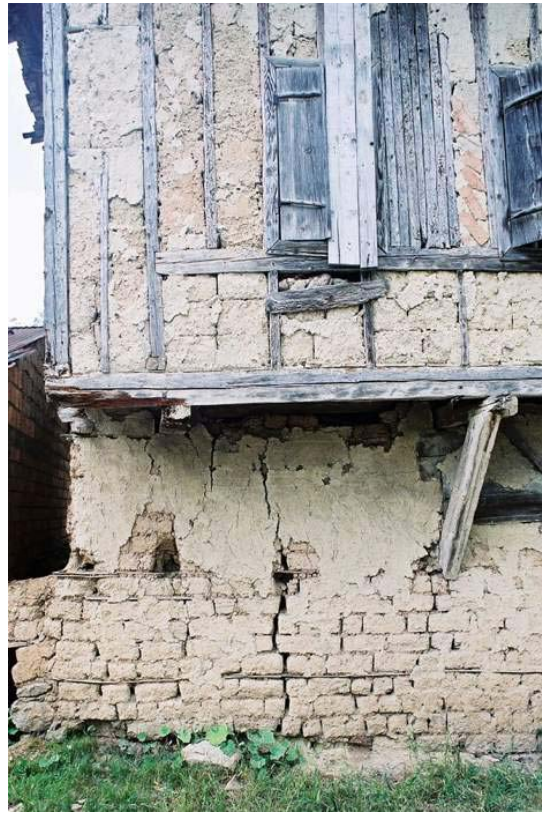
Figure 4: View of Infill-frame construction in the historic Ottoman town of Safranbolu, Turkey

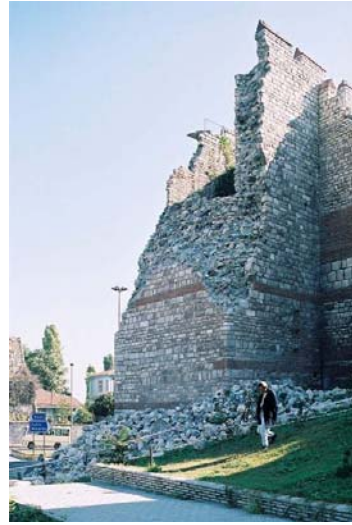
Figure 5 & 6: Istanbul City walls showing brick banding in surviving historic section and collapsed reconstructed section with fake banding.

Laced Bearing Wall construction may have had its origins in ancient times as well, although it is not so identified in Vitruvius' work. An even earlier example has been identified at the Minoan "New Palace" of Knossos, dated 1450BC (Kienzle, 2002). It may also be loosely related to the utilization of horizontal bands of wide and flat Roman brick that was sometimes laid at intervals into walls composed of more random mortared masonry. At Pompeii, a number of the piers between storefronts were reconstructed with brick bands, and this construction may have been part of repairs of damage from an earthquake that occurred 17 years prior to the volcanic eruption that buried the city. This same type of construction can be found in Istanbul most notably in the medieval city walls, where the belts of red brick are an integral part of the architecture – so much so that when modern restorers reconstructed a section of the walls, they applied the brick band as a thin layer on the surface, rather than as a structural layer extending through the masonry. Interestingly, it was only this newly constructed section that collapsed when the tremors which radiated out from the distant August 17, 1999 Marmara earthquake reached Istanbul. The far more deteriorated portions of the wall where the brick bands remained in their original form remained standing.

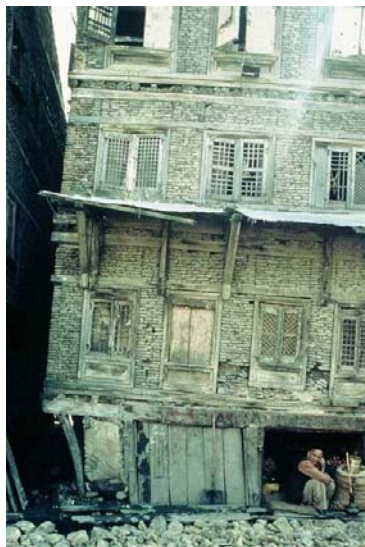
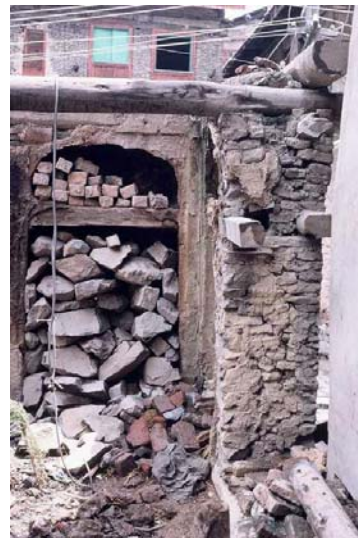
Figure 7 & 8: *Taq* construction in Srinagar, Kashmir and demolished section of wall showing timber lacing in wall section.

Some of the most elaborate examples of laced bearing wall construction can be found in Srinagar, Kashmir, where this type of construction, referred to as *Taq*, is the predominant historical vernacular type. Here the type evolved to allow building of structures onto soft waterlogged banks of the alpine lakebed in the Vale of Kashmir, where the heavy masonry structures were subjected to differential settlement. Here the heavy timber beams are laid in only horizontally, with the masonry carrying all of the vertical loads. The timber bands, which resemble ladders laid into the walls, run both above and below the window frames and at each floor level, where the joists extend through the wall and are secured to the wall by the timbers laid below and above them, which are themselves surmounted by the weight of the overburden of masonry of the floor above or the parapet under the roof.<sup>4</sup>

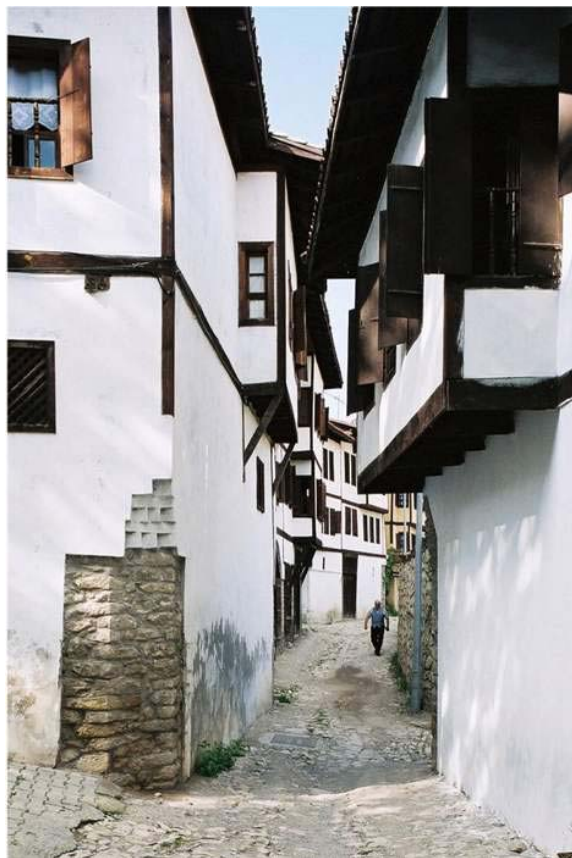
Figure 9: Traditional Ottoman style Turkish architecture in Safranbolu, Turkey.

In Turkey, and also in Greece, houses were often designed with the laced bearing wall construction on the ground floor level, and the infill-frame used for the upper stories. The thicker, often windowless, bearing walls served to enclose the storage or barn area of the structures, with the lighter more open infill walls above enclosing the living quarters. The Turkish Ottoman-style house, with its tiled roof and overhanging timber-and-brick bays above a heavy stone first floor wall, has become an icon known worldwide. Where they survive, the overhanging upper stories, or jetties, contribute to the visual vitality and delight of historic Turkish towns. The jetties strengthen the buildings because the joists that cantilever over the walls below hold those lower-story walls firmly in place with the help of the weight of the infill masonry overhanging upper story. This compressive force gives the heavy walls below added strength against lateral forces.

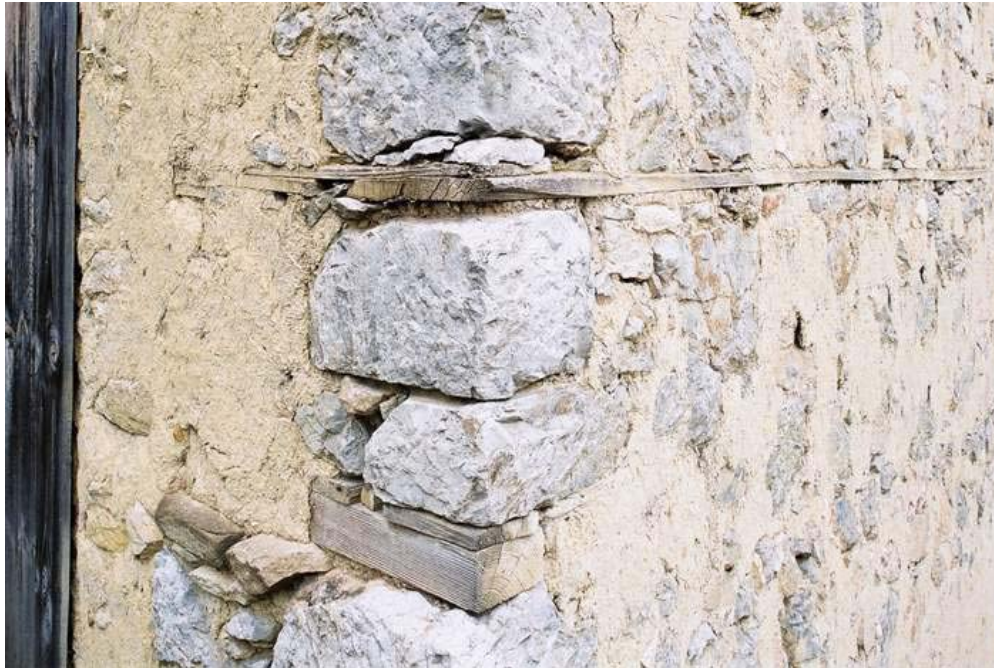
Figure 10: Laced bearing wall in Safranbolu, Turkey

For those houses where the *himiş* style rests on the heavy load bearing masonry base, the multi-wythe masonry bearing walls of the first story, are often laced with horizontal timbers, (in Turkish, the timbers are “*hatil* (s) *hatillar* (pl)” ). In contrast to those used in Kashmir, these are often very thin timber boards laid into the wall at vertical intervals of about 3 feet (1m). They are placed so that they overlap at the corners. They thus serve to bind the stone layers together without interrupting the continuity of the masonry construction. In those regions most affected by the 1999 earthquakes, however, the bearing wall type was rare. There, the houses were of *himiş* construction from the ground up, thus the discussions of earthquake performance of the timber-laced construction as witnessed following the recent earthquakes in Turkey and in India will be focused primarily on this type.

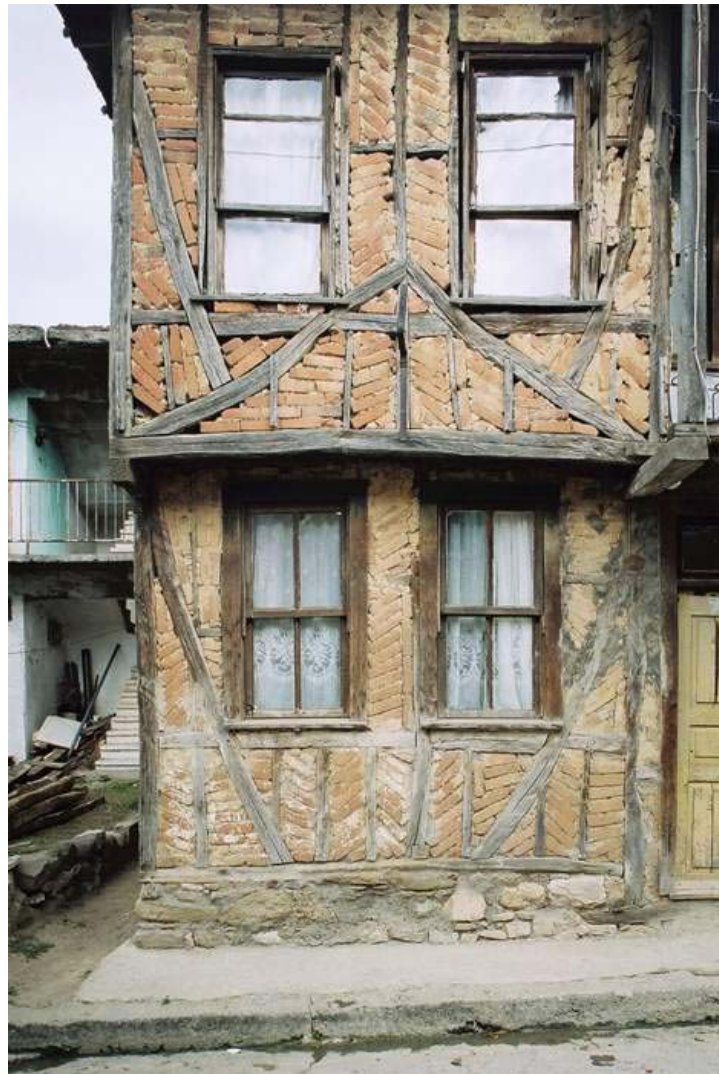
Figure 11: *Hımış* house in Gölcük after earthquake constructed in 1955. There was only slight damage to the interior of this house.

In one area surveyed in Adapazzari a single *hımış* house collapsed, killing an occupant – a rare occurrence of a death caused by the collapse of *hımış* construction. Decayed timbers could be seen in the ruins. It was the partially damaged traditional buildings here and in Gölcük provided evidence of how this type of construction responded to earthquake forces. Once each building was inspected, and the damaged area in each building identified, a pattern began to emerge. Of those inspected where structural damage was found, most of the damage was concentrated at areas around rotted timbers. Interviews with residents often revealed that the buildings with the most timber decay had been unoccupied for years. It appeared that decayed timber significantly degraded a buildings’ performance in earthquakes. In occupied houses, the most severe damage resulted mainly from alterations and modernization work that had corrupted the integrity of the original frames and walls.

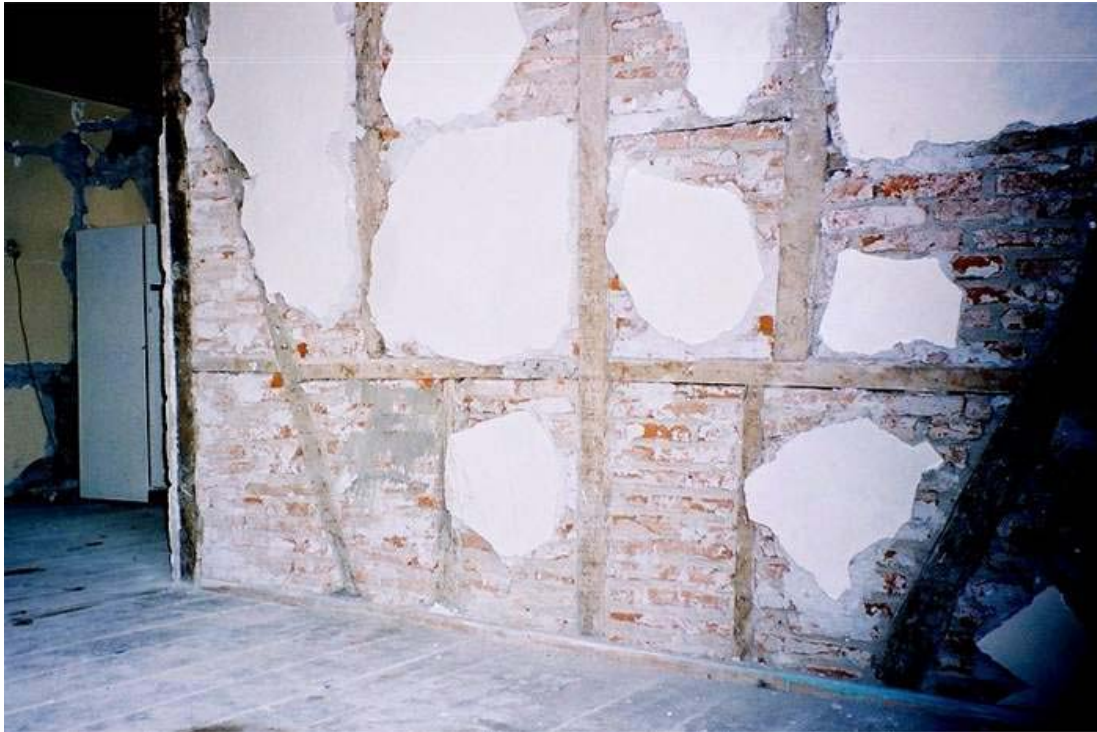
Figure 12: *Himiş* interior wall in Düzce after earthquake.

Inspecting the interiors of some of the houses provided a more complete understanding of the behavior of *hımış* as a structural system. It was evident that the infill masonry walls responded to the stress of the earthquake by “working” along the joints between the infilling

and the timber frame; that is, the straining and sliding of the masonry and timbers dissipated a significant amount of the energy of the earthquake. The only visible manifestation of this internal movement was the presence of cracks in the interior plaster along the walls and at the corners of the rooms, revealing the pattern of the timbers imbedded in the masonry underneath. This level of damage was evident in every house. On the exterior, unless the house was stuccoed, damage was impossible to see. The bricks themselves were only infrequently displaced sufficiently for a crack to be visible. The movement was primarily along the interface between the timbers and the brick panels rather than forming a crack within the panels themselves.

The typical *himiş* construction does not have mechanical ties between the timber and masonry to hold the infill masonry in place. As a result, in some cases, small sections of the infill were shaken out from between the studs near the top of the upper-story walls. Because of the existence of the timber studs, which subdivided the infill walls into small panels, the loss of portions or all of several panels did not appear to lead progressively to the destruction of the rest of the wall. Many walls were missing some of their infill, but evidence of ‘X’ shear cracks, so common in the infill in the modern reinforced concrete buildings, was non-existent in the *himiş* structures. The closely spaced studs reduced the likelihood of the propagation of ‘X’ cracks within any single panel. In addition, the subdivision of each structural bay with a tight network of vertical, horizontal, and diagonal timbers, rather than vertical studs alone, appeared to have been successful in reducing the possibility of the masonry falling out of the frames.

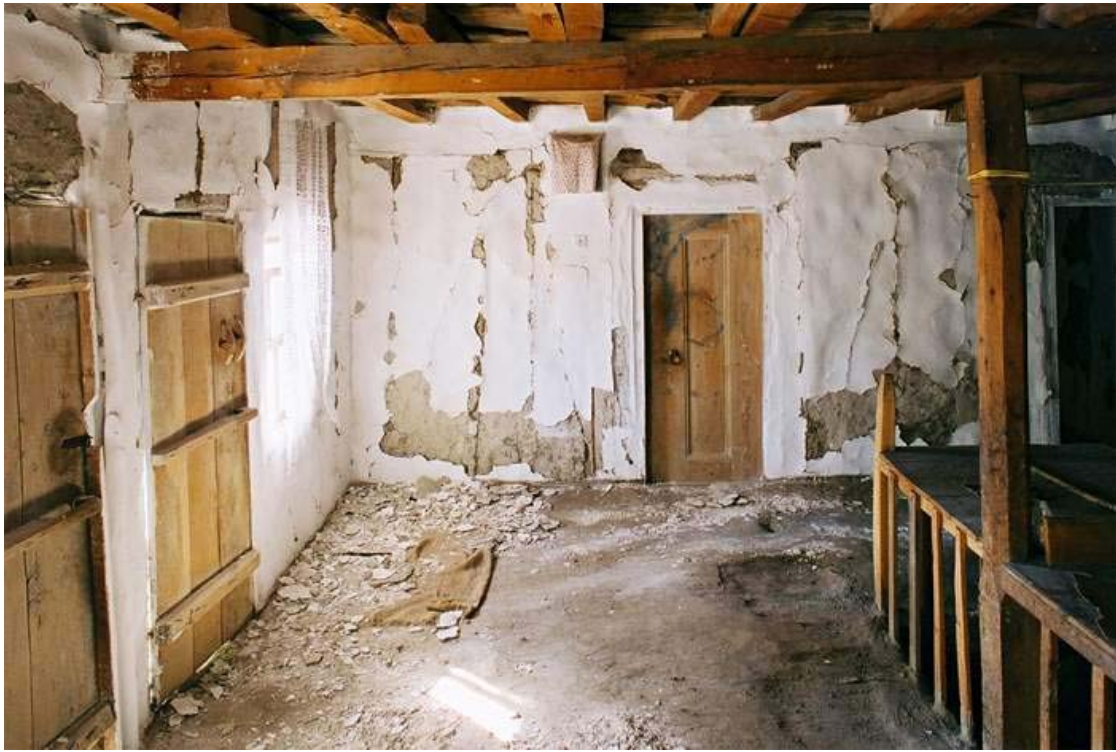
Figure 13: Interior of *himiş* house in Orta after earthquake showing damage to mud and lime plaster over infill walls.

In this earthquake, many *himiş* houses did suffer widespread cracking and shedding of plaster and stucco, and a few had damage to the infill masonry. This level of damage was hard to explain when compared to that found in the infill-frame houses subjected to the full brunt of the Marmara earthquake, where the shaking was stronger and continued for a longer period. The *himiş* houses in Gölcük and Adapazari had about the same level of damage as the Orta houses. This stands in sharp contrast to the performance of the reinforced concrete buildings. While in Orta the reinforced concrete buildings were only lightly damaged, in the Marmara and Düzce earthquake area vast numbers of them suffered heavy damage or collapse.

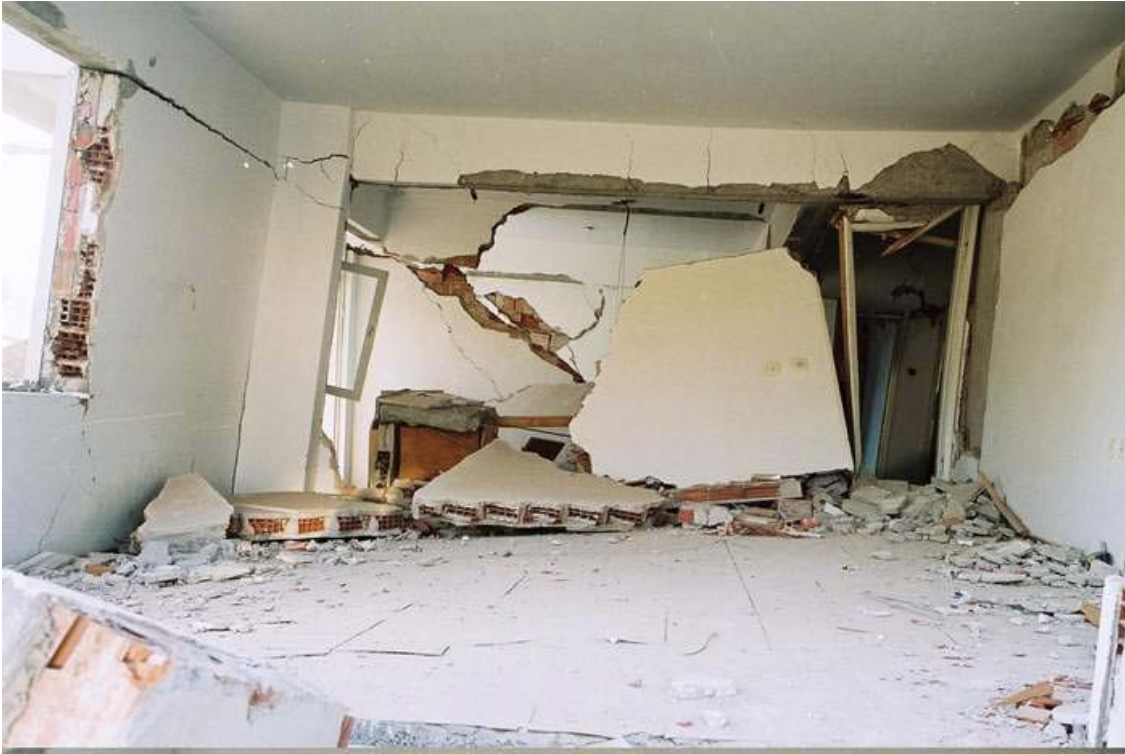
Figure 14: Collapsed interior infill wall in reinforced concrete building in Gölcük

The infill walls in modern reinforced concrete construction generally have strong mortar binding weak masonry units, and these masonry walls fill each structural bay without intervening studs. In Turkey, the most common infill for the interior partitions and exterior walls is a lightweight hollow clay block that has barely more strength than a dinner plate. In India, commonly it is a low temperature fired brick that performs better than the Turkish material, but none-the-less it can crumble easily.

Rarely is the infill considered in the engineering design process as part of the lateral resisting system, and it is often ignored in calculations. In spite of this, the masonry infill does play a significant role that sometimes can help to save a building that has weakened joints. More often, however, it can contribute to the collapse of a building because its rapid degradation in specific areas can transfer concentrated loads onto localized parts of the frame, which are then overwhelmed. As can be seen in Figure 14, these infill walls can readily collapse completely when an earthquake distorts the building's frame. Sometimes, to avoid damage to the surrounding reinforced concrete frame from the “diagonal strut” effect, where the stiff infill causes a corner column to break, leading to collapse, the infill material is sometimes deliberately separated from the frame.

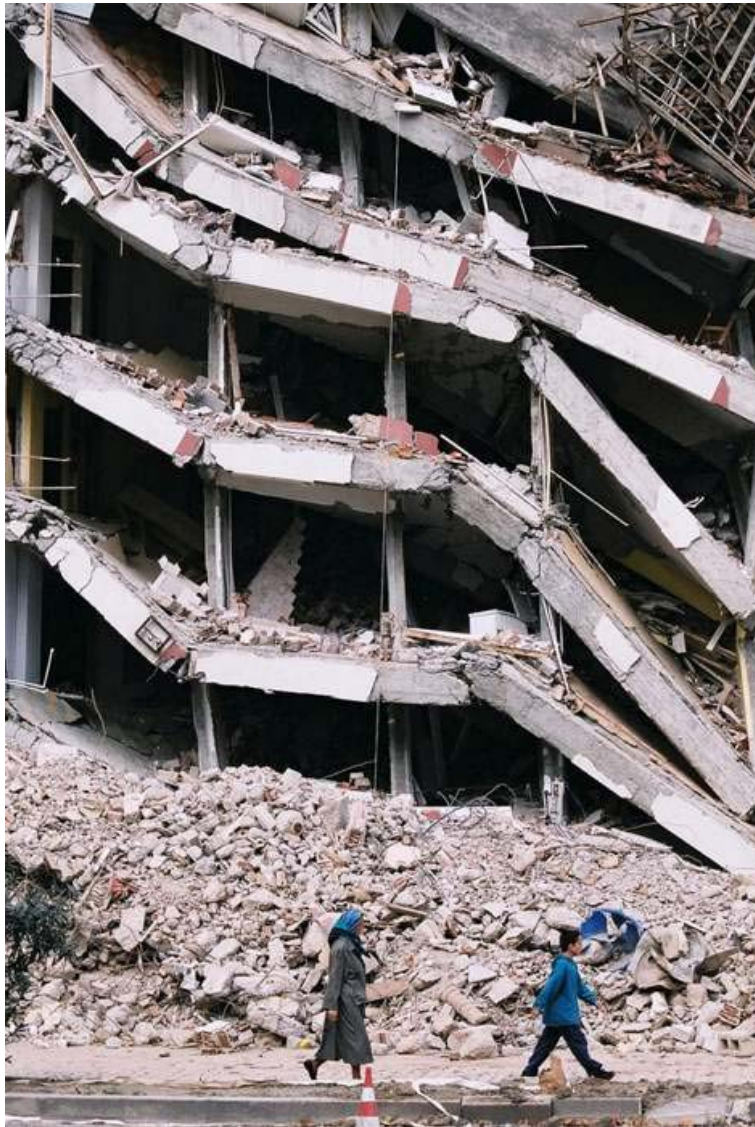
Figure 15: Collapsed Reinforced concrete building in Gölcük.
