“CROSSWALLS” INSTEAD OF SHEARWALLS A Proposed Research Project for the Retrofit of Vulnerable Reinforced Concrete Buildings in Earthquake Areas based on Traditional *Hımiş* Construction

Randolph LANGENBACH*

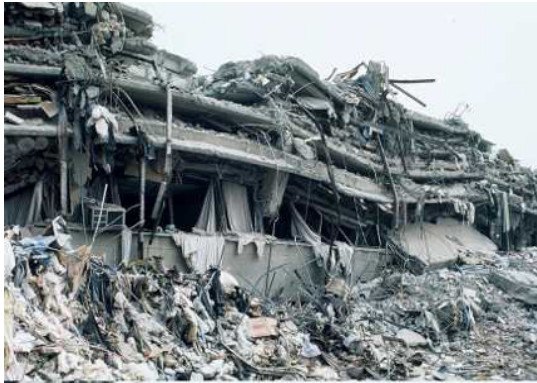
Figure 1: “Pancake” collapse in Mexico City, 1985.

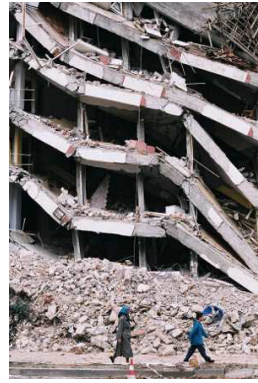
Figure 2: Partial collapse of RC Building, Gölçük , Turkey, 1999.

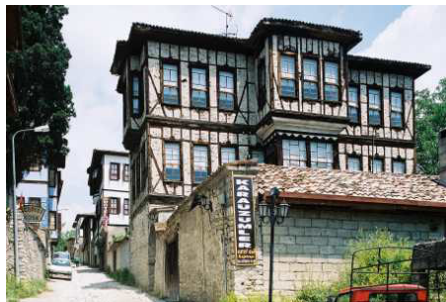
Figure 3: Large 3 story house in *himiş* construction, Safranbolu, Turkey, 2000.

Figure 4: *Himiş* construction on 3 story house in Safranbolu, Turkey, 2000.

Himış construction is simply described as a timber frame with masonry infill. The masonry is usually a single “wythe” or layer, often with the bricks laid at angles to fit between the studs, or alternatively, if stone is used, random rubble set into thick layers of mortar. Depending on the local, the mortar commonly a lime mortar, but in some more rural areas, a mud mortar may be used.

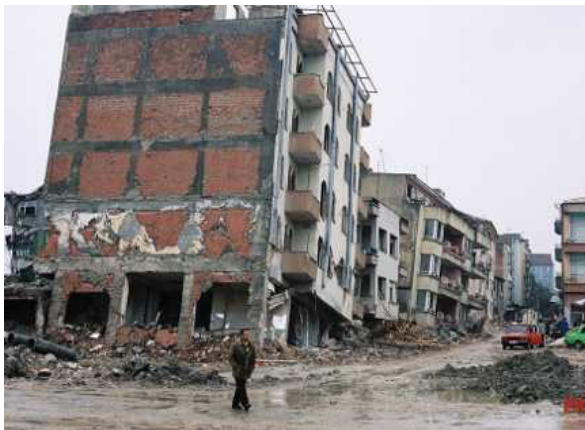
Figure 5: Row of collapsed RC buildings showing typical hollow clay block infill on end wall left exposed by the collapse of another building.

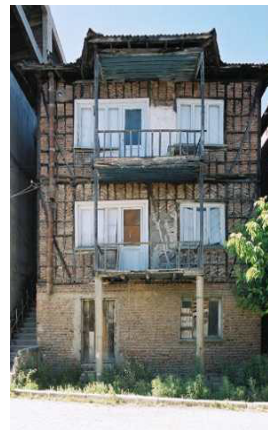
Figure 6: 3 story *himiş* house in the heart of the damage district in Gölcük, photographed one month after the 1999 earthquake. There was no evidence of damage visible on the exterior, yet many RC buildings had collapsed within the surrounding area.

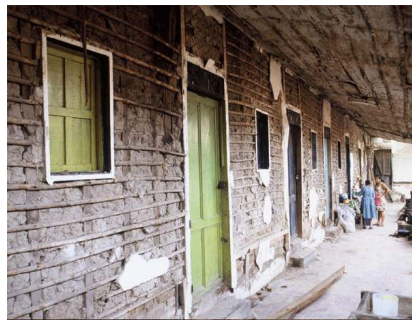
Figure 8: *Bahareque* construction in San Salvador showing effects of 1986 earthquake. The loss of the stucco shows that the wall underwent deformations without loss of its underlying structural integrity.

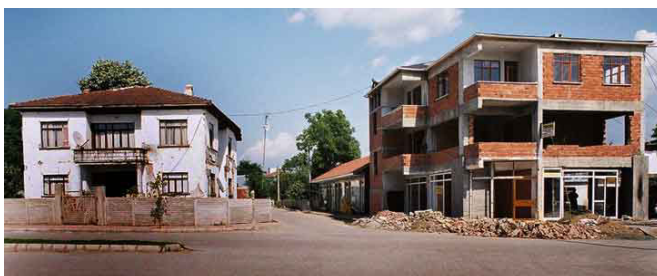
Figure 9: Three story RC building next to a 2½ story *himiş* house near Düzce showing the repair of severe damage to the RC building (notice the size of the ground floor columns). The *himiş* structure has lost only stucco on the side. Almost all of the hollow clay block on the RC building has been reconstructed after the earthquake. This shows that even low rise RC buildings sometimes suffered more damage than nearby traditional buildings.

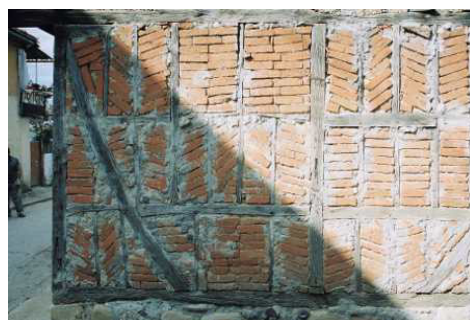
Figure 10: Exterior of 1955 *himiş* house in Gocuk damage district one month after 1999 earthquake. Do damage is visible.

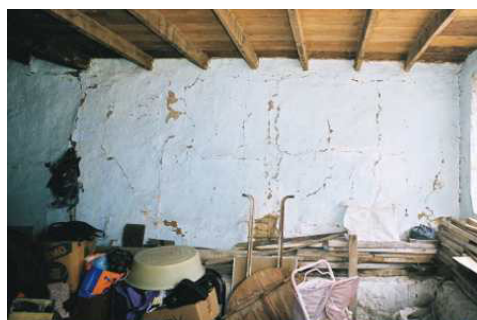
Figure 11: Same wall as Fig.10 showing earthquake caused cracks in interior mud plaster.

Inspecting the interiors of some of the *himiş* houses provided a more complete understanding of the behavior of *himiş* as a structural system. It was evident that the infill masonry walls responded to the stress of the earthquake by “working” along the joints between the infilling and the timber frame; that is, the straining and sliding of the masonry and timbers dissipated a significant amount of the energy of the earthquake. The only visible manifestation of this internal movement was the presence of cracks in the interior plaster along the walls and at the corners of the rooms, revealing the pattern of the timbers imbedded in the masonry underneath. This level of damage was evident in every house. On the exterior, unless the house was plastered on the exterior, damage was mostly impossible to see. The bricks themselves only infrequently were displaced sufficiently for a crack to be visible. The movement was primarily along the interface between the timbers and the brick panels rather than forming a crack within the panels themselves.

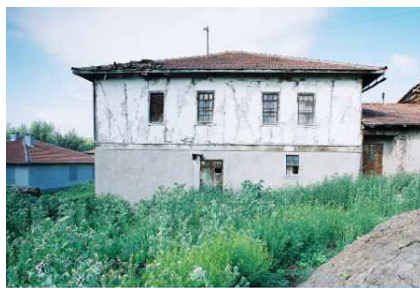
Figure 12: House in Orta, Turkey one day after the 2000 Orta earthquake – showing plaster cracking that reveals the timber frame.

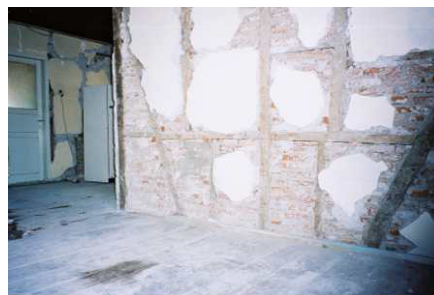
Figure 13: *Hınış* interior wall in house in Düzce earthquake damage district showing “working” of wall that caused loss of plaster.

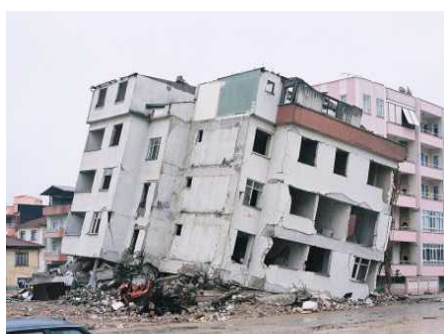
Figure 14: Soft-story collapse of a RC infill wall building in Adapazzari where the infill walls resisted the pancake collapse of the upper floors.

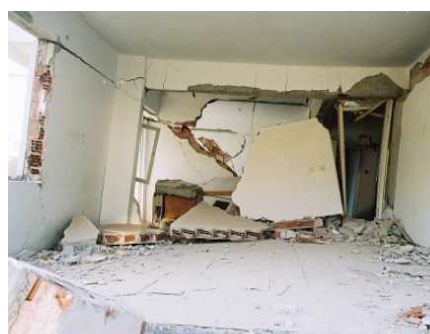
Figure 15: Collapse of a brittle interior hollow clay block wall illustrating typical failure pattern for such walls lacking subdivisions.

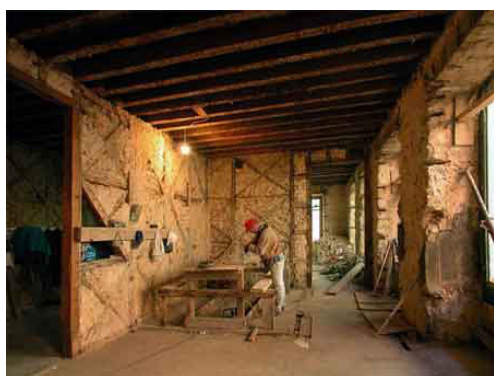
Figure 16: Pombalino “Gaiola” walls in Baixa, Lisbon, Portugal.

The Pombolino system used on the interior of buildings consisted of timber frames with vertical and horizontal timbers of approximately 10cm to 12cm square, with internal braces, forming an “X” or, as it is referred to in both Italy and Portugal, the “Cross of St. Andrew.” (Figure 16) The timbers for the cross are 9cm by 11cm in section. The frame was then “nogged”⁷ in the triangular spaces formed by the crosses with a mixture of stone rubble, broken brick, and square pieces of Roman brick in different patterns in each panel. The interior walls were then covered with plaster, hiding the timber frame. The infill masonry usually extended beyond the surface of the wood slightly, allowing for a thick coating of plaster to hide the wood, thus keeping plaster cracks to a minimum.

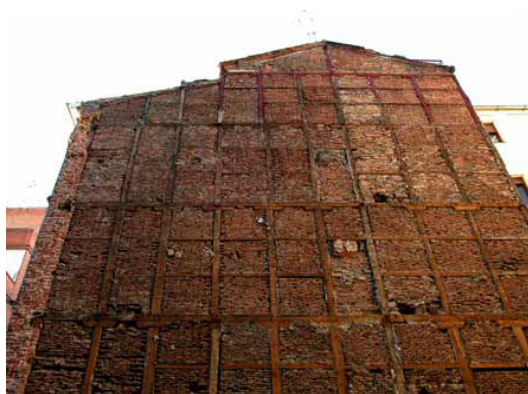
Figure 17: Typical hidden timber frame in central Madrid, Spain, 5 story building.

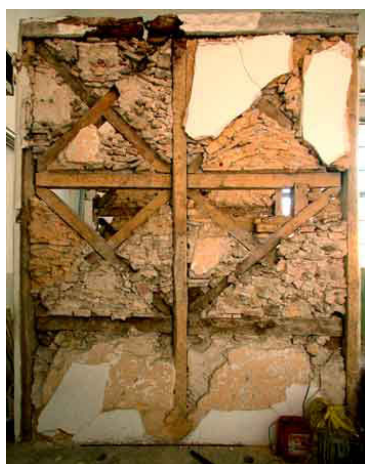
Figure 18 & 19: One story frame section removed from “gaiola” building tested for strength and stiffness in Portuguese National Lab by C6ias e Silva recently. Fig.18 shows one of three walls after cyclical tests to a point just short of collapse, and Fig.19 shows hysteretic behavior of one of the walls. The loss of the plaster and the wide hysteresis loops show that the walls were able to dissipate energy over many cycles without losing their structural integrity. (C6ias e Silva, 2002)

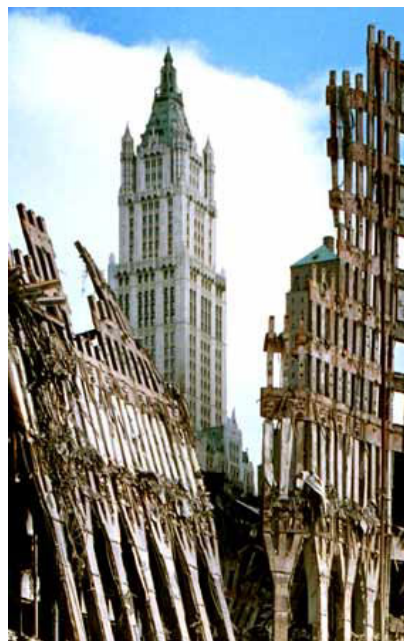
Figure 22: New York City's Woolworth Building, by Cass Gilbert, was constructed in 1913 using the Chicago Frame system. At the time of its construction in 1913, it was the world's tallest building.

With the collapse of the 110 story twin towers of the World Trade Center in 2001, visible in the foreground, it resumed its place as the tallest structure in Lower Manhattan, and its 1931 successor for the title of World's Tallest Building, the Empire State Building, also a Chicago Frame type structure, resumed its place as the tallest building in New York City.

The watershed event that is often cited as having defined the introduction of modern construction practice for mid and high-rise buildings is the “invention” of the steel frame skyscraper in Chicago in the 1880's with the construction of the world's first high-rise steel frame building, the Home Insurance Company building, in 1885, designed by William LeBaron Jenney.

In some sense, there was a more profound, but more subtle revolution that followed it – the “invention” of the curtain wall. It was only with the invention of the curtain wall that the structural frame became free to work as a frame laterally and vertically. While in the simplest sense, this was thought to be the case with Chicago Frame buildings, in practice, it was not. In many ways, the masonry infill dominated the performance of the frame, stiffening and strengthening it. For example, a 1938 report on the tallest, and one of the last, examples of this type, the 1931 Empire State Building in New York City, reveals that the infill masonry at the 29th and 41st floors cracked during a storm with wind speeds of 90MPH. Strain gages that had been placed on the steel only began to register strain in the steel frame after the masonry cracked, thus showing that it was the “non-structural” masonry infill that bore 100% of the lateral loads until cracking. (Rathbun, 1938, reported in Eldakhakhni, 2002)

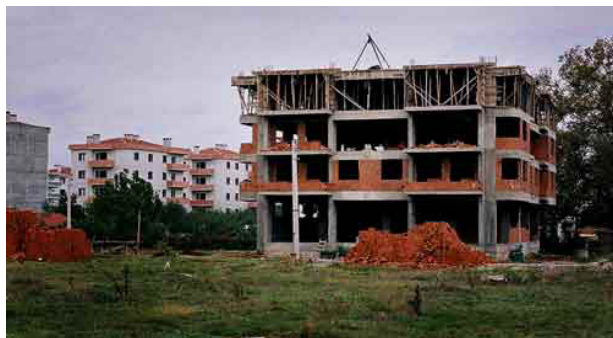
Figure 23: Typical Turkish RC building under construction showing the hollow block infill being installed.

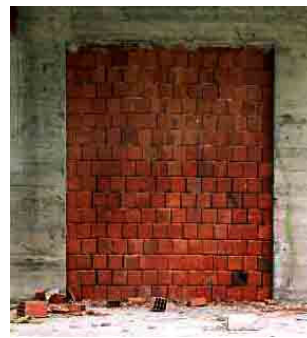
Figure 24: Typical hollow clay block infill as used in reinforced concrete residential construction in Turkey.

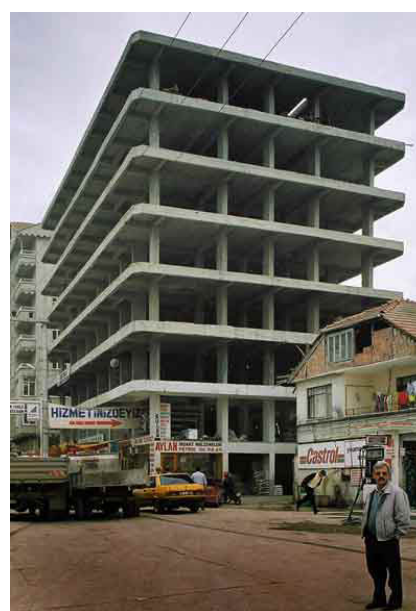
Figure 26: Eight-story reinforced concrete frame structure in Gölcük under construction at the time of the İzmit, Turkey earthquake in 1999, which collapsed many occupied buildings around it. From a street-level inspection, this building did not appear to be damaged. Undoubtedly, the absence of the masonry infill allowed the frame to deflect evenly, rather than causing a soft story at the base of the structure where it is most vulnerable. Had the building been finished at the time of the earthquake, the results may have been quite different.

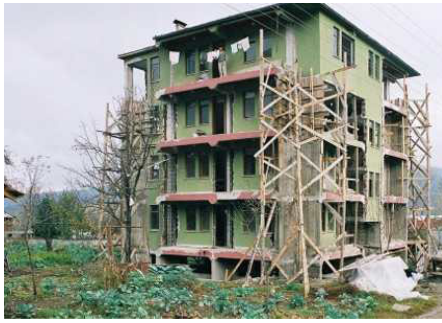
Figure 27 & 28: Five story building damaged in the 1999 Düzce earthquake in Turkey, being retrofitted with reinforced concrete shearwalls. No.28 shows the existing hollow clay block walls removed and steel being inserted for the construction of a reinforced concrete shearwall. These images illustrate the extent of the work, and disruption needed for earthquake strengthening using shearwalls. The occupants had to move out for the duration of this work as many existing walls were removed.

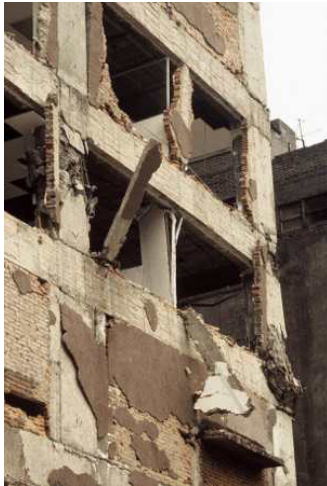
Figure 29: Infill wall RC building in Mexico City damaged in 1985 earthquake. The infill masonry in this structure almost caused the collapse of the building. The damage to the corner column that left the building teetering on the edge of collapse can be seen on the right.

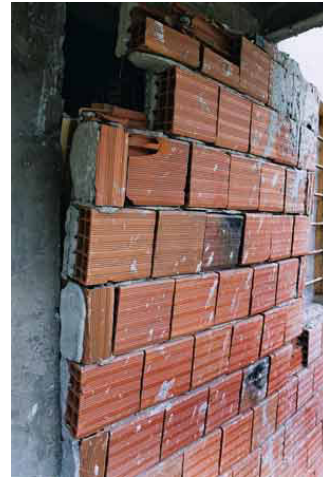
Figure 30: Typical hollow block infill wall partially fallen out of the frame of a building under construction at the time of the İzmit earthquake in Turkey in 1999. The typical infill construction has no mechanical ties other than loosely packed mortar to hold the infill masonry from falling out of the frame. The subdivisions in *himiş* construction help hold the masonry together in the frame because the panels are much smaller.

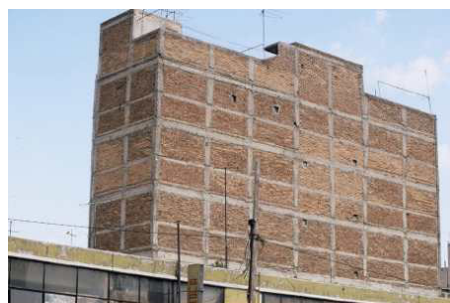
Figure 31: Infill RC building in Mexico City after the 1986 earthquake collapsed many buildings nearby. Each panel is subdivided vertically and horizontally.

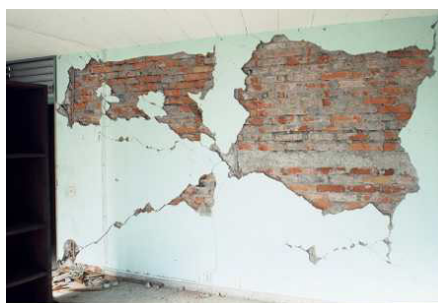
Figure 32: A subdivided internal brick infill wall in San Salvador after the 1986 earthquake.

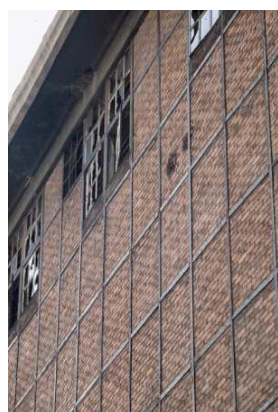
Figure 34: Detail of exterior wall of Mexico City power plant in the heart of the damaged district photographed after the earthquake in 1985 showing light steel frame and infill wall construction. The building had no visible damage, yet was next to reinforced concrete buildings that collapsed. It had a floorless open interior space that was approximately 20 meters high. This photograph provides an idea of how steel channels or angles could be inserted into existing hollow clay block infill walls to subdivide them.

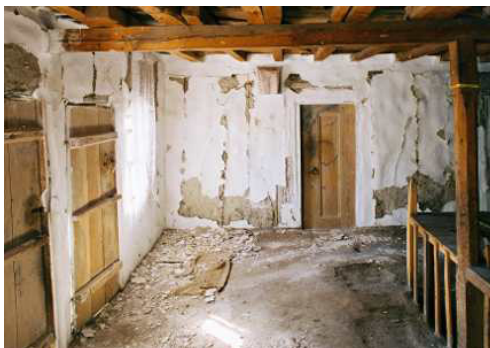
Figure 35: Interior of *himış* house after the Orta earthquake showing the “working” of the masonry panels.

For both new and existing walls, the subdivision of the wall is intended to cause the wall to “work” in an earthquake as a series of smaller blocks – as is demonstrated in traditional *himış* structures which resist earthquakes with a degree of flexibility and ductility imparted by the stud frame which subdivides the masonry walls into panels. Testing of the retrofit procedure will be aimed towards development of a viable detail to accomplish this.

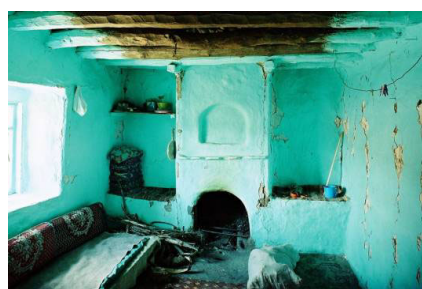
Figure 37: Interior of house of family in tent in Fig.36 the day after the earthquake in 2000.

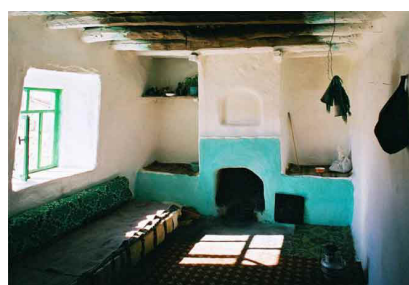
Figure 38: Same room six months later after they had repaired the house and moved back in. *Hımsı* construction can be easily repaired, and, in contrast to damaged RC, when repaired, it retains its capacity.
