# SOIL DYNAMICS AND THE EARTHQUAKE DESTRUCTION OF THE EARTHEN ARCHITECTURE OF THE ARG-E BAM

*Randolph Langenbach\**

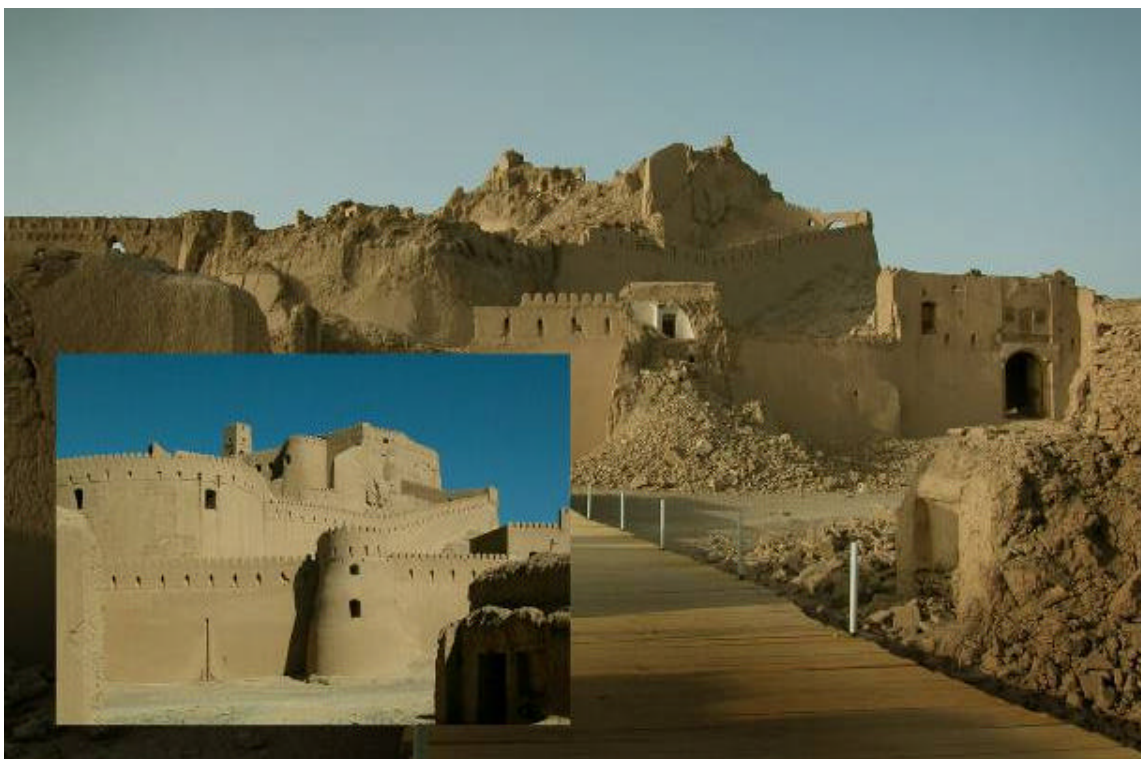
**Figure 1:** The Arg-e Bam upper citadel before and after the earthquake. *Before photo by James Conlon, 2003.*

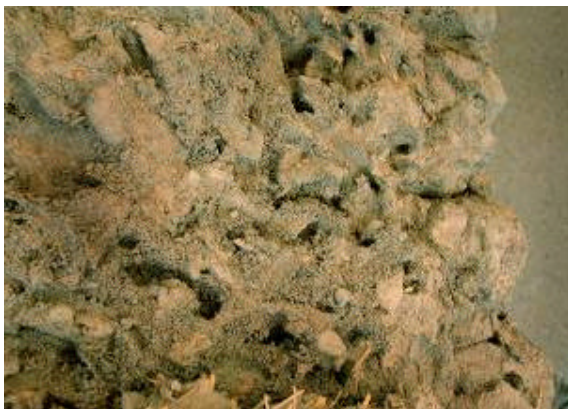
**Figure 2:** Evidence of termite damage in a wall of the Arg-e Bam showing extensive deposits of frass with insect tunnels.

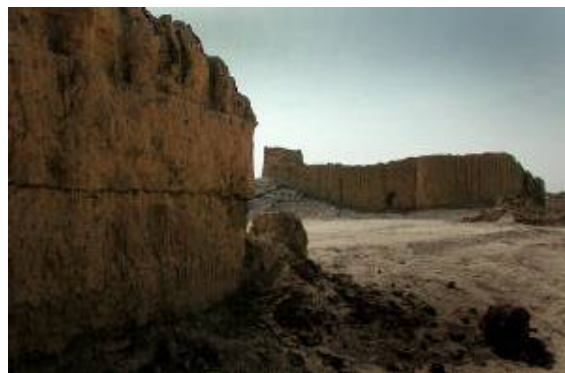
**Figure 3:** Unrestored ancient earthen structures including the Shahr-bast Wall in the distance after the earthquake. These structures were only lightly damaged.

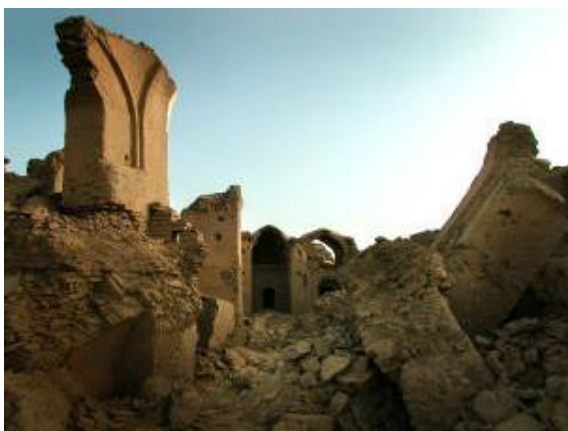
Figure 4: View of the ruins of the Arg-e Bam.

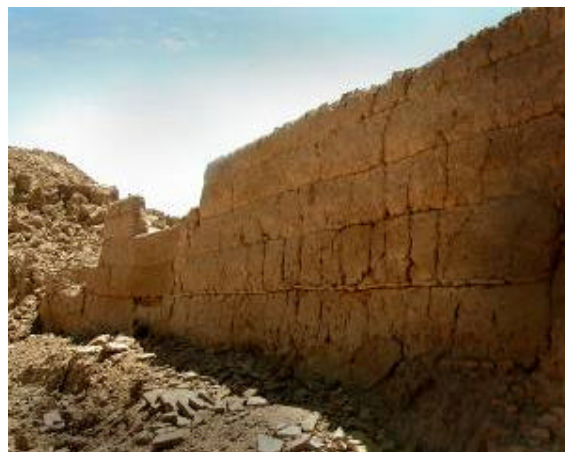
Figure 5: *Chineh* wall inside the Arg-e Bam that was only slightly damaged in the earthquake.

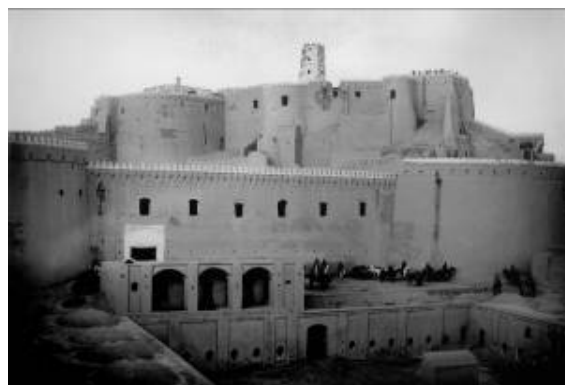
Figure 6: Late Qajar Period (19<sup>th</sup> Century) view showing soldiers in the inner citadel.

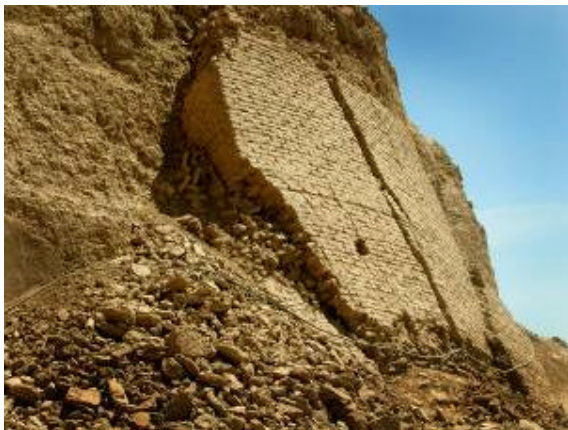
**Figure 7:** View of collapsed outer walls of a round tower. The *Khesht* construction of the outer layer has fallen off of the earlier inner layers that are most likely a combination of periods of building in different methods.

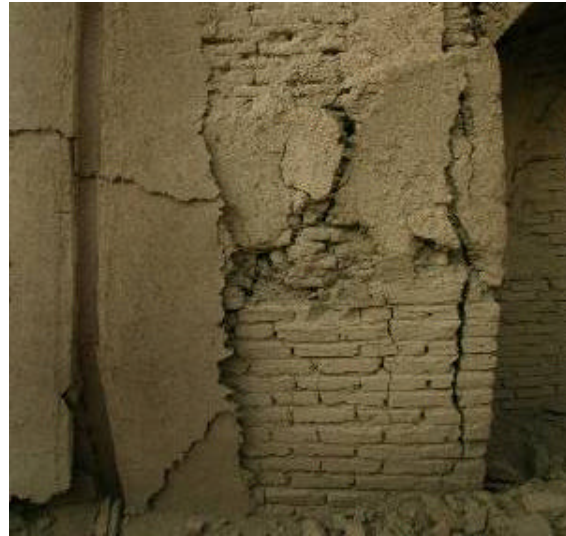
**Figure 8:** Pier in a partially collapsed section of the Caravansary showing the bursting of the outer layers from internal expansion from the earthquake vibrations.

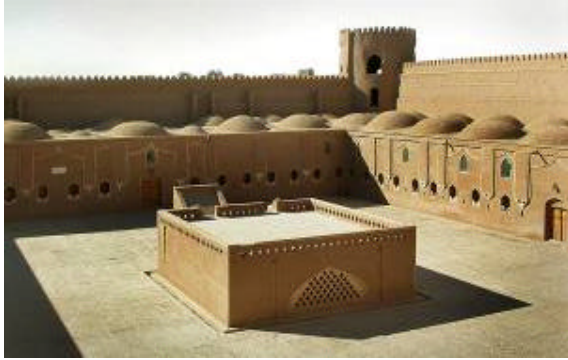
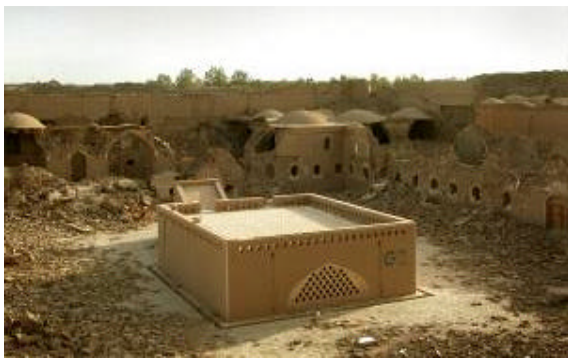
**Figure 9&10:** Before (November 2003) and After (April 2004) of the same view of the Stables courtyard showing the superstructure over the cistern that was recently reconstructed in fired bricks. (Before photo by James Conlon, 2003)

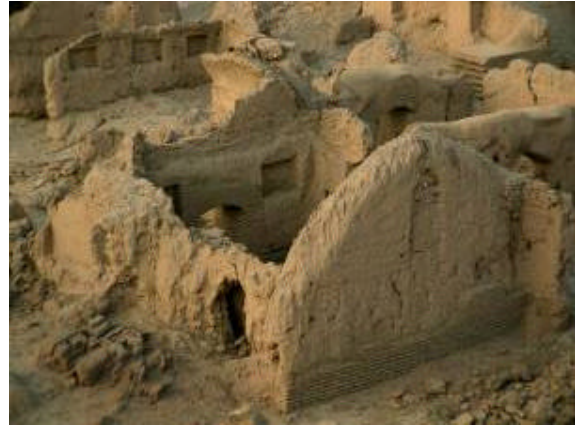
**Figure 11:** Unrestored ruins in the Konari neighborhood of the Arge Bam that survived the earthquake with comparatively little damage.

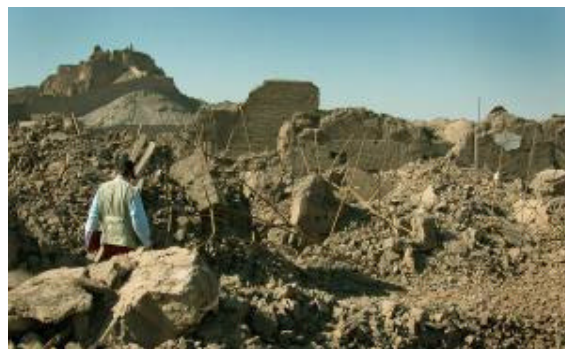
**Figure 13:** Ruins of the Grand Mosque. The north-west section of the main courtyard was on the right side of the view.

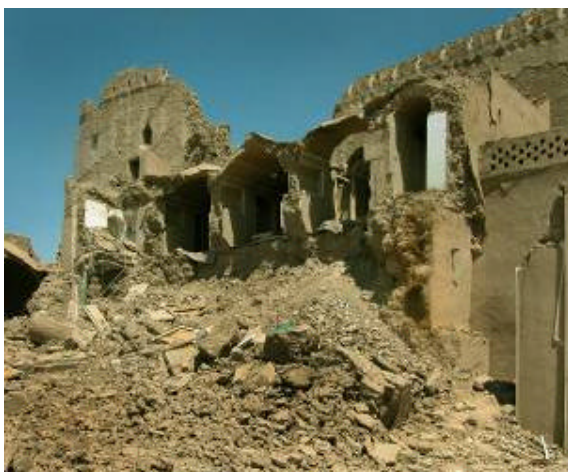
**Figure 14:** Buildings above the Stables courtyard that collapsed from the lateral spreading failure of the retaining wall and fill beneath.

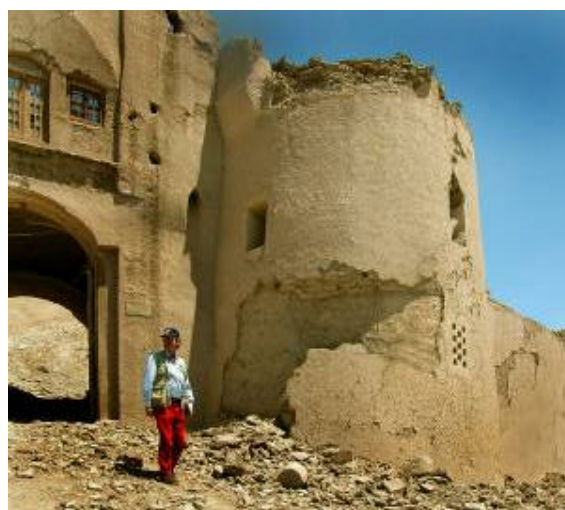
**Figure 15:** One of the few surviving turrets has a room in its base, as shown by the ground floor window. The floor diaphragm timbers extend through the walls, and are now visible after the stucco fell off. The collapsed masonry and stucco is from what appears to be a modern-day modification of the shape of the tower in the tradition of Viollet-le-Duc. The tower's original surface underneath is intact.

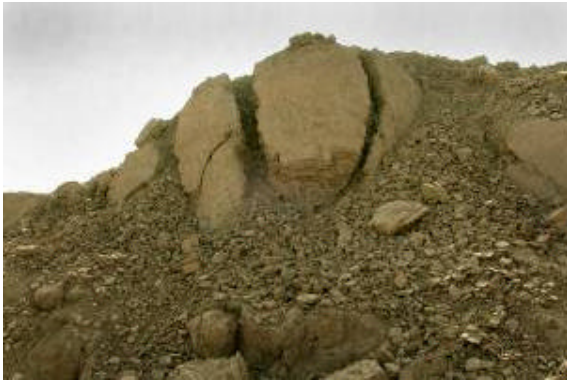
**Figure 16:** Collapsed round turret on the ramparts that shows evidence of having burst apart from collapse of internal layers.

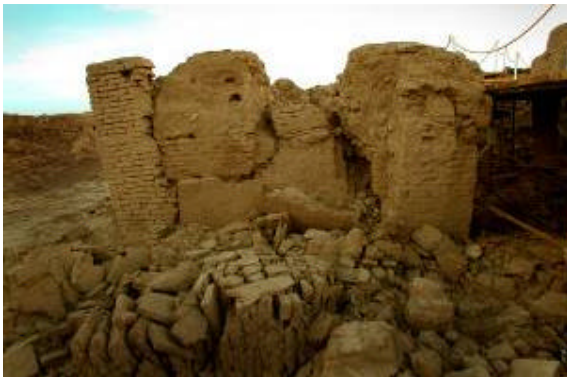
**Figure 17:** A massive pier composed of different periods and types of *Khesht* and *chineh* construction that have separated from each other during the earthquake.

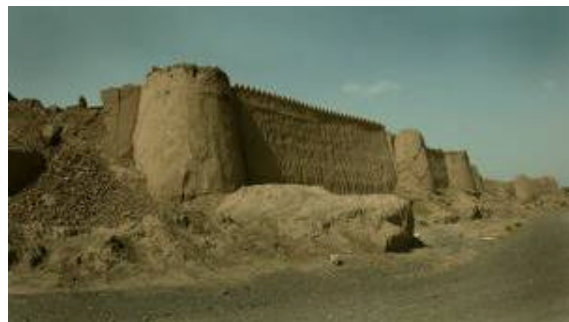
**Figure 18:** North-facing ramparts that were significantly less damaged in the earthquake than the other city walls. Notice that the crenellations are still intact on this one section, the only section where that was observed to be the case.

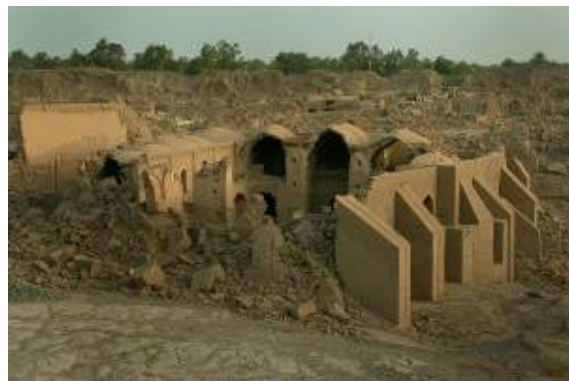
**Figure 19:** The ruins of the Caravansary show that the domed rooms on the second level behind the buttresses have collapsed, while the ones opposite still remain. There are no buttresses behind the external wall of the opposite side. The base of the 5<sup>th</sup> buttress is crushed.

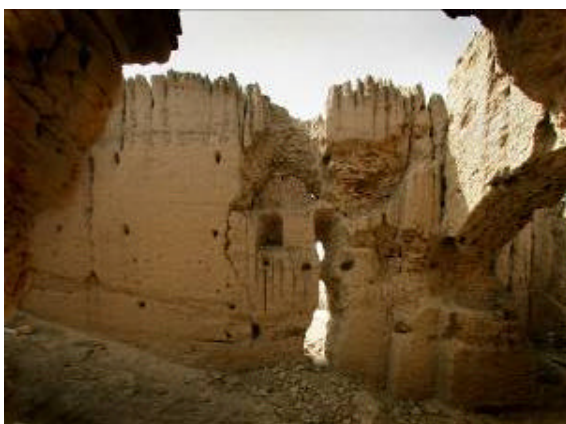
**Figure 20:** The interior of the unrestored “Shahrbast Wall” showing 3-story high walls that survived the earthquake. Notice the older section with later work constructed around it. This is a good example of the onset of damage at the interface of construction of different age and type, as a small area of collapse has revealed this interface. Notice the debris on the ground.

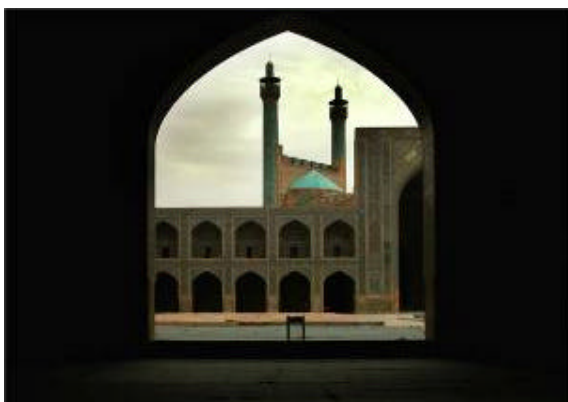
**Figure 21:** The Imam Mosque in Isfahan, April, 2004. The inner cores of many of these walls and the walls of other great monuments in Isfahan are constructed of unfired clay.

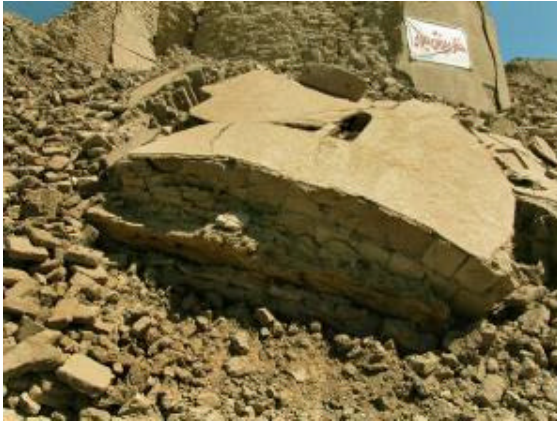
**Figure 22:** Collapsed section of the main gateway showing imbedded timber reinforcement of the *Khesht* wall.

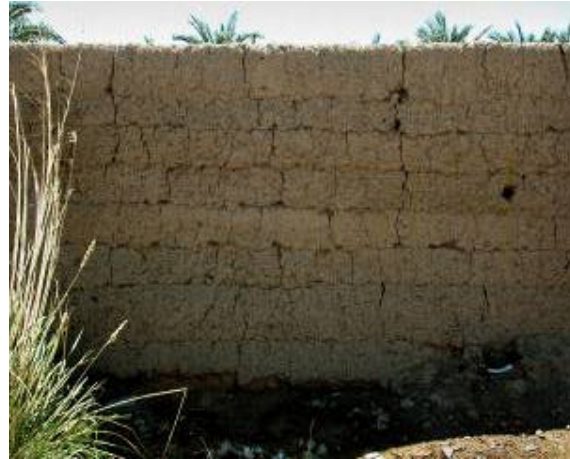
**Figure 23:** *Chineh* garden wall, probably of recent origin, in Baravat (near to Bam). This wall shows the cracks that commonly exist in *chineh* walls, and how the layered construction helps to ensure stability by allowing the cracked sections of the mud layers to perform like large blocks of masonry.

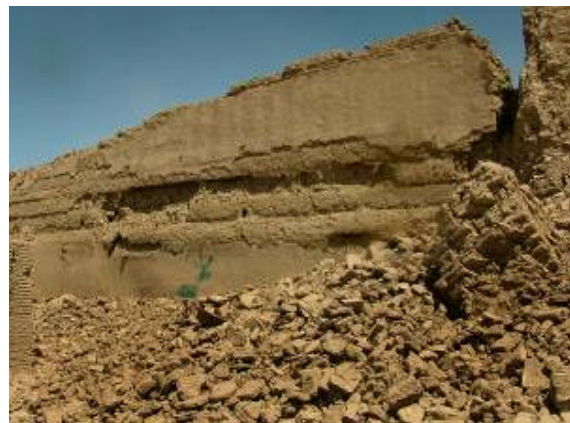
**Figure 24:** South-facing outside wall of the stables courtyard showing how the layering of the *chineh* walls has interrupted the cracking and collapse of sections of the wall, thus helping to maintain the stability of the partly undermined upper part of the wall.

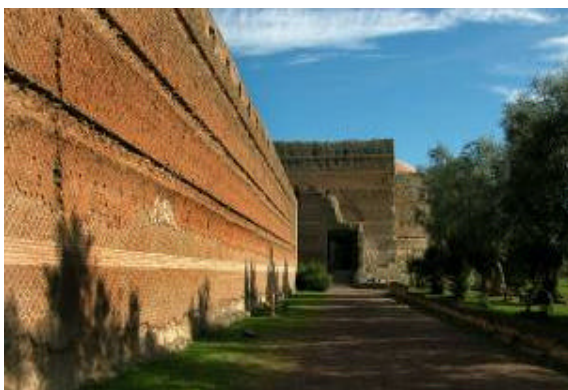
**Figure 25:** Long Wall, Hadrian's Villa near Rome showing the bands of brick that were laid into a wall constructed with natural cement with a tile facing. The crevices are the result of the later chipping out of the bricks for reuse.

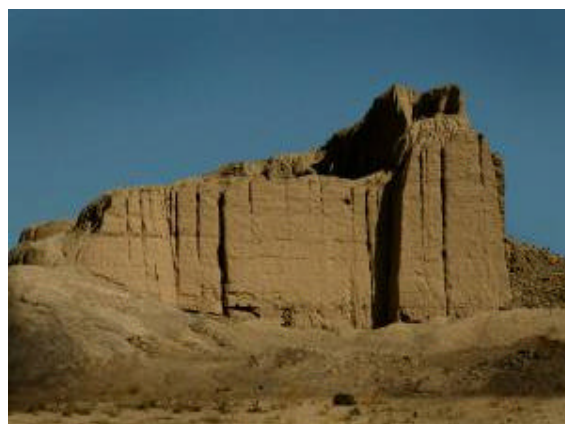
**Figure 28:** The unrestored Khale Dokhtar, a small Arg (or citadel) on the riverbank opposite the Arg-e Bam that survived the earthquake with the collapse of some arches. The high walls of the massive structure otherwise survived intact. (Termites and other insects were also in evidence where the collapses occurred.)
