## ARMATURE CROSSWALLS

**How pre-modern construction practices may hold the key to avoiding the collapse of vulnerable urban housing blocks.**

**Randolph Langenbach, FAAR'03**

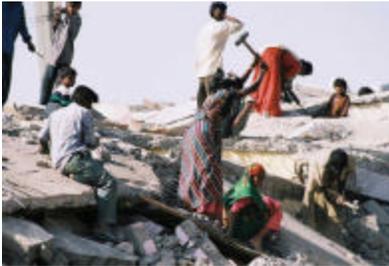
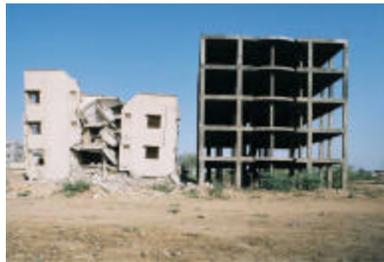
- 1) Male and female demolition workers on collapsed RC infill building in Bhuj, 2001 one month after the Gujarat Earthquake. Women work alongside men in heavy construction tasks in India.
- 2) Bare Frame of incomplete building next to partial collapse in Bhuj, 2001. Bare frames, even if weak and poorly constructed, often do better than expected in earthquakes that happen before the infill is installed because the buildings are lighter than when finished, and frame action can take place.
- 3) Collapsed steel frame infill wall building in Bam, Iran, after the 2004 earthquake. Many light frame buildings with infill masonry collapsed in the Bam earthquake largely because of defective welding and poor layout that resulted in torsion.

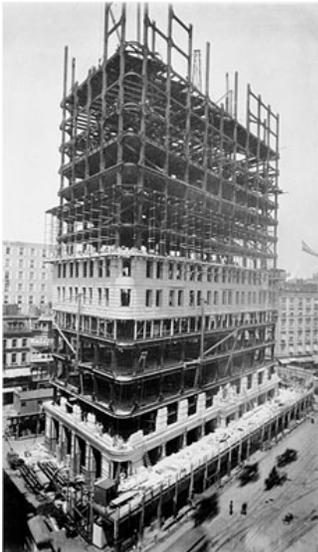
**4)** Flatiron Building in NYC under construction showing masonry started at 7<sup>th</sup> floor level and at base at same time. (1901). (NY Historical Soc.)

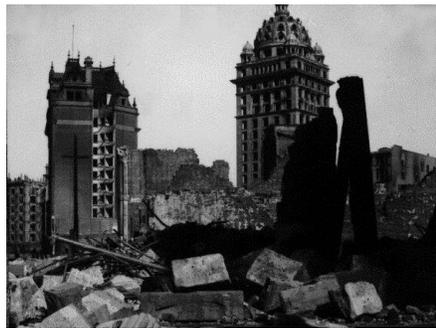
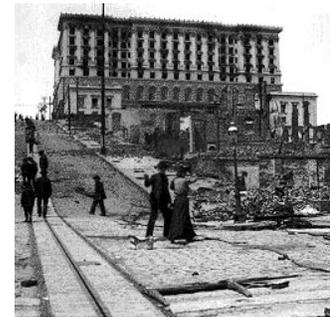
**5a&b)** Chicago Frame Bldgs in San Francisco after 1906 earthquake. All standing buildings shown are still extant today. (Museum of City of SF)

This was a practice that would later meet with criticism, and steel braces quickly became common, but the masonry infill and cladding also remained, even though it was not included in the engineers’ calculations. The first earthquake test of the capacity of the early steel skeleton frame buildings was the 1906 San Francisco earthquake and fire. A significant cluster of Chicago skeleton frame buildings had been constructed in San Francisco in the decade before 1906, and post-earthquake reports prove that their performance ranged from good to extraordinary. None collapsed from the earthquake, and damage in many was minimal. The masonry of the partitions and façades, as would be expected, showed the most disruption, but the steel frames were rarely found to be damaged (**Fig.5**).

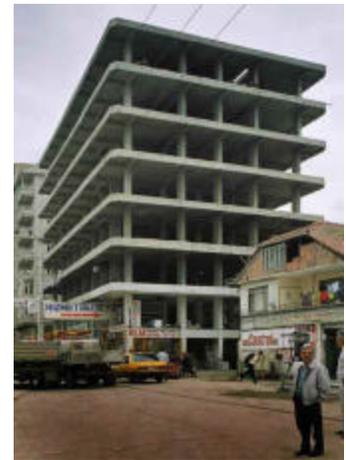
7) A massive RC frame in Golcuk, Turkey under construction at time of 1999 earthquake before installation of infill masonry walls. Much greater damage or collapse would have been likely had the infill walls been installed by the time of the earthquake.

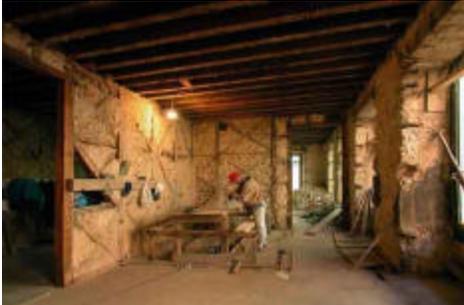
**8)** Pombalino walls in Baixa, Lisbon, 2003

construction selected has become known as the Pombalino system. It is essentially a well-braced form of half-timber construction, the use of which was probably inspired by what Pombal's engineers could see had survived the earthquake. The significance of the Pombalino system lies in the fact that it was deliberately developed and selected as earthquake-resistant construction for a major multi-story urban area (**Fig.8**).

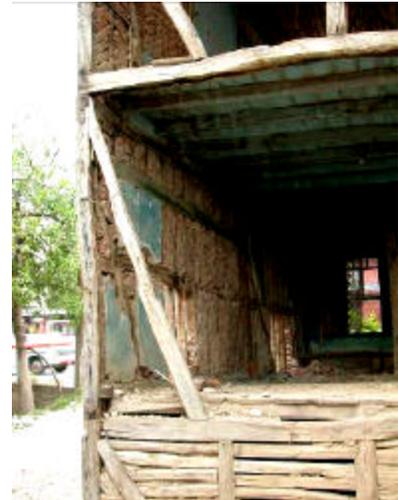
**9)** House in Golcuk showing *himis* construction. This house was abandoned and in ruins at the time of the Kocaeli earthquake in 1999, but remained standing with little additional damage from the earthquake.

In Turkey, 20<sup>th</sup> Century examples of *himis*, another regional form of half-timber construction, survived on average much better than the modern reinforced concrete buildings around them (**Fig.9**). (Langenbach, 2000) In other earthquake areas, variations on this construction system can be found with a history of resilience in past earthquakes. The way these pre-modern infill wall buildings responded to the earthquake vibrations is not unlike the way that the Chicago Frame structures must have behaved in the 1906 earthquake – with the masonry confined by the steel frame, working together with the frame and also protecting it by cracking and dissipating energy without falling out.

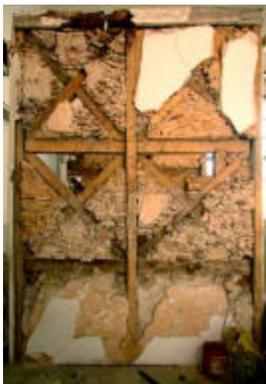
**10a&b)** Sections from a Pombalino wall that was cut out and tested in the Portuguese Govt. lab.

In recent Portuguese Government sponsored lab tests on actual wall sections removed from a Pombalino wall, the wide hysteresis loops show that the walls were able to dissipate large amounts of energy over many cycles, without losing their structural integrity. The sample remained largely intact despite having been cyclically pushed beyond what would be expected from an earthquake (**Fig.10&11**). (Cóias e Silva, 2002)

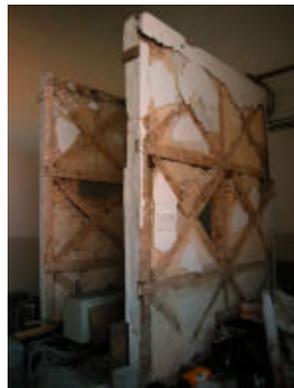
**11)** The hysteresis loop from the test of the Pombalino walls showing extensive ductility and reserve strength. (Cóias e Silva, 2002)
