## **Preventing Pancake Collapses: Lessons from Earthquake-Resistant Traditional Construction for Modern Buildings of Reinforced Concrete**

**Randolph Langenbach, FAAR'03**

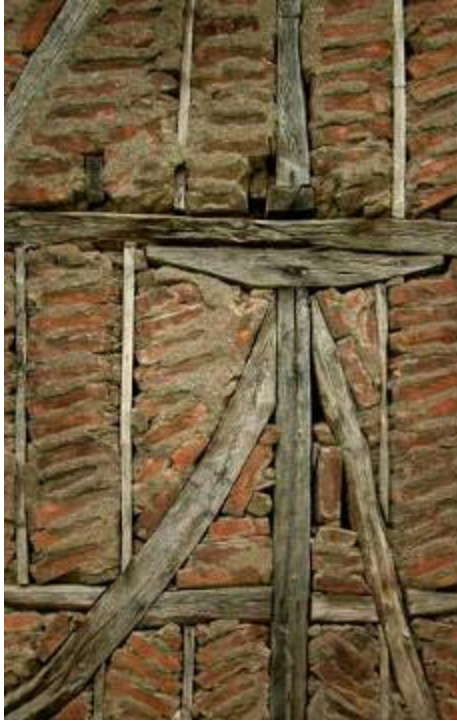
**Figure 1:** Detail of traditional *himis* construction in Turkey in mid-20<sup>th</sup> century house in Gölcük.

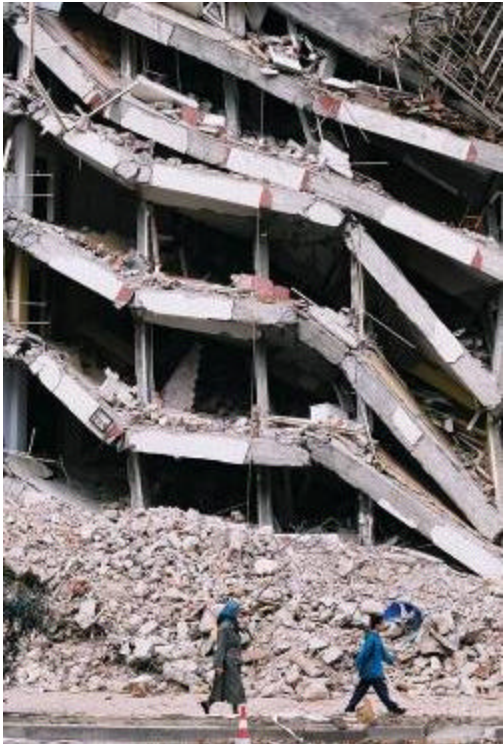
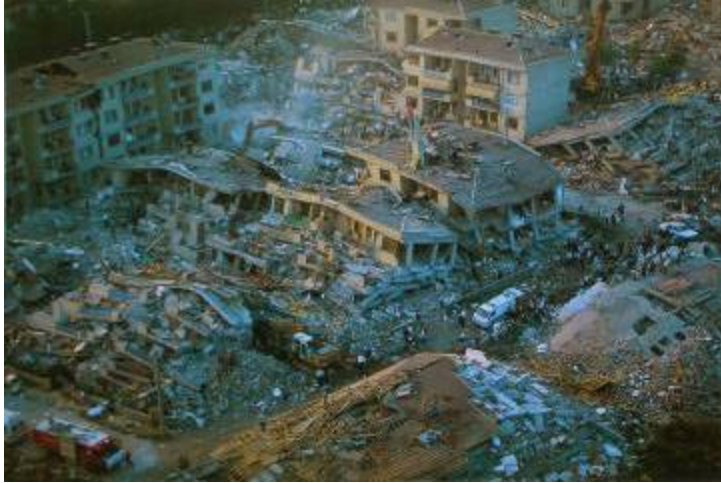
**Figure 2: LEFT:** Collapsed apartment block, Gölcük.

**Figure 3: ABOVE:** Aerial view of collapsed apartment blocks, Gölcük. (from UN-ISDR).

The 1999 earthquakes, however, provided an opportunity to re-visit this issue from a different perspective, as it was the newest buildings in the damage district that suffered the most damage. A new term had emerged in recent years to describe the problem – not with old buildings, but with new reinforced concrete buildings: “*pancake collapse.*” The pervasive image of floors piled one on top of another with the walls fallen away completely was heart-wrenching when one realized that between those floors lay the bodies of the occupants – thousands and sometimes tens-of-thousands of people. (Figures 2 & 3)

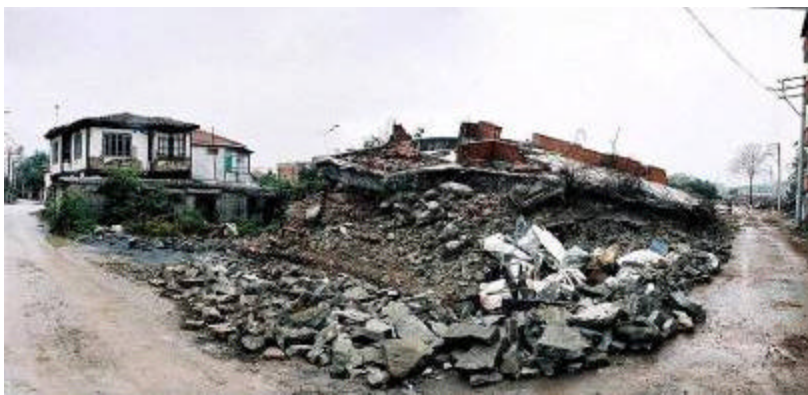
**Figure 4:** Surviving *himis* house next to a row of collapsed reinforced concrete buildings, Adapazari, Turkey, 1999.

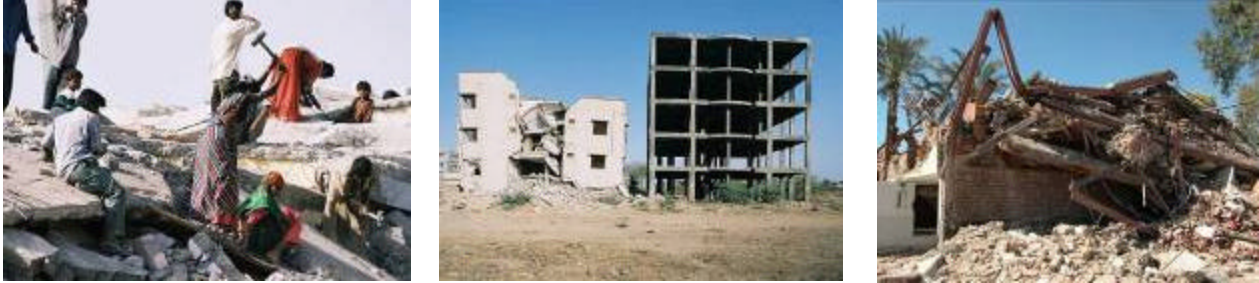
**Figure 5:** Demolition workers on collapsed RC infill building in Bhuj, 2001 one month after the Gujarat Earthquake. Women work alongside men in heavy construction tasks in India.

**Figure 6:** Bare frame of incomplete building next to partial collapse in Bhuj, 2001. Bare frames, even if weak and poorly constructed, often do better than expected in earthquakes that happen before the infill is installed because the buildings are lighter than when finished, and frame action can take place.

**Figure 7:** Collapsed steel frame infill wall building in Bam, Iran, after the 2004 earthquake. Many light frame buildings with infill masonry collapsed in the Bam earthquake largely because of defective welding and poor layout that resulted in torsion.

*world today are the occupants of reinforced concrete frame infill-masonry buildings.*” Concrete frame buildings with masonry infill-walls (RC infill) are commonly constructed with brick or hollow block masonry partitions and exterior walls. Thousands have died in this type of building in earthquakes in different countries around the world, including recently in Turkey and Taiwan in 1999, India in 2001 (Figure 5 & 6), and Morocco in 2003. In Iran, where light steel frames are used instead of concrete, these infill wall buildings also fell down in the Bam earthquake of 2004 (Figure 7).

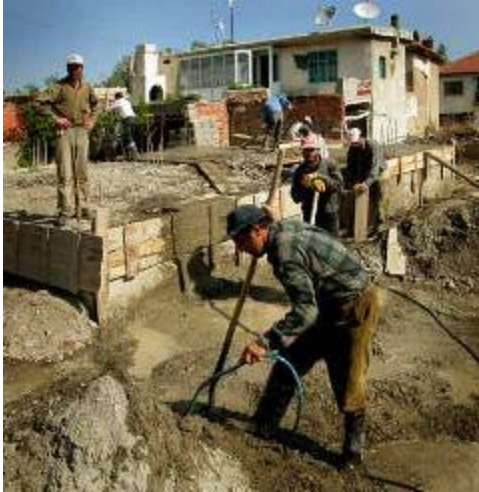
**Figure 8: LEFT:** House being reconstructed to replace one destroyed in Afyon earthquake. Concrete is being mixed on ground with garden hose and without slump test or measurements.

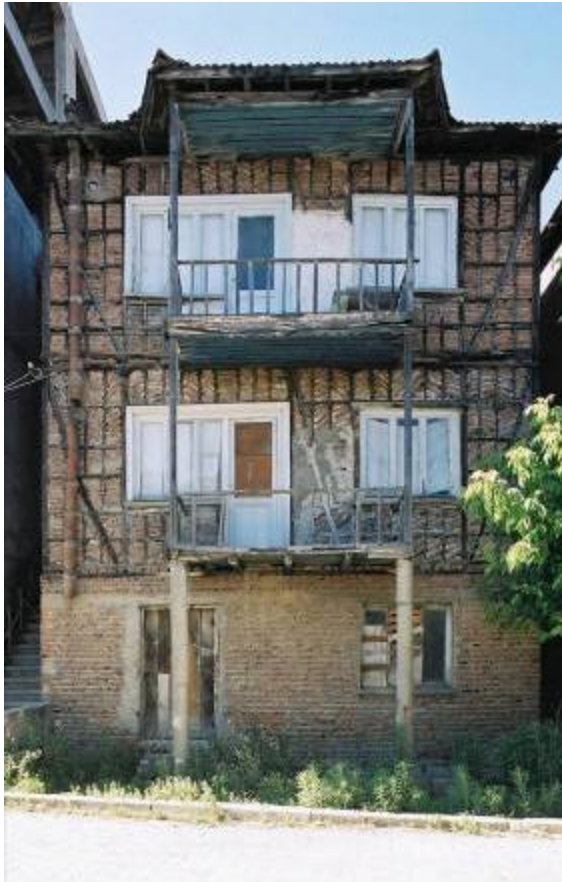
**Figure 10:** This three story house in Gölcük located less than one km from the fault was undamaged by the 1999 earthquake, while a number of reinforced concrete buildings on the adjacent blocks collapsed.<sup>1</sup>

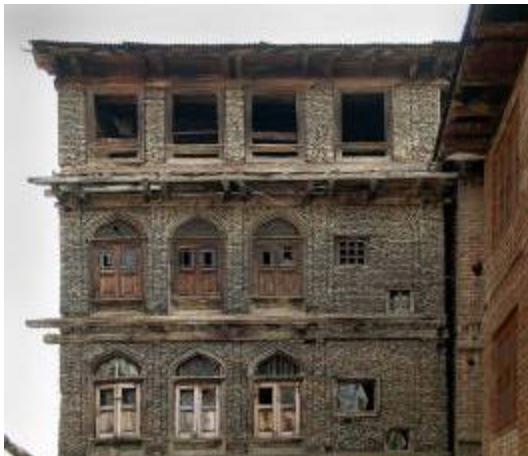
**Figure 15:** Example of *Taq* construction in Srinagar, Kashmir, 2005. The timbers in the masonry walls only run horizontally parallel to the wall and through the wall.

There are two basic types of traditional construction with earthquake resistance capabilities found in Kashmir. One, of solid bearing-wall masonry with timber lacing, is known as *“taq”* a word derived from the proportional system used to layout the building, rather than the construction (but no other more appropriate word seems to exist), and the other, a brick-nogged timber frame construction, known as *“dhajji-dewari”* from the ancient Persian “carpet weaver’s” language for “patch-quilt wall.” Both use timber within the plane of the masonry wall to serve to hold the buildings together. *Dhajji-Dewari* is characterized by having a complete timber frame,

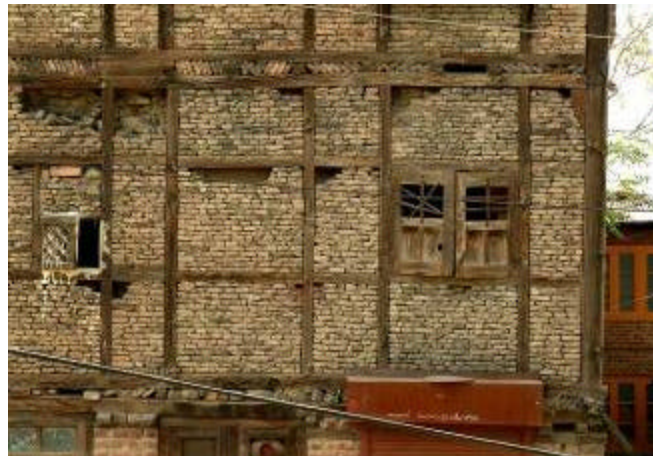
**Figure 16:** Example of *Dhajji Dewari* construction in Srinagar, 2005. The timbers form a complete frame, and the masonry is inset into the frame.

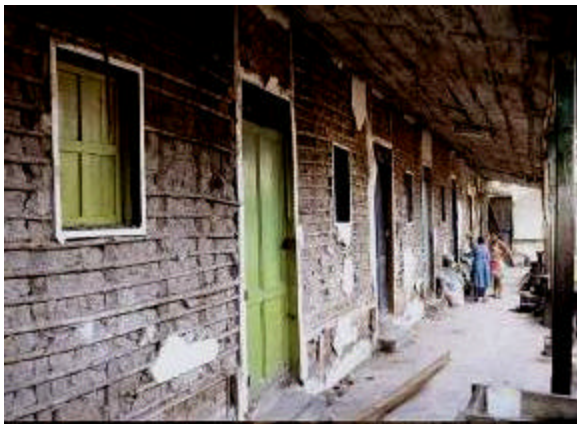
**Figure 17:** *Bahareque* construction in San Salvador showing effects of 1986 earthquake. The loss of the stucco shows that the wall underwent deformations without loss of its underlying structural integrity.

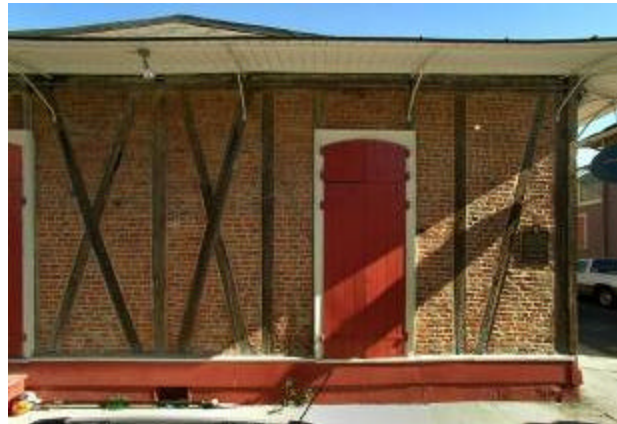
**Figure 18:** *Colombage* construction in the French Quarter of New Orleans, 2006.

***Colombage, Fachwerk, Half-timber, Himis, Bahareque and Quincha:*** In addition to Kashmir’s *dhajji dewari*, regional manifestations found in both earthquake and non-earthquake areas alike are called “*colombage*” in France, “*fachwerk*” in Germany, “*half-timber*” in Britain, and “*himis*” in Turkey. A variation that used loose earthen or stone filling in a bamboo or split-lath “basket” between the studs include *taquezal* and *bahareque* in Central America. Other variations that used earthen plaster and sticks or reeds (wattle and daub) include Turkish *Bagdadi* and Peruvian “*quincha*.” Despite the ephemeral nature of the material, 5,000 year old *quincha* construction has been unearthed at the Peruvian archeological site Caral. In the United States, the masonry infill version can be found in New Orleans and other historic French settlements on the Mississippi derived from French *colombage*, and also in parts of Pennsylvania, derived from the German *fachwerk*. (Langenbach 2006c).

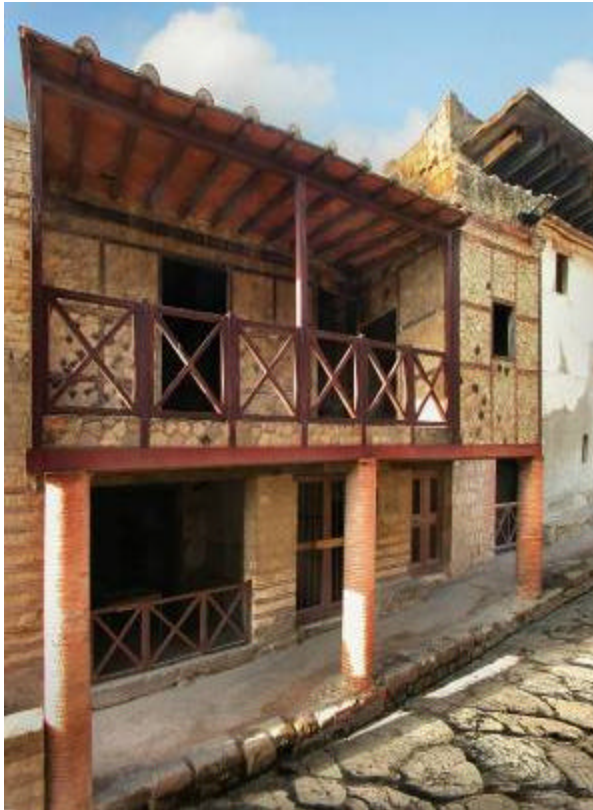
**Figure 19:** The *Cratichii* House at Herculaneum, 2003.

the seven or eight story tenements (*insulae*) that filled that city of a million and a half people (Figure 19). Masonry bearing walls would have been too thick at the base to fit on the known footprints of these ancient buildings with space for rooms left over, so it is likely that the Romans constructed many of these tall buildings with timber frames with infill masonry.

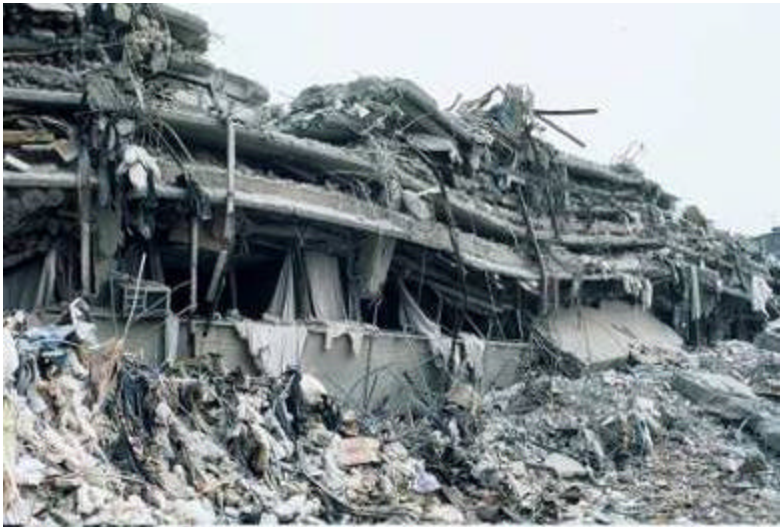
**Figure 20:** “Pancake” collapse in Mexico City, 1985.

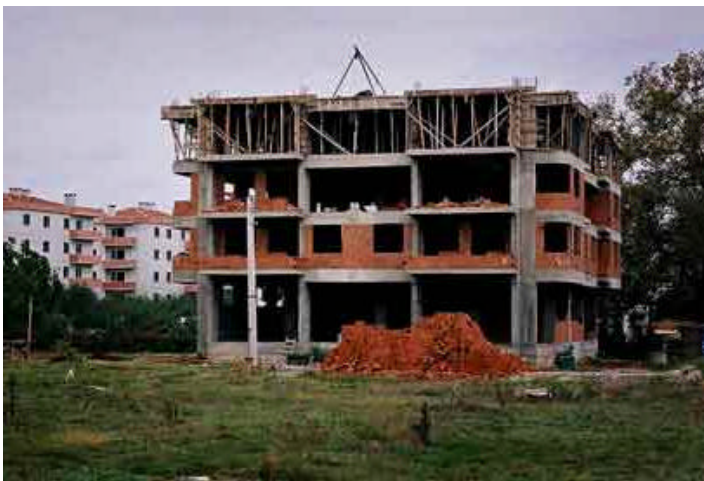
**Figure 22:** Typical Turkish RC building under construction showing the hollow block infill being installed.

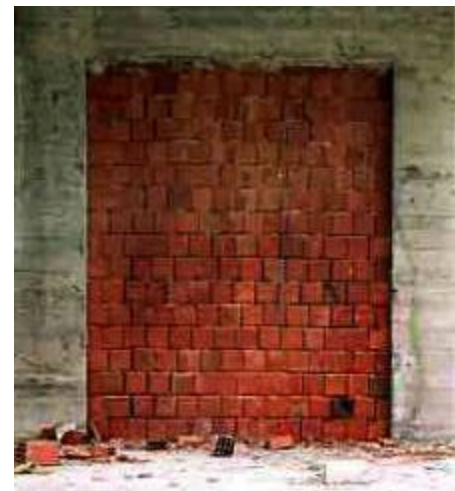
**Figure 23:** Typical hollow clay block infill as used in reinforced concrete residential construction in Turkey.

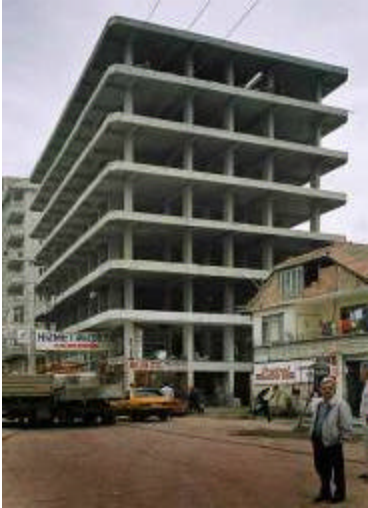
**Figure 25:** A massive RC frame in Golcuk, Turkey under construction at time of 1999 earthquake before installation of infill masonry walls. Much greater damage or collapse would have been likely had the infill walls been installed by the time of the earthquake.

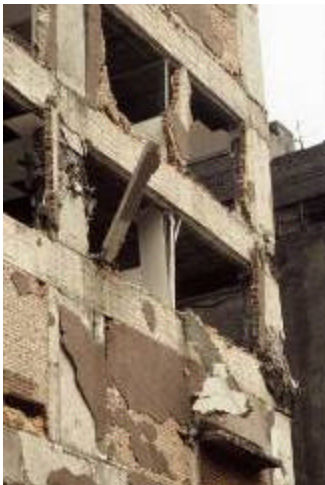
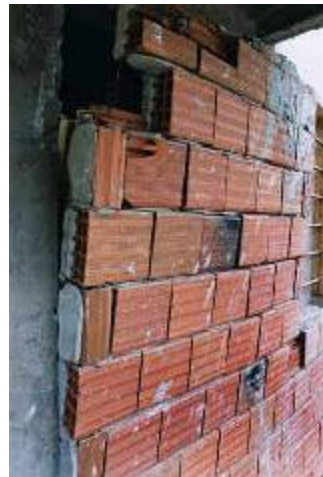
**Figure 26:** Infill wall RC building in Mexico City damaged in 1985 earthquake. The infill masonry in this structure almost caused the collapse of the building. The damage to the corner column that left the building teetering on the edge of collapse can be seen on the right.

**Figure 27:** Typical hollow block infill wall partially fallen out of the frame of a building under construction at the time of the Izmit earthquake in Turkey in 1999. The typical infill construction has no mechanical ties other than loosely packed mortar to hold the infill masonry from falling out of the frame. The subdivisions in *himis* construction help hold the masonry together in the frame because the panels are much smaller.

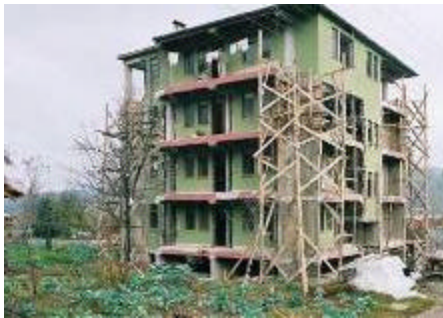
**Figure 29 & 30:** Five story building damaged in the 1999 Düzce earthquake in Turkey, being retrofitted with reinforced concrete shearwalls. No.30 shows the existing hollow clay block walls removed and steel being inserted for the construction of a reinforced concrete shearwall. These images illustrate the extent of the work, and disruption needed for earthquake strengthening using shearwalls. The occupants had to move out for the duration of this work as many existing walls were removed.

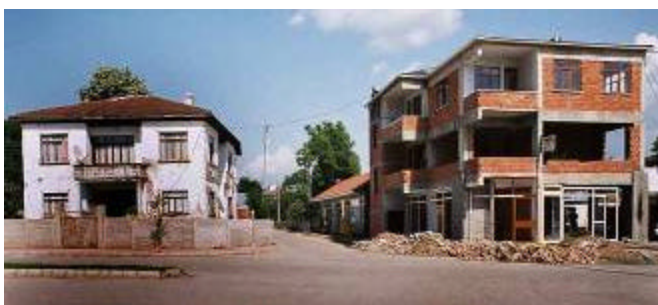
**Figure 31:** Three story RC building next to a 2½ story *himis* house near Düzce after the 1999 Düzce earthquake showing the repair of severe damage to the RC building (notice the size of the ground floor columns). The *himis* structure has lost only stucco on the side. Almost all of the hollow clay block on the RC building has been reconstructed after the earthquake. This shows that even low rise RC buildings sometimes suffered more damage than nearby traditional buildings.

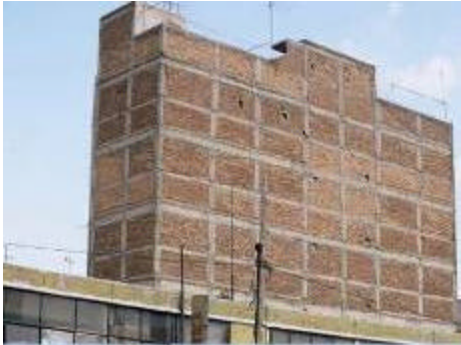
**Figure 32:** Infill RC building in Mexico City after the 1986 earthquake collapsed many buildings nearby, including the one in Figure 20. Each infill wall is subdivided vertically and horizontally into 4 panels.

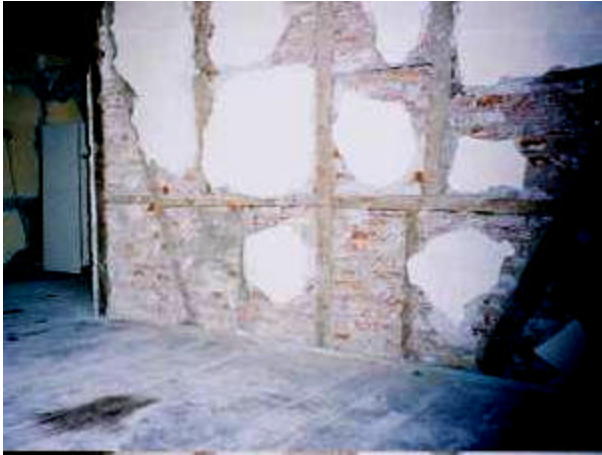
**Figure 36:** *Himis* interior wall in house in Düzce earthquake damage district showing “working” of wall that caused loss of plaster.

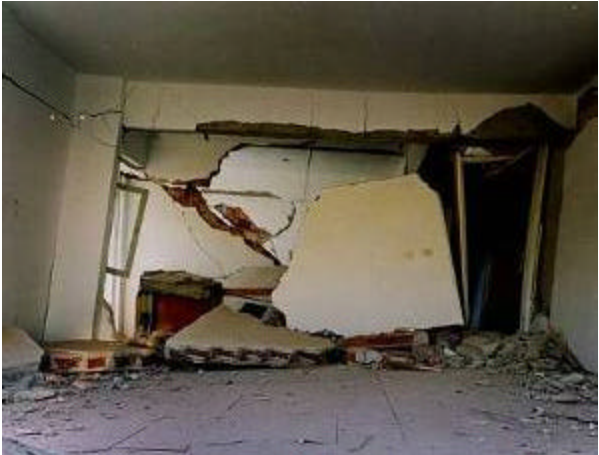
**Figure 37:** Collapse of a brittle interior hollow clay block wall illustrating typical failure pattern for such walls lacking subdivisions.

determined by the crushing strength of the masonry after substantial deformation of the wall. This strength is well above its initial elastic strength. The resulting mesh of hairline cracking produces many working interfaces, all of which allow the building to dissipate energy without experiencing a sudden drop-off in resistance. By comparison, standard brittle masonry infill walls without an “armature” lose their strength soon after the initial development of the diagonal tension “X” cracks. With fully developed “X” cracks, the walls are unstable, as the top triangular section can easily fall from out-of-plane forces. (Figure 37)

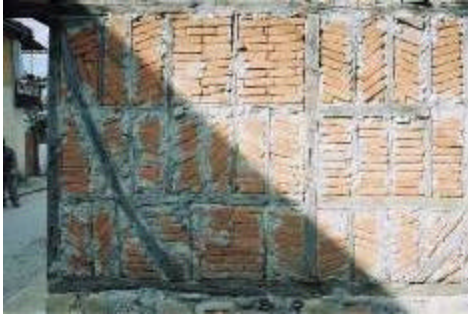
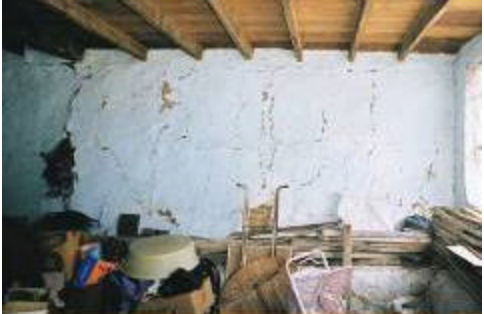
**Figure 39:** Exterior of 1955 *himis* house in Gocuk damage district one month after 1999 earthquake. Do damage is visible.

**Figure 40:** Same wall as Fig.10 showing earthquake caused cracks in interior mud plaster.

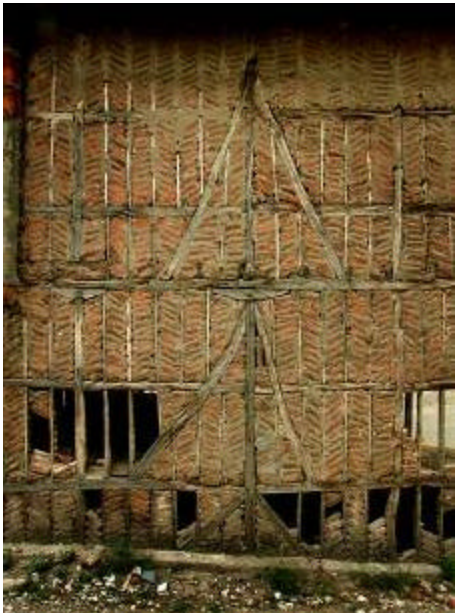
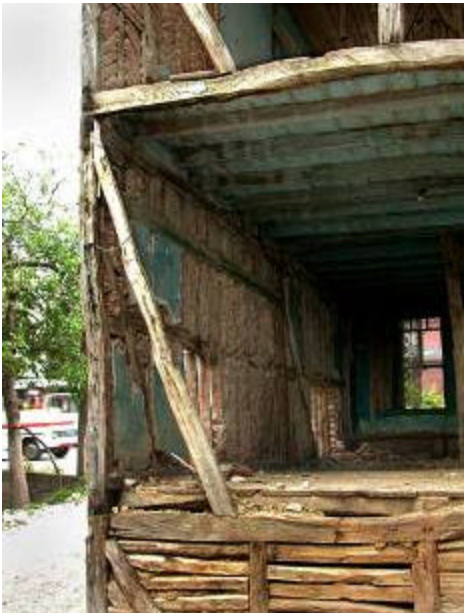
**Figure 41:** Partially demolished house in Golcuk showing the single brick wythe thickness of typical *himis* wall. On the LEFT is the exterior and on the RIGHT is the interior face of the same wall.

**Figure 42:** This house was abandoned and partially demolished at the time of the earthquake. Despite its condition, the earthquake had little affect on it. It was photographed in 2003.

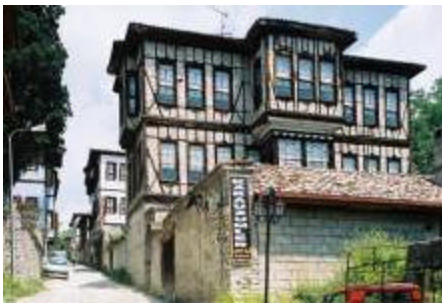
**Figure 43:** Large 3 story house in *himis* construction, Safranbolu, Turkey, 2000. Safranbolu is now on the World Heritage List because of its unique collection of intact Turkish vernacular houses.

**Figure 44:** *Himis* construction on 3 story house in Safranbolu, Turkey, 2000.

All too often, the post-earthquake inspection process is where cultural heritage takes an unnecessary hit, especially with unlisted and unofficially recognized cultural properties – namely vernacular buildings like the ones in figures 43 & 44. Because of the unrecognized lateral resistance provided by archaic structural elements, some historical buildings are often forced to meet a level of lateral resistance in excess of that required of fully code-conforming newly constructed buildings. The inspectors who are sent into areas after a disaster often have no training and even less sympathy for vernacular buildings and archaic construction, especially when buildings such as those with thin walls of light frame with masonry infill construction like that in Figures 41 & 42 are encountered, simply because they have no reference point in their training to understand how such buildings can competently resist earthquakes.

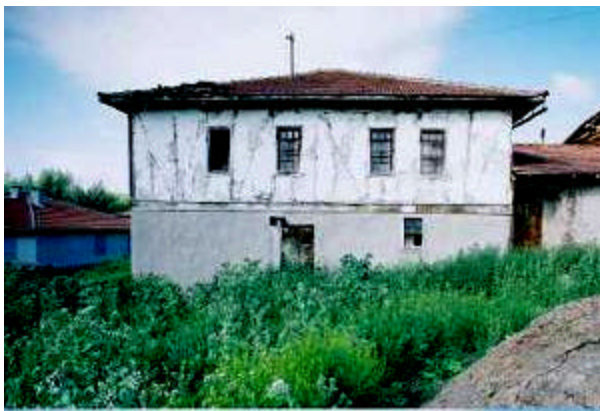
**Figure 45:** LEFT: House in Orta, Turkey one day after the 2000 Orta earthquake – showing plaster cracking that reveals the timber frame. There was no evidence of damage beyond that of the cracked plaster.

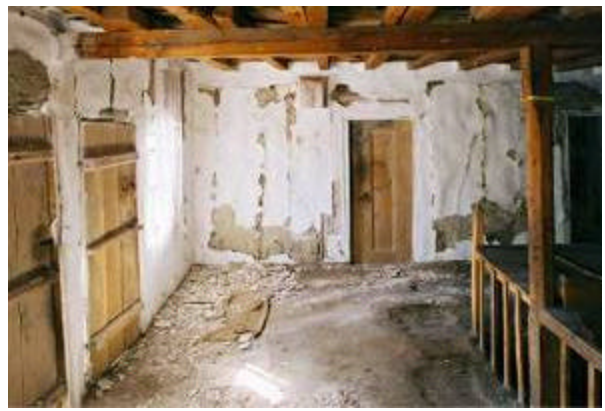
**Figure 46:** RIGHT: Interior of *himis* house after the Orta earthquake showing the “working” of the masonry panels. This view shows the inherent flexibility of the structures, but the inevitable disruption of the mud and lime plaster leads people, including both the owners and the government inspectors to assume that the buildings has lost strength when it has not.

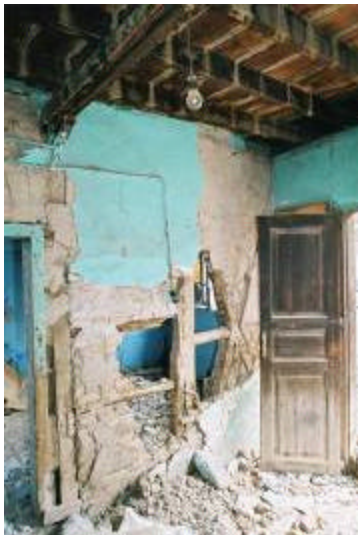
**Figure 47:** Interior vestibule of house in Adapazari after the 1999 Izmit earthquake.

A comparison of these views help illustrate that the damage in *himis* buildings in the two earthquakes is similar despite the fact that the 1999 earthquakes were very much larger than the Orta earthquake. (The house in 42 was abandoned and in poor condition prior to the earthquake, while that in 42 was occupied and in good condition – so the difference seen would have been less if both had been the same.)

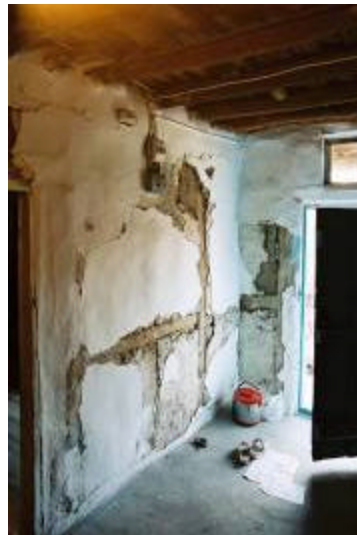
**Figure 48:** Interior vestibule of house in Orta after the 2000 Orta earthquake.

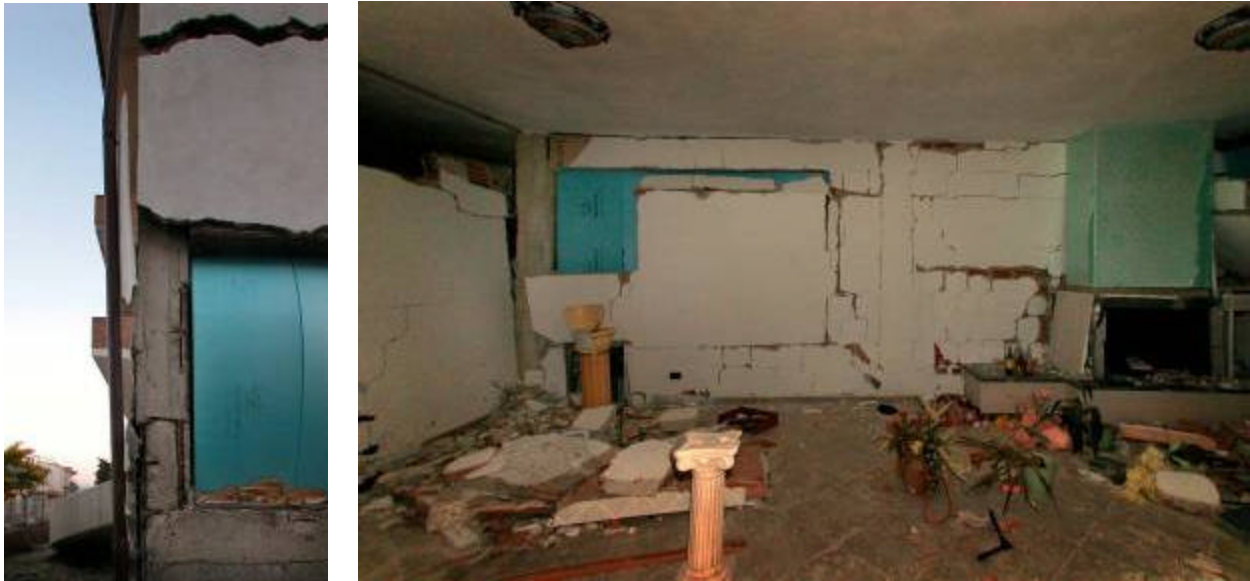
**Figure 49 & 50:** Interior and exterior of a damage reinforced concrete building in San Giuliano di Puglia after the Molise earthquake illustrating that the frame is on the verge of collapse. While this building will be difficult or impossible to repair to an earthquake-safe condition, the traditional house in Orta in Figure 46, with a similar amount of debris on the floor has lost a negligible amount of its total capacity, and can be easily repaired.

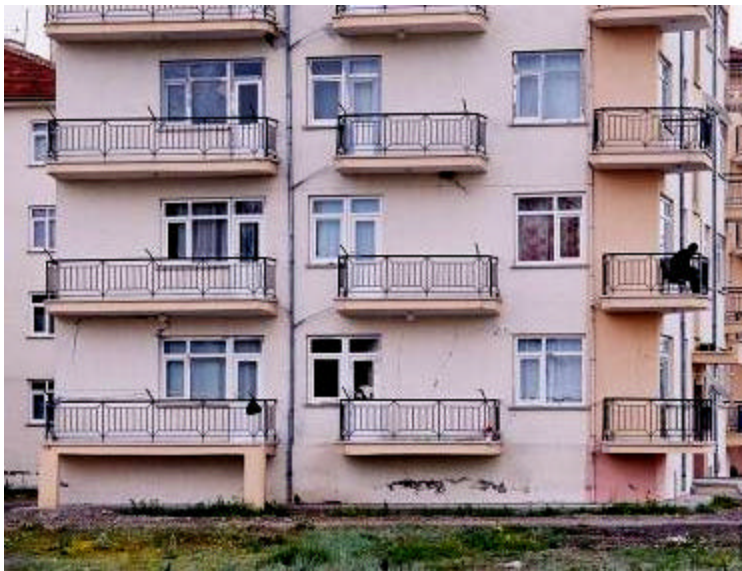
**Figure 51 LEFT:** RC apartment building in Orta after 2000 earthquake shows cracking in the infill walls.

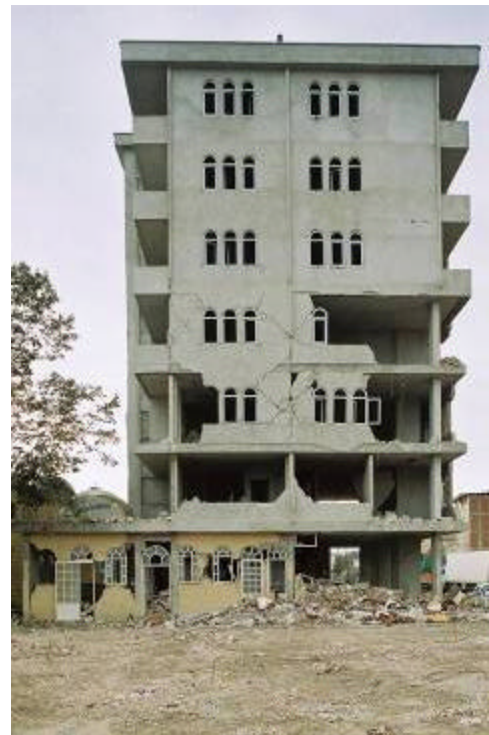
**Figure 52 RIGHT:** Apartment building in Golcuk after 1999 earthquake shows extensive collapse of infill walls and damage to the RC frame.

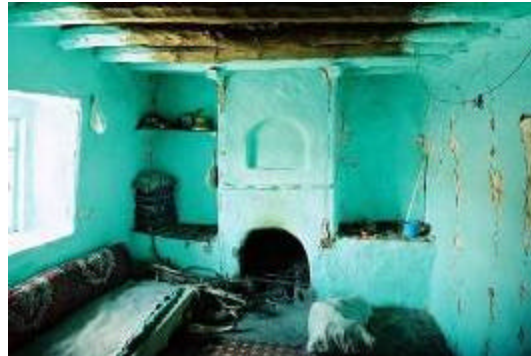
**Figure 63:** Interior of house of family in tent in Fig. above the day after the earthquake in 2000.

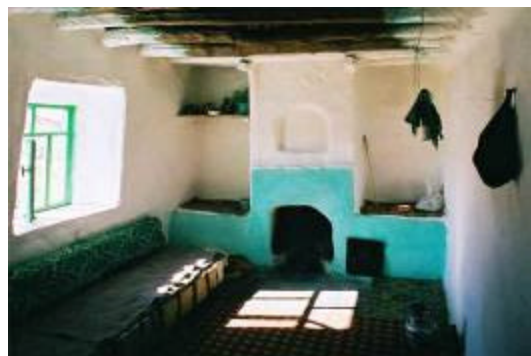
**Figure 64:** Same room six months later after they had repaired the house and moved back in. *Himis* construction can be easily repaired, and, in contrast to damaged RC, when repaired, it retains its capacity.

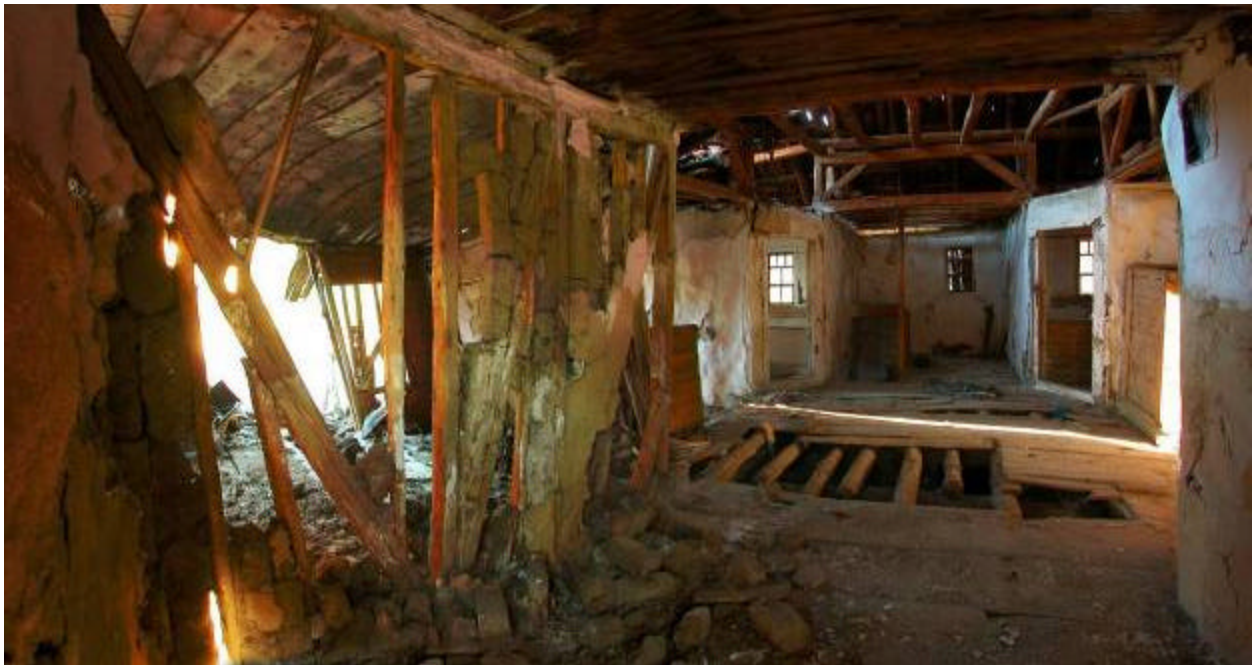
**Figure 65:** This house in Eden had been abandoned for years before the earthquake. Despite its deteriorated condition, the earthquake damage was limited to the collapse of some of its walls. The basic rough construction characteristic of a rural area without a saw mill or access to a kiln can be seen with the undressed logs used for the structure, and unfired adobe blocks used for the infill.

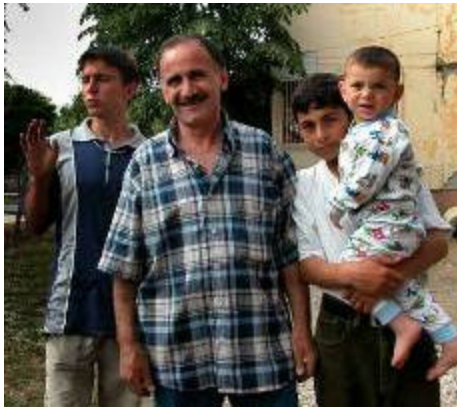
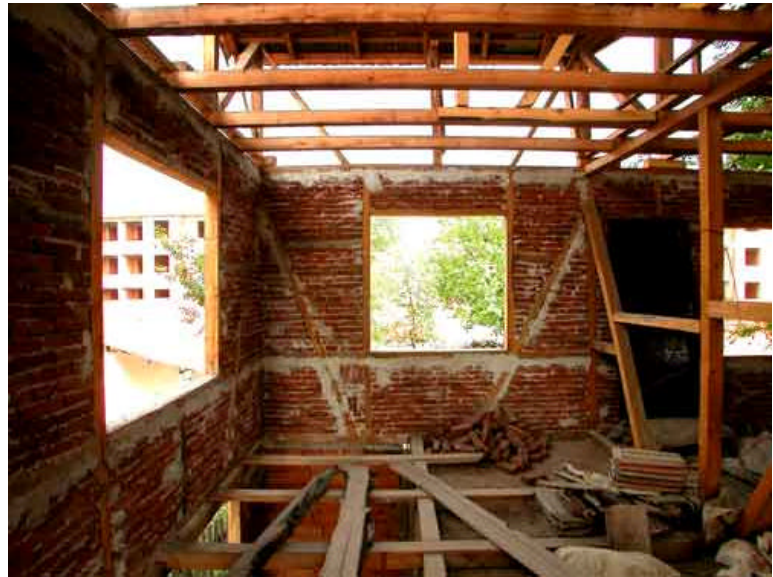
**Figure 66 & 67:** After witnessing the destruction of RC buildings in Duzce while his father's *himis* house survived undamaged, this resident of Düzce decided to stop construction of a new RC house and change it to *himis* construction.
