Rescuing the Baby from the Bathwater: Traditional Masonry as Earthquake-Resistant Construction

LANGENBACH, RANDOLPH¹

Keywords: *Earthquake, Traditional construction, Reinforced Concrete, Crosswall*

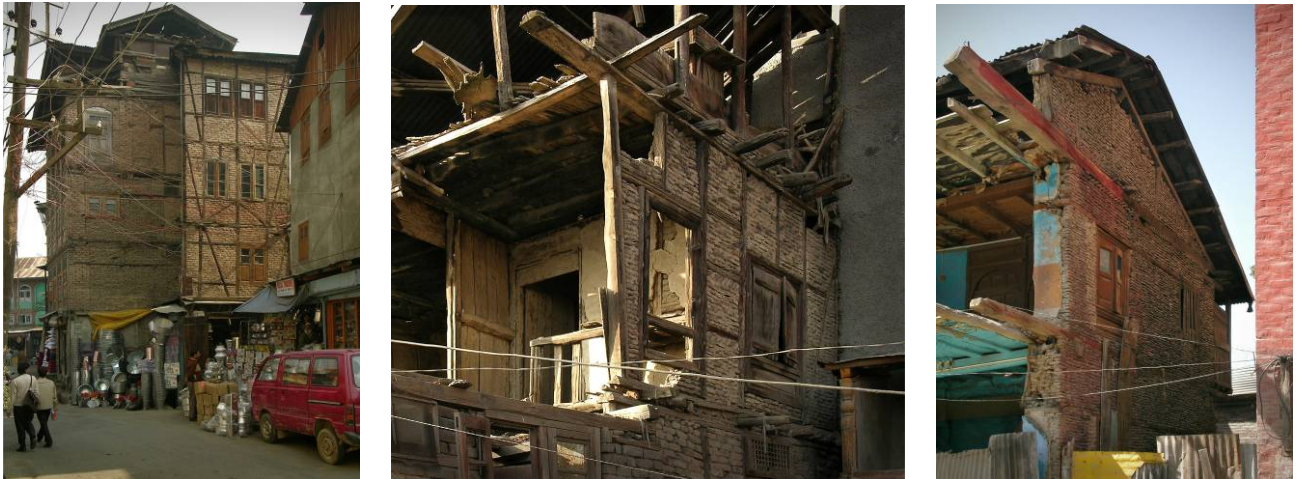
Figure 2. Buildings in Srinagar, Kashmir. **left:** The building on the left is of *taq* timber laced bearing wall construction, and on the right is of *dhajji dewari* construction. **middle:** A partially demolished *dhajji dewari* building showing timber frame with infill masonry construction. **right:** A partially demolished building showing timber-laced masonry bearing wall typical of *taq* construction.

While documenting the Indian textile industry in 1981, I became fascinated by the different types of traditional masonry construction found in Srinagar, Kashmir. The vernacular masonry buildings were constructed with a lacing of timbers laid into the walls that has become referred to as *taq* construction with local variations on what in English is called “half-timbered” construction. In Kashmir, this was given a textile term *dhajji dewari* to describe it, which means “patch quilt wall” in old Persian.(Fig. 2)

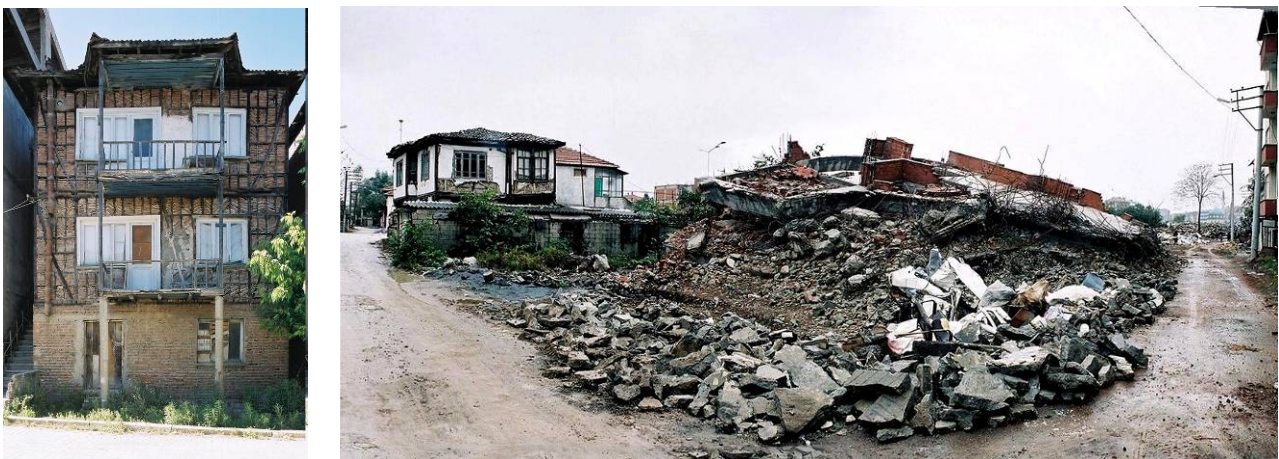
Figure 3. **left:** Undamaged three story *himiş* house in Gocuk, Turkey after the 1999 earthquake. **right:** View of a collapsed row of reinforced concrete apartment buildings with *himiş* house standing behind.

The Kocaeli Earthquake in Turkey in 1999 was soon followed by the Düzce earthquake. Turkey was home to historic construction systems similar to those found in Kashmir, and these earthquakes affected buildings similar to the *dhajji dewari*, which in Turkish are called *himiş*. In the epicentral area cities of Gölcük and Düzce, surviving *himiş* construction buildings could frequently be found standing next to collapsed modern engineered buildings of reinforced concrete. (Fig. 3)

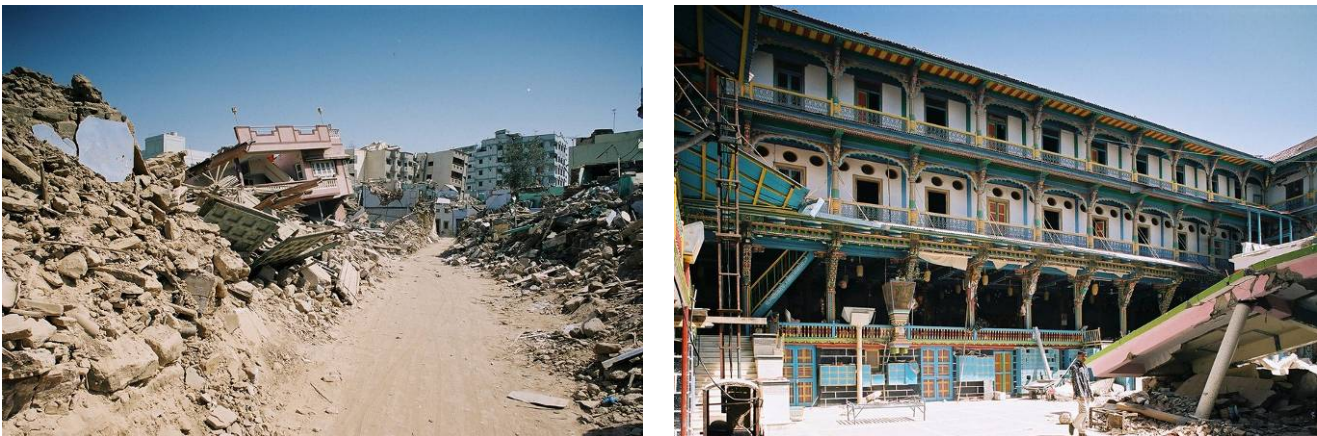
Figure 4. left: Total destruction of rubble stone and concrete buildings the city of Bhuj after the 2001 earthquake. right: Swaminarayan Temple complex in Bhuj after the earthquake.

The lack of damage to the Swaminarayan building in comparison to most of the rest of the city of Bhuj provided further evidence that such details can make a critical difference. However, it leaves unanswered the question of how to quantify that difference, and does not offer an objective measure of such buildings against a threshold for acceptable seismic performance in the modern world.[2]

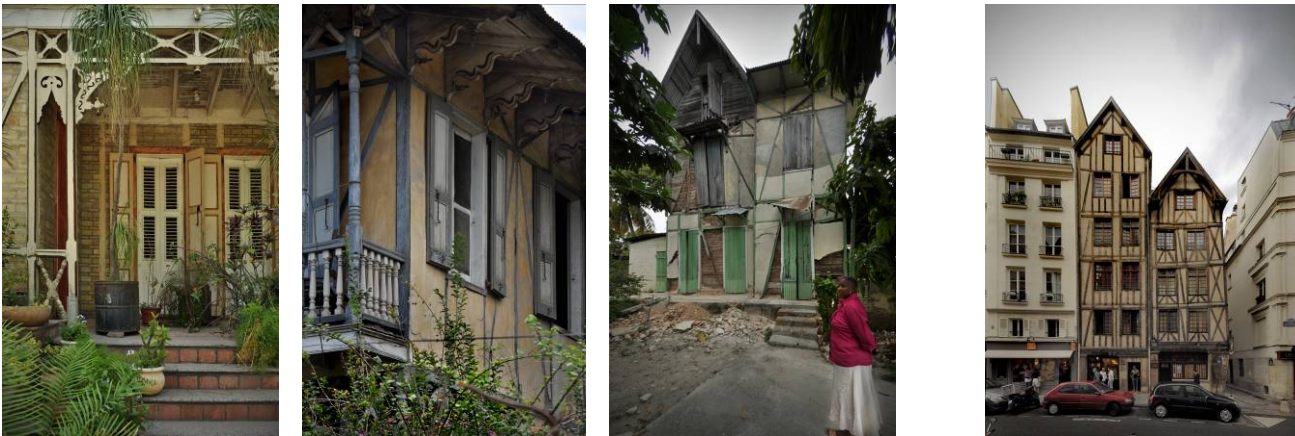
Figure 5. The three photos on the left show *pan-de-bois* houses in Haiti. The left view shows brick infilling, the middle, with stucco over rubble stone, and the right shows a house that was heavily eaten by termites, yet which survived. The interior timber cladding is visible where the infill stone has fallen. The right hand view shows medieval *pan-de-bois* houses in Paris with their steeply gabled roofs.

The masonry infilling used in the *pan-de-bois* was either fired brick or hollow clay tile, or the same kind of rubble stonework with clay mortar used in the bearing wall masonry buildings described below. The question of whether the Haitian version would exhibit the resistance characteristics of its Kashmiri or Turkish cousin is complex. Clearly, the *pan-de-bois* buildings survived the earthquake much better than did the buildings with the rubble stone masonry. Those with the *pan-de-bois* on the 2nd floor with bearing wall masonry on the ground floor were often left with the *pan-de-bois* floor almost perfectly intact atop the heavily damaged brick and rubble masonry walls of the floor below.

The Haitian *pan-de-bois* is different from the Kashmiri and Turkish examples in a crucial way – the interior walls are clad with sawn wood boards in all but a very few instances. These boards make the building almost into an all-wood structure, with the brick or stone infilling simply an architectural feature. There is, however, clear evidence that the masonry infilling did have a beneficial effect by helping to damp out the earthquake excitations, and thus help prevent the collapse of those timber structures – and there were many – that had been so heavily eaten by termites that much of the wood structure had been compromised.

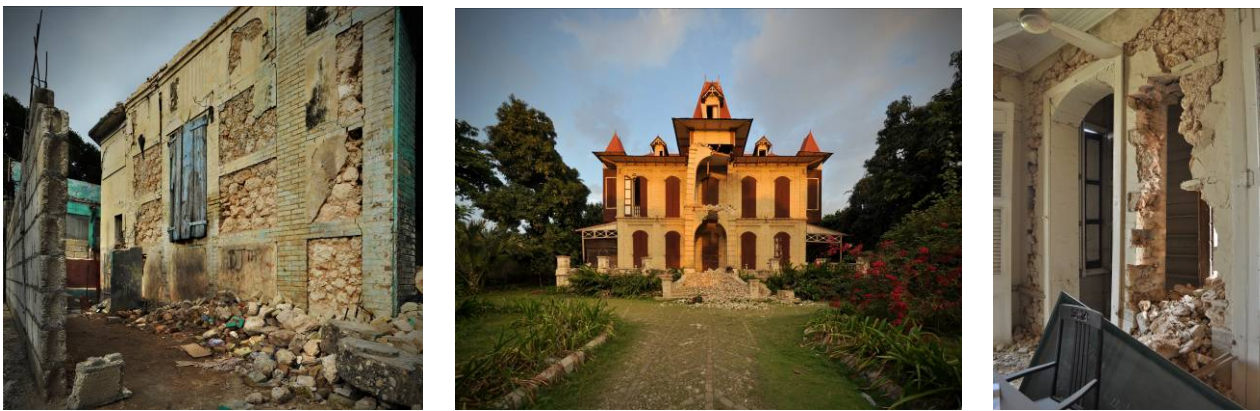
Figure 6. **left:** masonry wall in Port-au-Prince after the earthquake showing the typical Haitian construction with brick surrounding panels of rubble stone. **middle:** The Villa Castel Fleuri, a mansion in the Gingerbread District of Port-au-Prince after the earthquake. **right:** Interior of Villa Castel Fleuri showing partial collapse of a rubble masonry panel between the brick piers.

These infill panels were often crossed at one-meter levels with two courses of brick on the inside and outside faces of the wall. These brick courses crossing the rubble masonry panel may have been intended to serve as crack-stoppers, to help with stabilizing and confining the rubble stonework. This use of brick courses in rubble stone walls continues a building tradition that can be found in many other places, in ancient Rome and Medieval and Renaissance construction,, and in Haiti is probably a carryover from French medieval and early Renaissance masonry construction practices. Unfortunately, several examples showed that the brick courses were not bonded through the wall, but were extended only across the inside and outside surfaces.(Fig. 6)

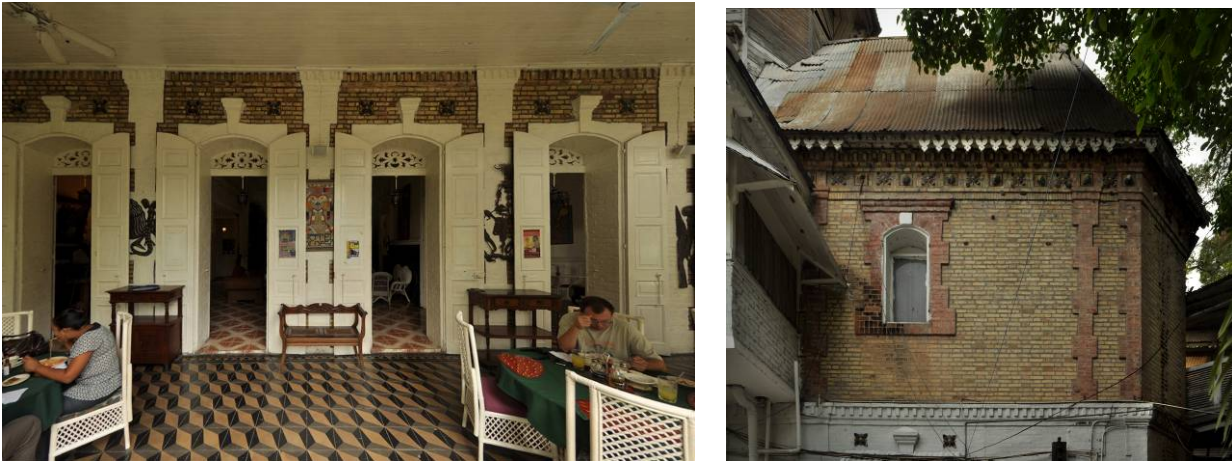
Figure 7. **left:** First story front wall of the Hotel Oloffson after the earthquake showing the undamaged masonry wall penetrated by many doors. **right:** A section of the exterior wall of the Hotel Oloffson. Most of the walls are hidden behind wide porches, but this section shows the brick construction.

An important point of comparison is the Hotel Oloffson (Fig. 7), which had been constructed as a private home at the end of the 19th century. This building is unique among the masonry Gingerbread houses because it was constructed of unreinforced load bearing masonry, but without the rubble stone panels. The masonry was laid in a Flemish bond. The walls appear to have been laid up in brick all the way through, and of similar thickness (about 20 inches or 50cm) as in other buildings, and the building is constructed on an upslope site with two stories plus a full height basement in front. Thus, the loads were by comparison higher than for the many smaller Gingerbread houses with only one story masonry walls overtopped with timber framed second stories.

This building stands as an icon in Port-au-Prince because it suffered almost no damage during the earthquake, and the hotel has remained open since the earthquake. The hairline cracks seen on the second floor are too small to show in any but high resolution close-up photographs, despite the fact that two of the total of seven piers between the windows, including the corners of the building on the rear of the building, had been removed to form large floor to ceiling openings to expand the public room into the rear yard of the building. To allay any suspicion that the site was uniquely quiet during the earthquake, behind the Oloffson was a multi-story concrete hotel building that collapsed completely, providing evidence of considerable shaking at the site. Its survival in an almost undamaged state provides a good data point showing that the much greater damage to many of the other masonry buildings was largely a result of the unique weakness and vulnerability of the rubble masonry panels. It also conspicuously shows that the vast numbers of newer reinforced concrete infill wall buildings that collapsed were way below the onset of damage to unreinforced brick masonry.

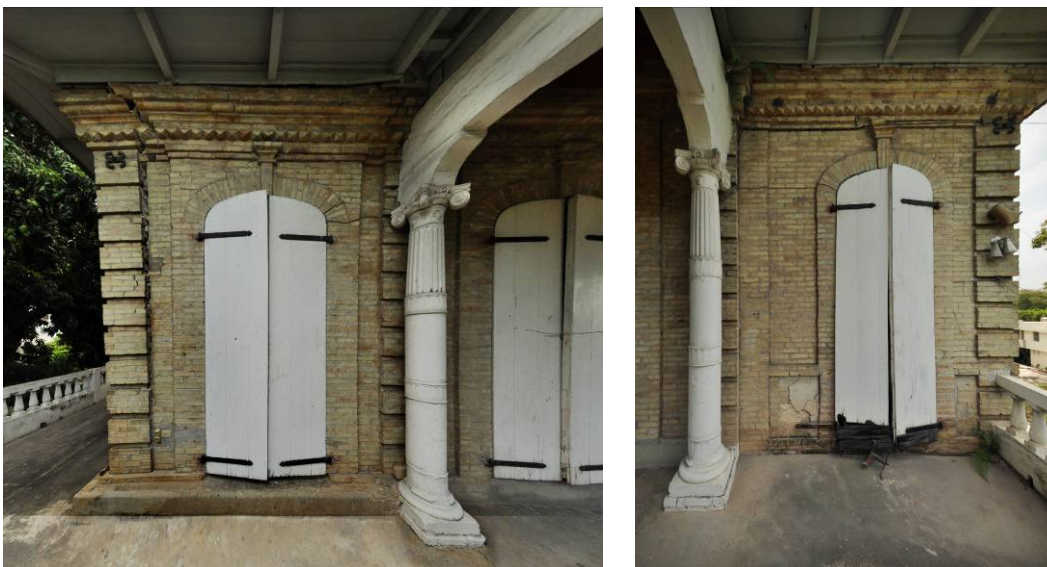
Figure 8. 2nd storey wall of a masonry house showing the iron brackets that connect the through wall steel ties that form a continuous ring around the house. The left view shows the wall deflected outward because the plate was missing on the wall around the corner, whereas the view of right hand end of the same wall shows no visible damage because the plate was still attached and thus effective in preventing the spreading.

One very important asset found in many of the masonry buildings in the Gingerbread district is that walls were tied together with iron or steel rods at the floor and roof levels. These rods were hooked together to form chains and laid into the masonry walls, with ornamental plates at either end in the form of a star or something resembling a double ended fleur-de-lis. They were installed as rings around the buildings, and sometimes across the interior masonry walls at the floor levels. There is considerable evidence that these proved very effective at preventing the collapse of many of the masonry walls. This observation is supported by examples where the plates were missing, having failed from rust, or not installed when the building was built. In comparison to those buildings where they were present, their absence was associated with a greater amount of damage and disruption of the masonry.(Fig. 8)

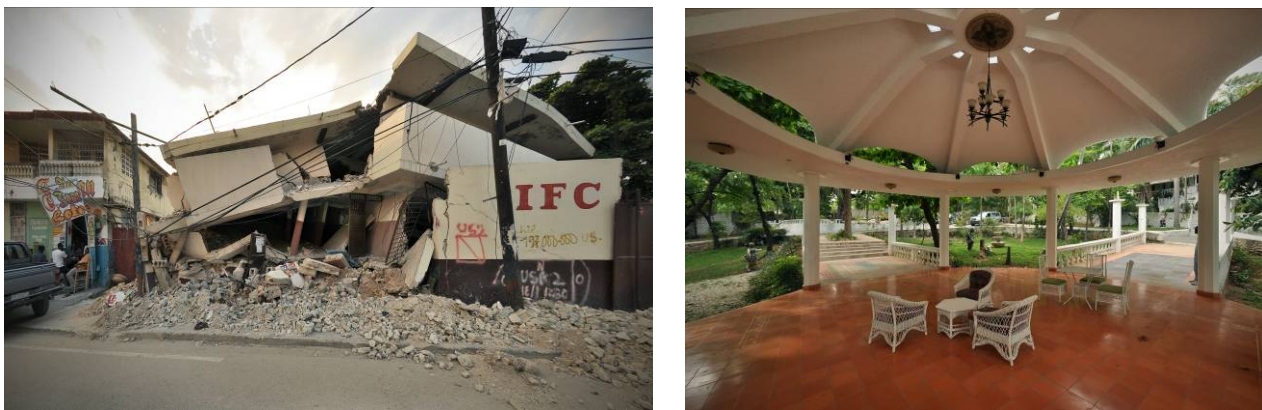
Figure 9. **left:** An example of vulnerable construction: earthquake collapsed reinforced concrete building, Port-au-Prince. **right:** An example of good construction: view of large open air gazebo at the Hotel Oloffson of reinforced concrete construction that survived the earthquake with nothing more than a few cracks in the pantry wing behind the photographer.

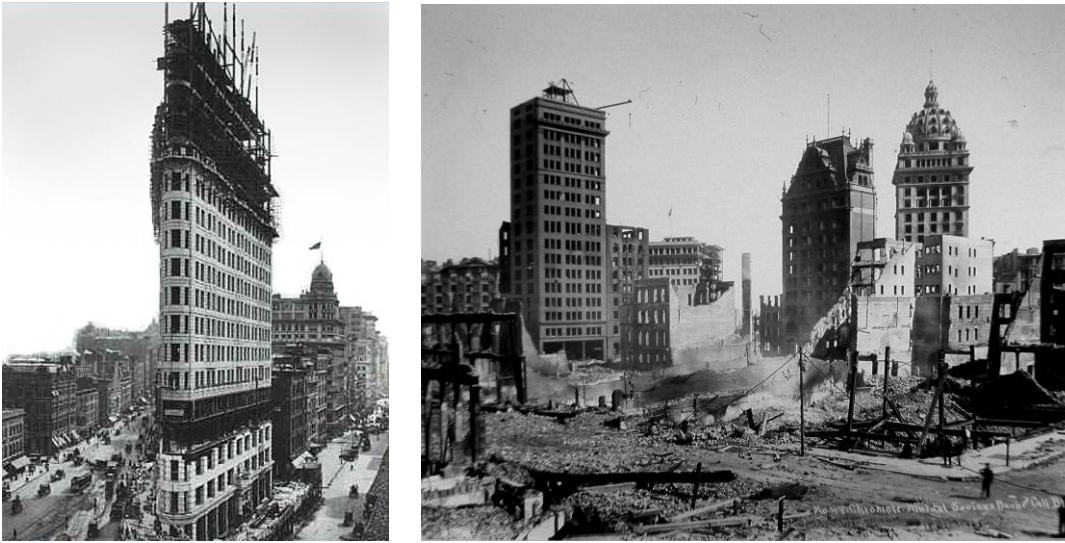
Figure 10. **left:** Flatiron Building in New York City under construction in 1902 showing the heavy stone masonry façade resting on the steel frame. The upper walls are constructed separately probably to ensure the weight is bearing on the frame rather than the lower masonry walls. *Credit: vazyvite.com.* **right:** View of San Francisco after the 1906 earthquake and fire. The three tall buildings visible in this view were burned out by the fire that followed the earthquake, but all three were in good enough condition despite this to be repaired, and they are still extant today. *Credit: Bancroft Library.*

Contraflexure portal frame analysis thus made a substantial reduction in the sizes of the members of a frame possible. However, the solid masonry exteriors of the first generation of skeleton frame “skyscrapers” did not change. The walls continued to be thick masonry, and although no longer load-bearing to the ground, these walls still shared significant loads with the internal steel frame, as well as protecting the frame from exposure to fire. Many historians of the early skyscraper era view the evolution of skeleton frame building design as one almost like that of a genie waiting to come out of the bottle – true transformation could only come when this traditional masonry envelope was shed, and the open frame itself made the basis for the architectural expression with flexible systems of open spaces and moveable walls. [11]

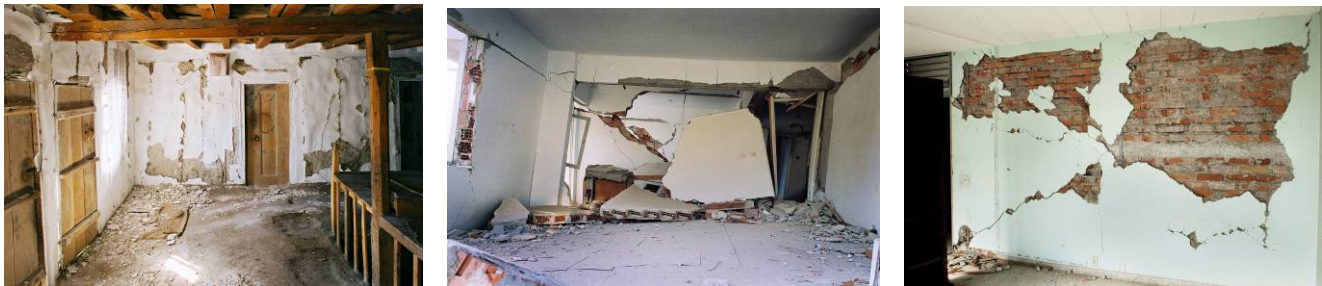
Figure 12. **left:** Interior of a traditional house in Yuva, Turkey of after the 2000 Orta earthquake showing evidence of the working of the *hımiş* walls. **middle:** Typical hollow clay tile masonry wall in a reinforced concrete apartment building in Gölcük, Turkey collapsed by the 1999 Kocaeli earthquake. **right:** Typical infill masonry wall found inside the upper stories of a four story building that suffered a soft story collapse during the 1986 San Salvador earthquake showing that the infill wall was subdivided with a concrete beam and column similar to that advocated for Armature Crosswalls. These sub-frames prevented the collapse of the ground floor from progressing to a complete pancake collapse, saving the lives of the occupants.

Returning to the aftermath of the 1999 Kocaeli earthquake in Gölcük, one answer to this problem may lie hidden behind the heaps of rubble from the collapsed concrete apartment houses. As different as they are from their concrete cousins, the *himiş* houses that remained standing amongst the ruins also have masonry infill confined within a frame, and their survival has provided a source for one idea on how to keep reinforced concrete buildings from collapsing — a concept called “Armature Crosswalls.” The Armature Crosswall concept is based on using the ancient infill-wall masonry technology for modern reinforced concrete construction. Instead of the existing method of constructing infill walls in reinforced concrete buildings totally out of hollow clay tile or brick, they are constructed with a sub-frame of studs and cross-pieces with the masonry infilling this sub-frame. The material chosen for these studs need not be limited to one type - it may be timber, steel, or concrete. The mortar for the masonry, however, is best if it is of low strength, rather than of high strength Portland cement. This is best accomplished by using a lime-based mix that is less strong, stiff, and brittle than ordinary cement mortar. [13]

The intention behind the assembly of these elements is that the infill walls would have less initial stiffness and more frictional damping than standard infill masonry walls. The reduced initial stiffness can avoid the potentially destructive development of the “equivalent diagonal strut,” thus, allowing the frame-action to occur, on which the portal frame analysis is based. In addition, the energy dissipation from the working of the combination of timber, bricks and mortar against each other serves to dampen the excitation of the building by the earthquake. As demonstrated by the *hımiş* buildings in the epicentral region of the 1999 earthquakes in Turkey, this working of the composite structure during an earthquake can continue for a long period before the degradation advances to a destructive level. This was not the case with the nearby reinforced concrete buildings. Interestingly, the same phenomenon can be observed with the bearing wall masonry buildings in Haiti, where the enframing brick piers and subdividing brick courses often prevented total collapse - even when the panels of rubble had completely crumbled.

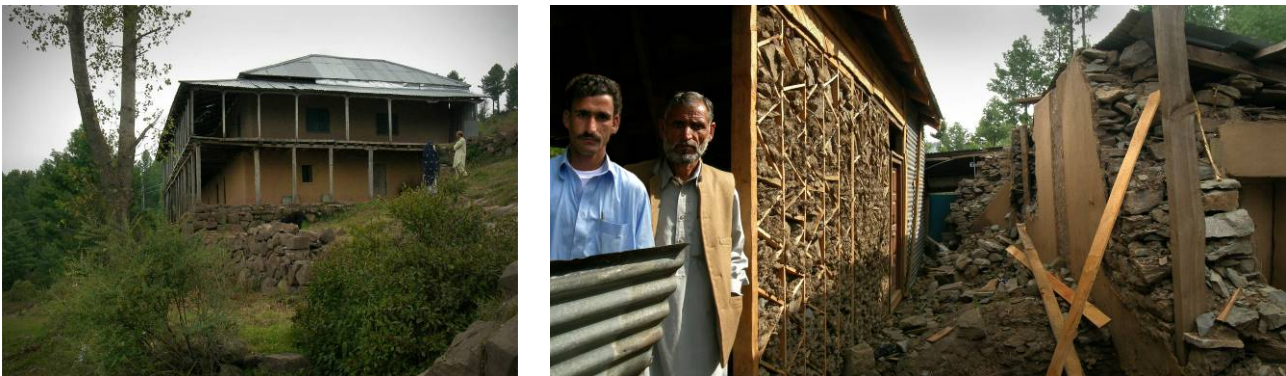
Figure 13. **left:** This is the only house to survive the 2005 Kashmir earthquake in the remote Pakistani village of Topi. It is of *dhajji* construction. **right:** Also in Topi, the owner (right) is standing next to his carpenter in the half-completed *dhajji* house he was building next to the ruins of the rubble stone house that collapsed in the earthquake seen on the right. He is using *dhajji* after seeing that the house on the left is the only one that survived. By proceeding with *dhajji* for his reconstruction, the owner was forgoing government disaster assistance which mandated using their reinforced concrete specifications. One year after the earthquake, shortly after this picture was taken, the government approved *dhajji* construction for as qualifying for disaster assistance. [16]

international non-governmental organizations for post-earthquake disaster new construction. That only begin to happen in the next earthquake, a short four years later, in Kashmir itself. (See Fig.13)
