KEYNOTE ADDRESS

**ANCIENT CONSTRUCTION TECHNOLOGIES THAT CAN PROTECT
MODERN BUILDINGS FROM COLLAPSE IN EARTHQUAKES**

Randolph Langenbach

Conservationtech Consulting

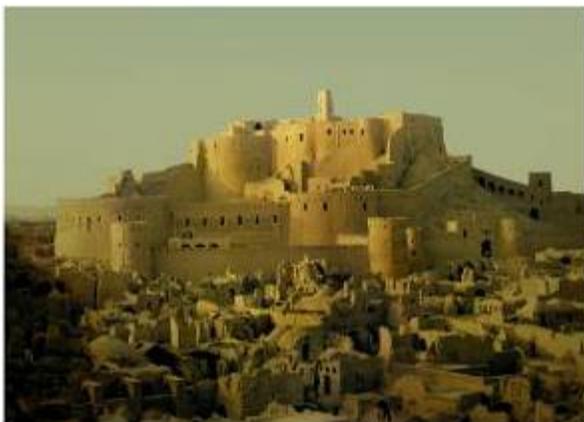
Fig. 1. The Arg-e Bam before the earthquake (photo courtesy Iran Tourism Organization)

In the morning of 26 December 2003 the world woke up to news of an earthquake in Iran, in which an entire city was reported to have been destroyed and tens of thousands of people killed. This news was illustrated with a pair of pictures of Bam's iconic earthen walled city, the Arg-e Bam. The post-earthquake picture showed a sea of rubble where the majestic undulating

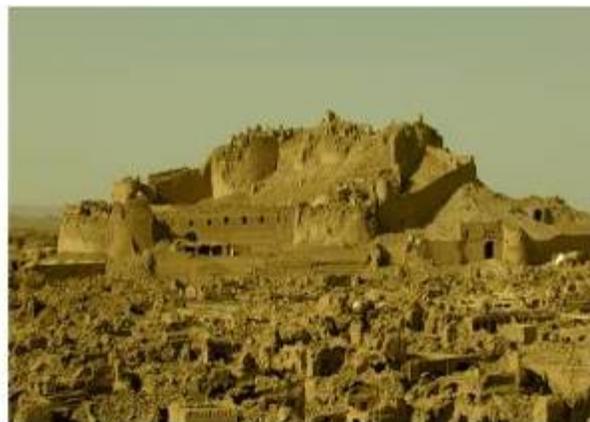
Fig. 2. The Arg-e-Bam, exactly the same view after the earthquake.

earthen walls had once been—like a child’s sand castle on the beach after it had been kicked down by rude teenagers. This pair of pictures became the unwitting symbol for the sudden annihilation of approximately 30,000 people estimated to have died in the earthquake. Unfired earthen construction—how can it possibly be safe? Isn’t it time that it should be banned outright?

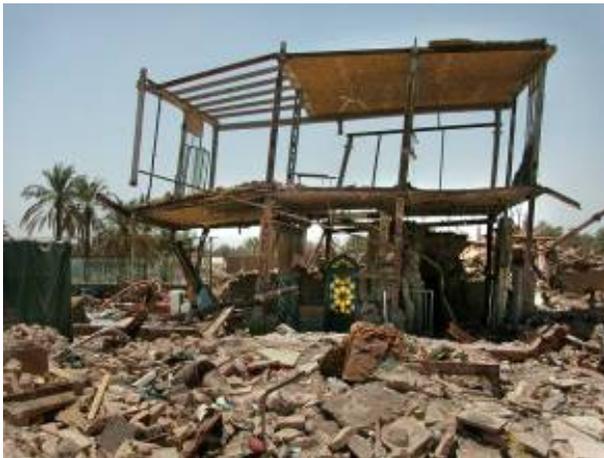
Fig. 3. Light steel frame building with jack-arch floors and roof damaged in the 2003 Bam earthquake.

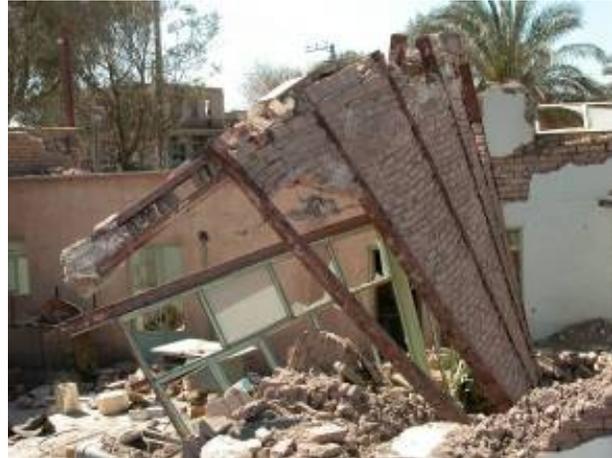
Fig. 4. Ruins from the 2003 Bam earthquake showing the steel and fired brick masonry jack-arch construction used for floors and roofs in Bam that were strong in themselves, but incompatibly rigid for the *Khesht* (unfired adobe) walls.

The proof that modern buildings were responsible can be shown with simple arithmetic. At the time of the earthquake, Bam had a population of 100,000, of which approximately a third were killed. However, as recently as in 1968, Bam had only 7,000 residents. While many of the new buildings that housed this expanded population did have adobe walls, their upper floors and roofs frequently were often constructed of steel and fired brick. Lacking ties to secure them to the walls, the roofs collapsed onto the occupants.

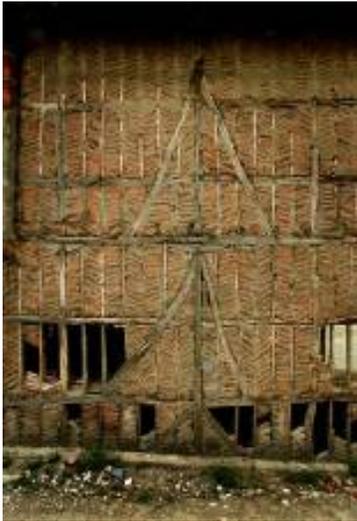
Fig. 5. Partially demolished house in Gölcük, Turkey at the time of the earthquake showing the single brick wythe thickness of typical *hımsı* wall. The building had been abandoned for many years prior to the earthquake.

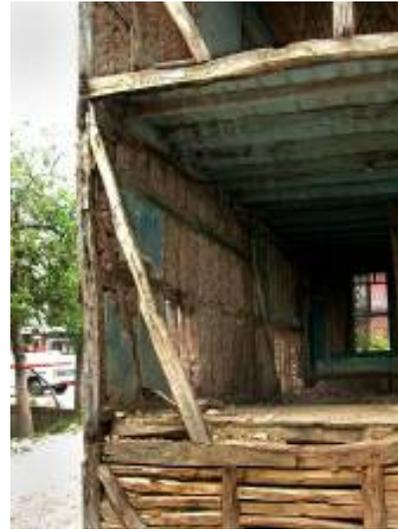
Fig. 6. The interior face of the same wall in Fig. 5. Despite its condition, the 1999 Kocaeli earthquake which caused the collapse of hundreds of nearby modern buildings, had little effect on it.

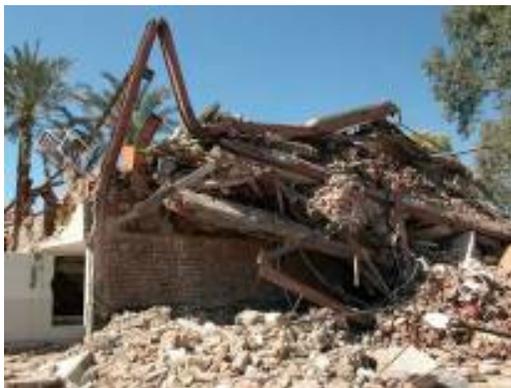
Fig. 7. Steel frame building collapsed by the 2003 Bam, Iran earthquake.

in 2003. In Iran light steel frames, also with masonry infill, are more common than concrete frames, but many of these buildings also collapsed in the 2003 Bam earthquake.

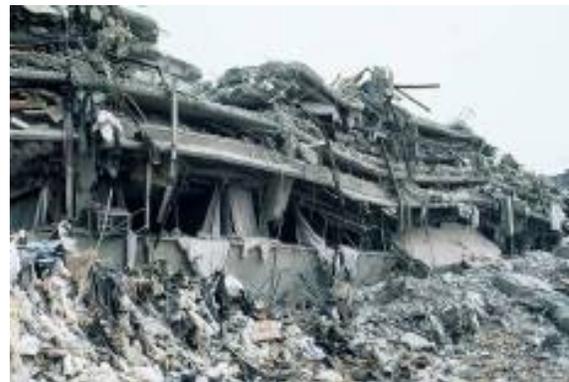
Fig. 8. The Juarez Hospital collapsed by the 1985 Mexico City earthquake.

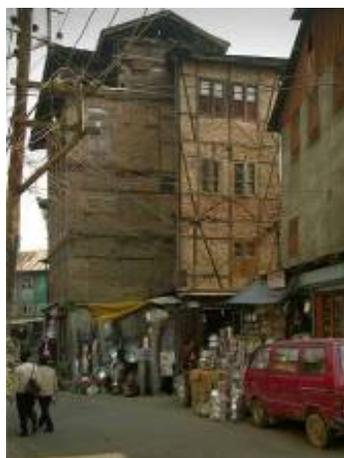
Fig. 9. Buildings in Srinagar, Kashmir. The building on the left is of *taq* construction, and on the right is of *dhajji dewari* construction.

There are two basic types of traditional construction with earthquake resistance capabilities found in Kashmir. One, of solid bearing-wall masonry with timber lacing, is known as *taq* and the other, a brick-nogged timber frame construction, is known as *dhajji-dewari* from the Persian words for “patchquilt wall.” Both use timber within the masonry wall to serve to hold the buildings together. *Dhajji-dewari* is characterized by having a complete timber frame, with one wythe (layer) of masonry forming panels within the frame.[4]

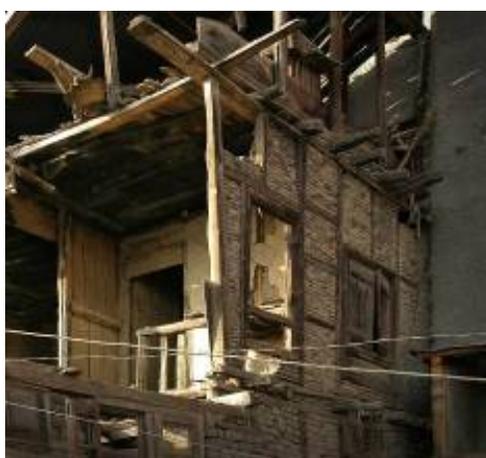
Fig. 10. A partially demolished *dhajji dewari* building showing timber frame with infill masonry construction.

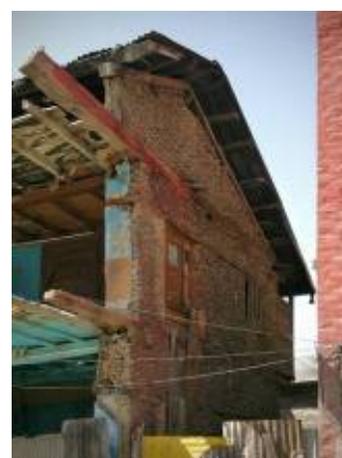
Fig. 11. A partially demolished building showing timber-laced masonry bearing wall typical of *taq* construction.

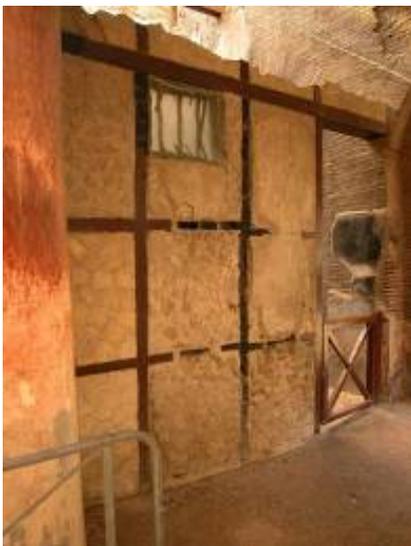
Fig. 12. Ancient Roman interior wall of *Opus Craticium* construction excavated in Herculaneum, Italy.

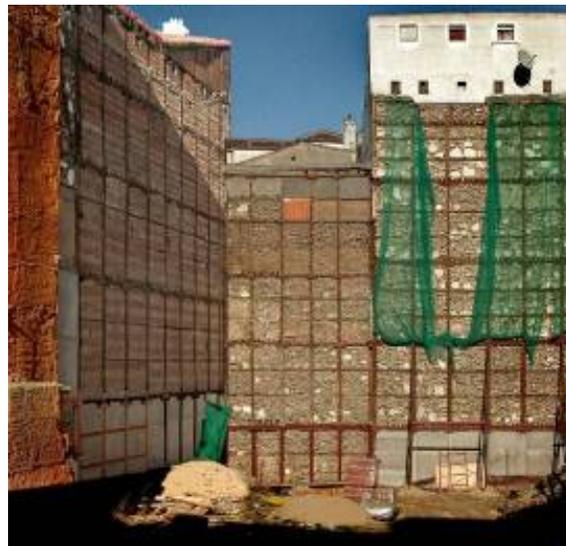
Fig. 13. Backs of 5 to 7 story buildings in central Madrid exposed by demolition of adjacent structures showing the timber frame construction with rubble masonry infill typical of the area in the 17th-19th centuries.

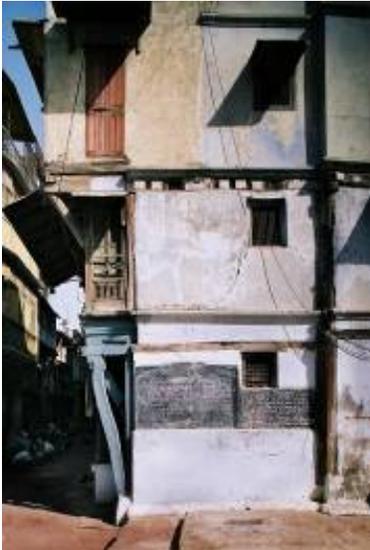
Fig. 14. Timber-laced four story masonry building in historic center of Ahmedabad after 2001 earthquake.

This technology transfer along ancient cultural routes could explain why similar construction is found in the historic center of the Mogul city of Ahmedabad, Gujarat, but not in nearby Bhuj. In Ahmedabad, timber-laced vernacular buildings of similar construction to that found in Turkey and Kashmir survived the 2001 Gujarat earthquake when scores of reinforced concrete buildings collapsed. In Bhuj, historically a Rajput princely state, the buildings in the walled city were mostly of unreinforced rubble stone, which were devastated by the earthquake.

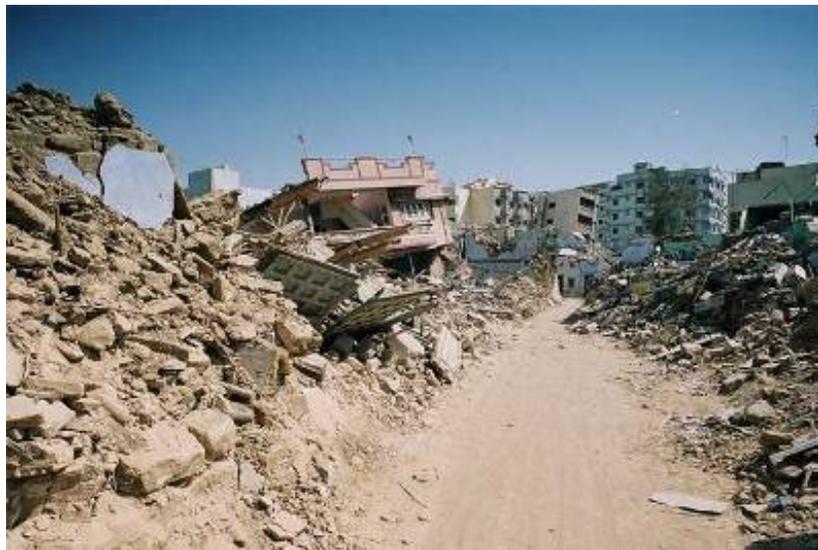
Fig. 15. In Bhuj, Gujarat, ruins of unreinforced rubble-stone buildings that collapsed during the 2001 earthquake. Unlike in Ahmedabad, much of the historic center of Bhuj, which lacked timber-laced construction, was destroyed.

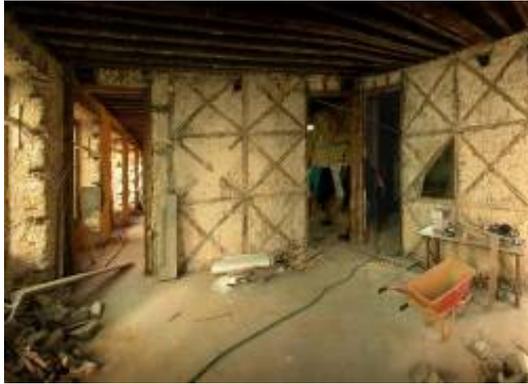
Fig. 16. 18th century building in central Lisbon showing 'Pombalino gaiola' construction, 2003.

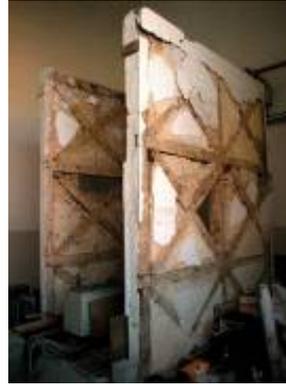
Fig. 17. *Gaiola* wall sections removed to a government testing lab.

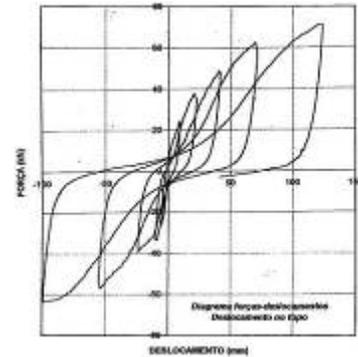
Fig. 18. Hysteresis diagram from one of the wall tests of the walls in figure 17.

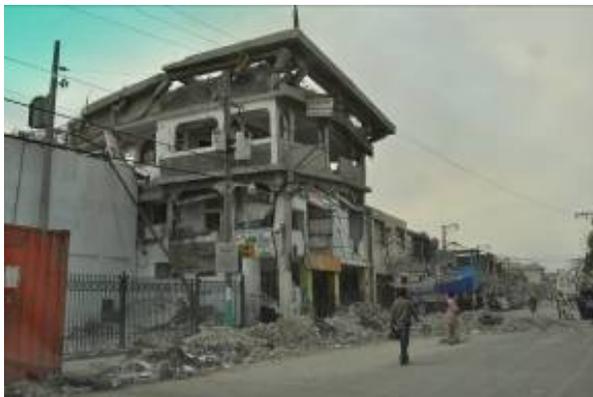
Fig. 19. Reinforced concrete building in central Port-au-Prince nearly collapsed by the 2010 Haiti earthquake.

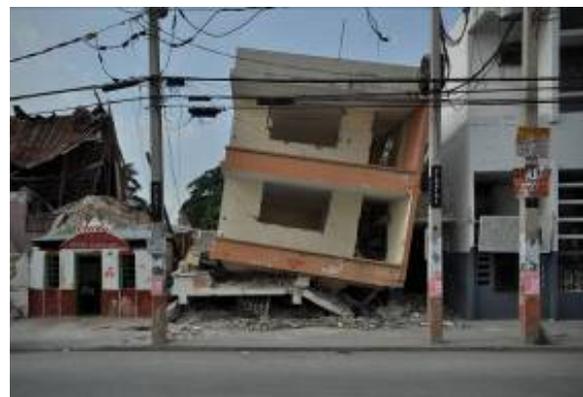
Fig. 20. A formerly four story building in Port-au-Prince showing weak story collapse.

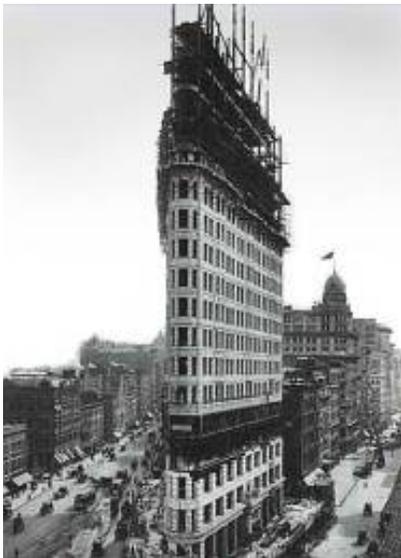
Fig. 21. Flatiron Building in New York City under construction in 1902 showing the heavy stone masonry façade resting on the steel frame. The upper walls are constructed separately probably to ensure the weight is bearing on the frame rather than the lower masonry walls.

Contraflexure portal frame analysis thus made a substantial reduction in the sizes of the members of a frame possible. However, the solid masonry exteriors of the first generation of skeleton frame “skyscrapers” did not change. For another generation and a half, the standard form of construction was exactly as it had been in post-1755 earthquake Lisbon, except that the timber frame was now replaced with iron and steel. The walls were of thick masonry. Although no longer load-bearing to the ground, these walls still shared significant loads with the internal steel frame, as well as protecting the frame from exposure to fire.

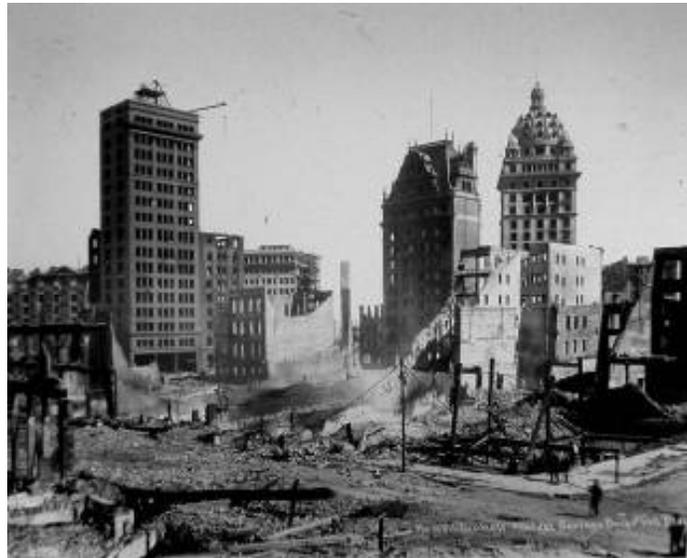
Fig. 22. View of San Francisco after the 1906 earthquake and fire. The three tall buildings visible in this view were burned out by the fire that followed the earthquake, but all three were in good enough condition despite this to be repaired, and they are still extant today.

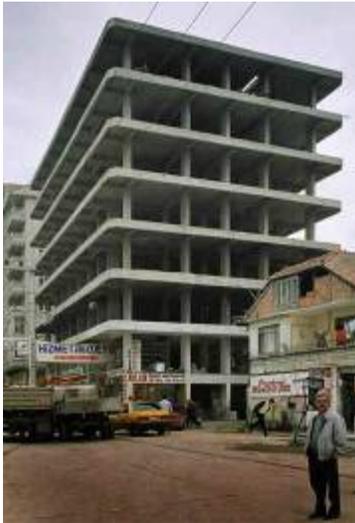
Fig. 24. Building under construction in Gölcük, Turkey shown after the 1999 earthquake. Because the masonry infill walls had not yet been installed, frame action was able to occur, and thus the building was not collapsed by the earthquake.

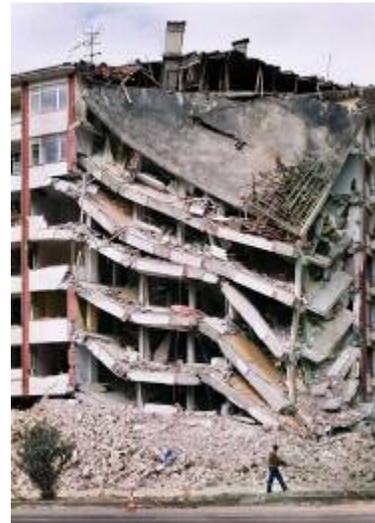
Fig. 25. Building in Gölcük close to the one shown in Fig. 17 collapsed by 1999 earthquake. The heavy masonry infill walls together with open (soft) ground floors were often contributors to such collapses.

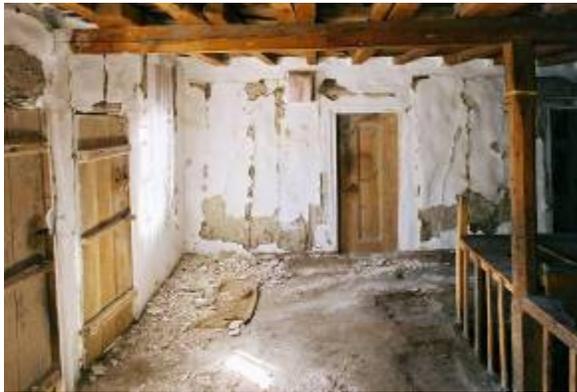
Fig. 26. Interior of a traditional house in Yuva, Turkey of after the 2000 Orta earthquake showing evidence of the working of the *hımış* walls.

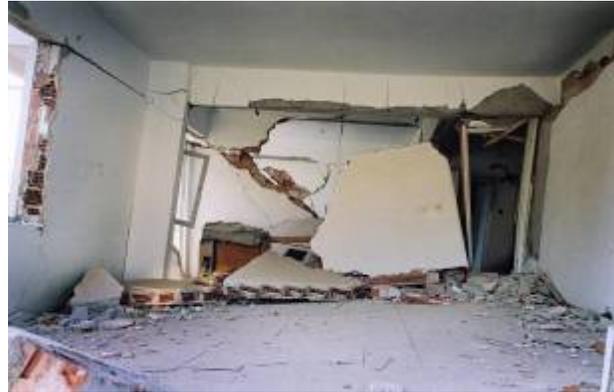
Fig. 27. Typical hollow clay tile masonry wall in a reinforced concrete apartment building in Gölcük, Turkey collapsed by the 1999 Kocaeli earthquake.

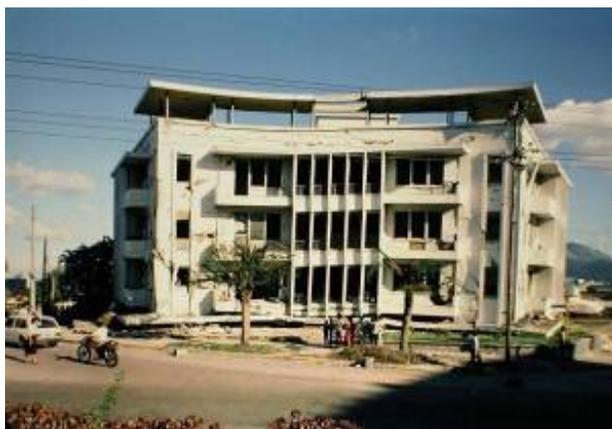
Fig.28. Apartment block in San Salvador that suffered a soft-story collapse in the 1986 San Salvador earthquake. The progressive collapse of the upper floors was stopped by the resistance of the infill masonry.

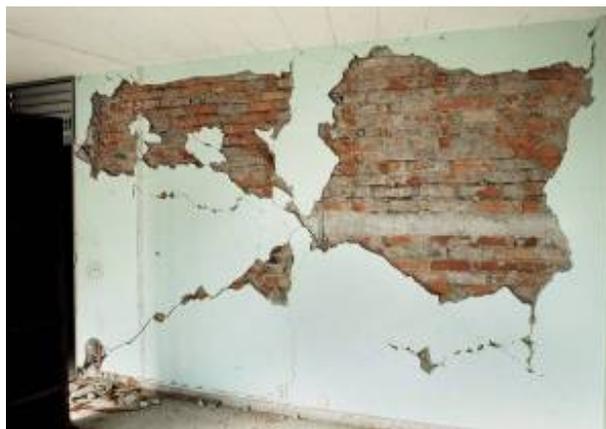
Fig. 29. Typical infill masonry wall found inside the upper stories of the building in Fig. 28 showing that the infill wall was subdivided with a concrete beam and column similar to that advocated for Armature Crosswalls.

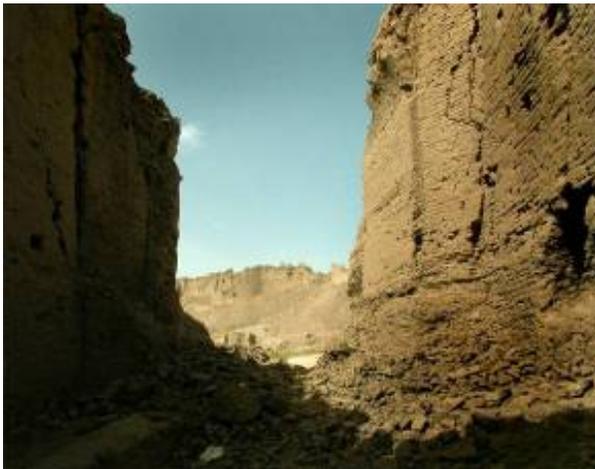
Fig.30. View from the Shahrbast Wall looking towards the ruins of the inner citadel of the Arg e-Bam. These towering walls, gnarled by time, were largely unaffected by the earthquake.

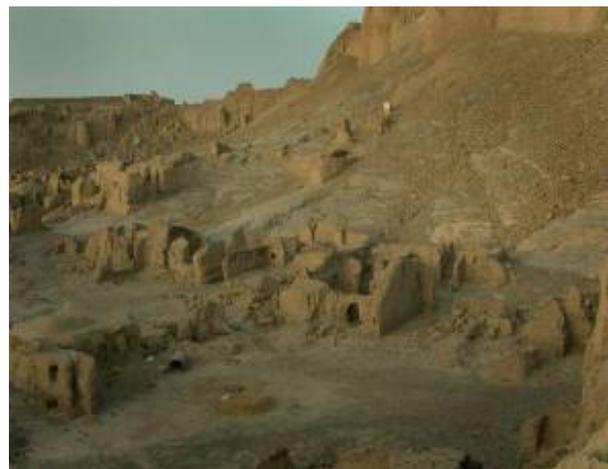
Fig. 31. The unrestored ruins in the Konari neighborhood of the Arg -e-Bam after the earthquake. Although abandoned and untouched for more than 150 years, these structures survived the earthquake with comparatively little damage.

Returning to the collapse of the Arg-e Bam in Iran, finding one and two-story high earthen remains of buildings that have been roofless and abandoned for over 150 years still standing atop the epicenter of an earthquake that turned nearby modern steel buildings into twisted pretzels and destroyed concrete buildings even farther from the epicenter has to make one reexamine some of our present day preconceptions. American journalist Henry Louis Mencken (1880 –1956) once wrote: *“There is always an easy solution to every human problem – neat, plausible, and wrong.”* There has to be a reason why the earthquake did not collapse these walls when it pulverized walls that had been repaired and rebuilt back into complete buildings, but teasing the message to be learned out of the ruins of what had been such a grand monument requires more than training in a single discipline. It also requires a certain amount of humility and willingness to learn to listen with our eyes to the message our ancestors are telling us through the cultural artifacts they have left behind.
