The Great Counterintuitive: Re-evaluating Historic and Contemporary Building Construction for Earthquake Collapse Prevention

Randolph Langenbach
Conservationtech Consulting

ABSTRACT: This paper discusses a way of classifying the differences in construction typology of buildings from around the world and of all ages. This classification is intended to focus on building performance in earthquakes, with pre-modern as well as contemporary code conforming construction materials and systems. Instead of using the classic subdivisions found in most building codes which are organized around construction materials and structural systems, the author explores an organization of structural systems along a continuum from ‘solid walls’ to ‘frames,’ with ‘mixed-wall dominant’ and ‘mixed-frame dominant’ in the middle. The discussion of this provides a platform for exploring different approaches towards the analysis of buildings that is more responsive to the inherent resilience of certain forms of archaic construction. This can also lead to the recognition of retrofit alternatives that utilize certain traditional masonry construction practices in more effective combination with steel and reinforc

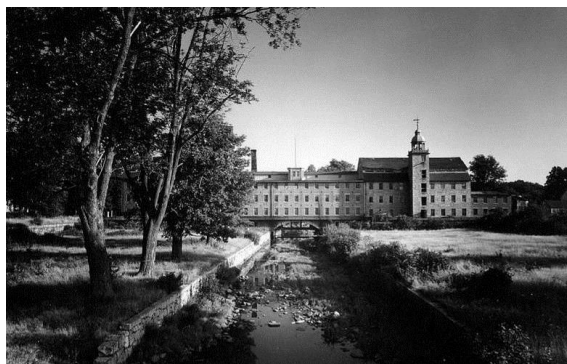
Figure 1. Crown and Eagle Mill, Uxbridge, MA., USA, ca. 1825.
All Photographs in paper by © Randolph Langenbach, 2013 except when marked.

My work in the field of Architecture and Heritage Conservation began in New England when I became interested in the 19th century architecture and town planning of the first planned industrial towns in North America. Driven at first by water power, these large but uniform interconnected rows of giant multi-story timber and brick textile mills along canals merged together, appearing from a distance like medieval walled cities – except that their walls were penetrated by the large double or triple hung sash windows necessary to let in the light for the workers to see their work in the days before the electric light (Figures 1 & 2).

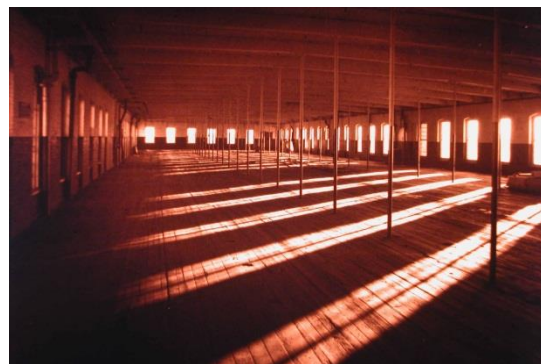
Figure 2. Interior of Mill showing typical “slow burning” heavy timber construction and brick masonry walls, Amoskeag Millyard, Manchester, NH, USA, Ca. 1835.

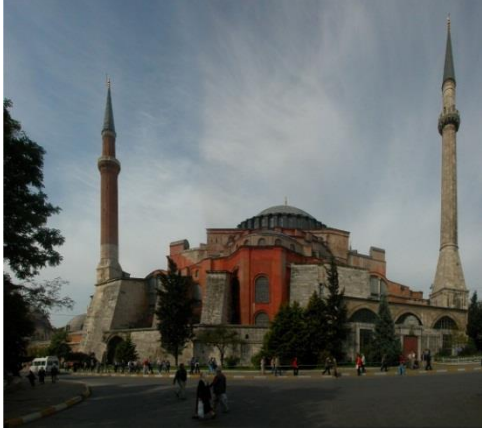
Figure 3. The Hagia Sophia in Istanbul has existed for over one and a half millennia. Repairs have been done and buttresses added after repeated earthquakes.

To graph this on a vulnerability table, it seems logical that the line between these two typologies would, as the statement says, be from vulnerable to safe. Yet, where along this line would one place the Hagia Sophia in Istanbul (Figure 3), which has survived many earthquakes, when

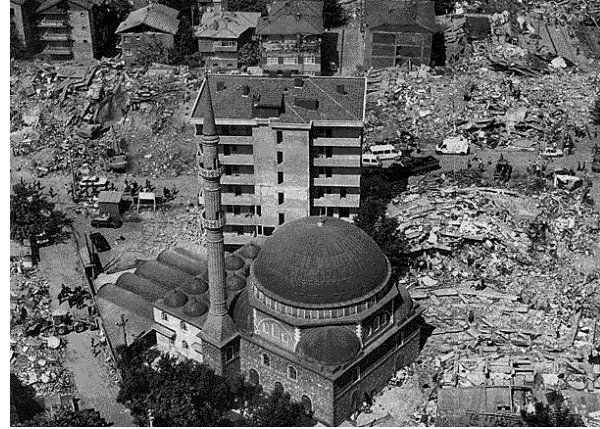
Figure 4. This intact unreinforced masonry mosque with its tall minaret in Gölcük, Turkey is surrounded by many RC buildings collapsed by the 1999 Kocaeli earthquake. *Photo: Enric Marti, Associated Press*

many modern and presumed to be code-conforming reinforced concrete buildings in Gölcük in 1999 failed in just one? Even more to the point is the view of the stone mosque in Gölcük with its tall thin stone minarets standing intact after the 1999 Kocaeli Earthquake surrounded by the collapsed ruins of almost every modern reinforced concrete (RC) building around it. (Figure 4). How can one create a taxonomy that can be effectively used for a global vulnerability analysis if one fails to recognize and account for such potential departures from standard expectations that are only visible after an earthquake?

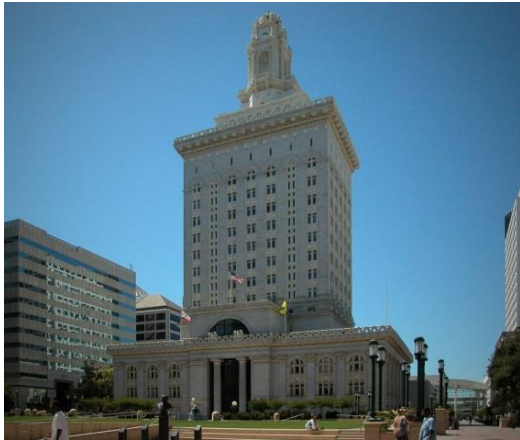
Figure 5. Oakland City Hall, Oakland, California, USA constructed in 1914. This is a steel frame, infill brick masonry building with a glazed terra cotta exterior.

This situation can be quite profound with the ‘mixed’ category of buildings. As mentioned above, a 1980’s engineering study of the 1914 Oakland City Hall (Figure 5) concluded that the steel frame was of inadequate strength to keep the building from collapsing in even a minor earthquake when considering the masonry infill and exterior masonry only as weight. The building was damaged in the 1989 Loma Prieta earthquake, but came nowhere near to the collapse that had been predicted. The building has very thick masonry walls surrounding the steel frame in the same way that the early skeleton steel frame highrise buildings had been constructed first in Chicago and in San Francisco prior to the 1906 earthquake and fire. The City Hall survived the 1989 earthquake in the same way that the earlier buildings had survived the 1906 earthquake – many of which remain standing today despite having been totally burnt out in the fire that followed. (Langenbach 2006)

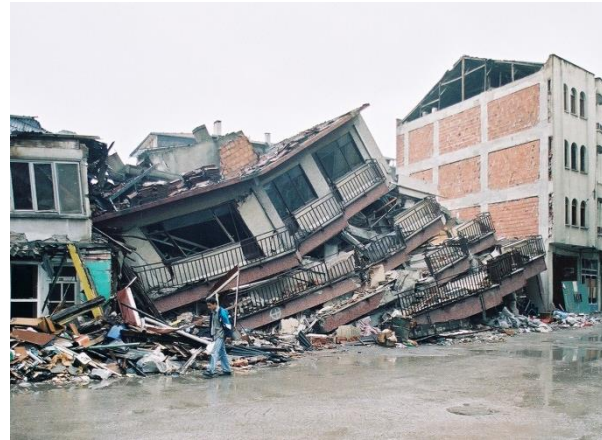
Figure 6. A typical view of a pancake collapse of a 5 story reinforced concrete infill masonry building in Adapazari, Turkey after the 1999 Kocaeli Earthquake.

Ironically, and at times tragically for structures recognized in the code, this can lead to the opposite situation when, for example, the architectural finishes that are not required to be part of the engineering analysis actually cause or contribute to the collapse of buildings. The primary example of this is when the infill material prevents “frame action,” on which the original engineering design is predicated, but is too brittle and weak to contribute to the lateral capacity of the structure once the system goes inelastic (Figure 6).

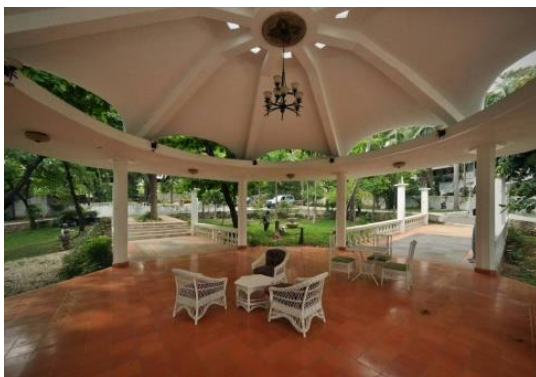
Figure 7. An RC pavilion in Port-au-Prince, Haiti after the 2010 earthquake shows that the earthquake which caused such devastation could not collapse this, in spite of the fact that it has thin columns, a heavy roof and masonry infill in only a single bay – behind the photographer.

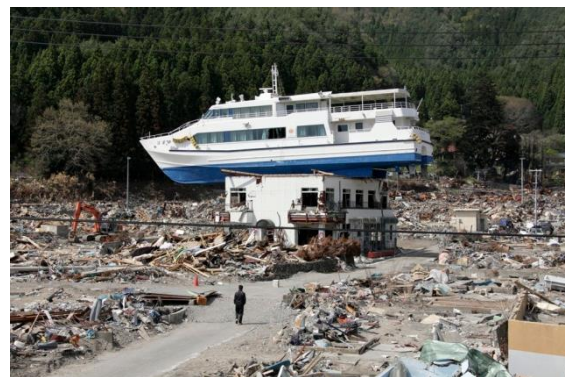
Figure 8. A boat on the roof of the only surviving building in this view in Otsuchi, Japan after the 2011 Tsunami demonstrates the remarkable resilience a well-constructed RC building. *Photo: Kimimasa Mayama/EPA published by the Boston Globe.*

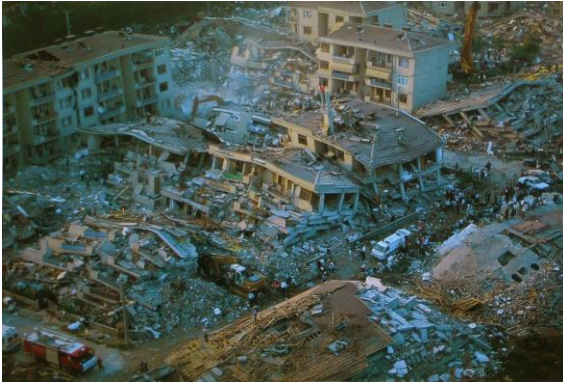
Figure 9. Aerial view of collapsed apartment houses in Golcuk, Turkey after 1999 earthquake. Most of the 17,000 fatalities (the unofficial estimate is over 25,000) in this earthquake were in pancake collapsed RC buildings. *Photo UN*

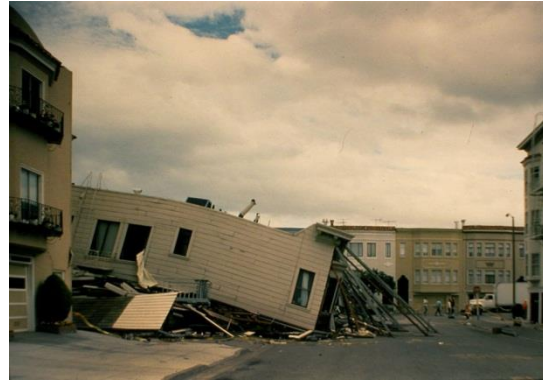
Figure 10. Collapsed timber framed multi-story apartment house in San Francisco after the 1989 Loma Prieta earthquake. There were only 3 fatalities in this earthquake caused by the collapse of timber frame buildings.

One issue that adds even more heterogeneity to the GEM project that must be dealt with is the difference between anticipated risks of injury and loss of life on one hand, and economic losses on the other. Some damage results in economic loss but is of less risk to human life, while other earthquake-caused building collapses have resulted in many fatalities with small numbers of survivors. Also, some types of hazards can result in injuries which are less lethal, while others more so. With the pancake collapse of RC buildings, for example, human survival followed by timely rescue is less likely (Figure 9), whereas many survivors have been extracted from collapsed wooden buildings (Figure 10).

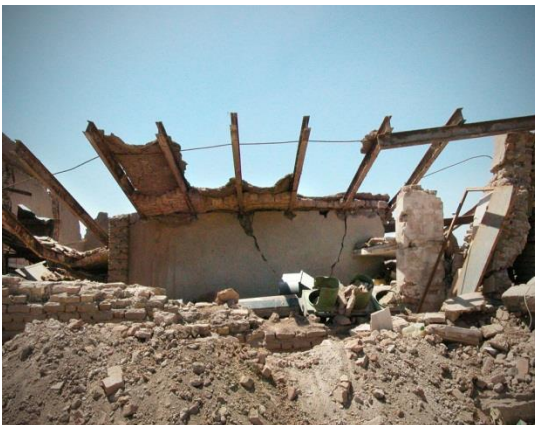
Figure 10. Collapsed building with adobe walls and steel and fired brick jack arch roof in Bam, Iran after the 2003 earthquake.

The reason was that the adobe walls surmounted by a steel and firebrick roofs turned out to have a greater likelihood of crushing the occupants, and the dust suffocated the few survivors.

The walls of most of these structures were not secured to the roofs, and as a consequence, the heavy steel and brick roofs would fall when the walls separated from them. Ironically, earthen buildings with the traditional construction of masonry vaulted roofs were observed to have done better on average than did those with the modern steel beamed roofs, although many of those did collapse as well (Figure 11).

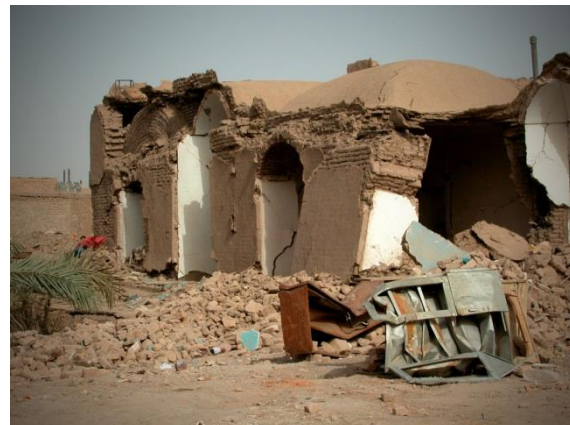
Figure 11. Partially collapsed adobe building of traditional unreinforced construction in Bam, Iran with most of its vaulted roofs still standing.

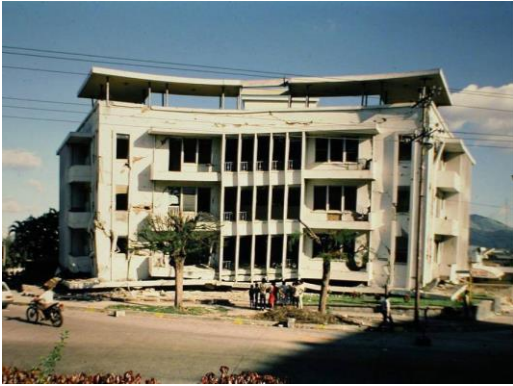
Figure 13. This was a 5 story RC frame building after the 1986 San Salvador earthquake caused a soft-story collapse. Figure 14 was taken in one of these remaining floors.

Frame construction is both a general term and one with very specific meaning as an engineering term of art – as for example in “*frame action.*” The question of whether a frame is a braced frame or a moment resisting frame is important on its own, but with buildings, almost all of which necessarily have enclosure walls and interior partitions, it is also important to recognize how these walls interact with the structural frame. For example, infill masonry is almost always left out of the engineering calculations except as dead weight, but it has often been cited as a significant contributor to soft/weak story collapse of RC frames. In addition, it has also served on occasion to arrest the soft story collapses it helped to precipitate through the strength of the upper floor infills which in residential structures are plentiful. This can allow almost all of the residential occupants to be able to survive and escape from the ruins as for example with the building seen in Figures 13 & 14.

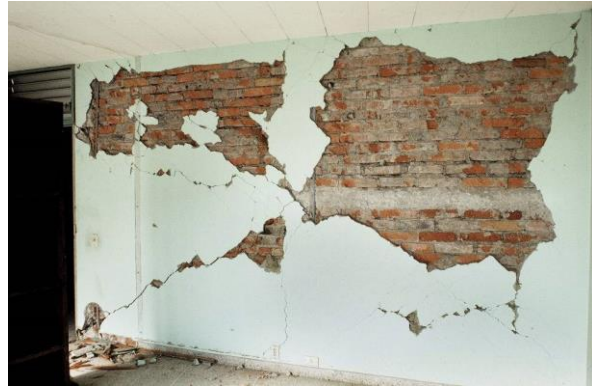
Figure 14. View of an infill wall in the building in Fig. 13. The fallen plaster has revealed that the wall was reinforced with an RC sub-frame that kept the masonry from falling out of the frame, and thus helped prevent a pancake collapse of the upper floors, saving the lives of the occupants. (See Section 2.10 below)

This modern variation of an ancient technology could even be economically applied to existing and future RC moment frame and infill masonry buildings to radically reduce their likelihood of collapse. I have given this concept the name “Armature Crosswalls” so as to distinguish the concept clearly from that of shearwalls. The term, ‘crosswalls’ is already used to describe interior partitions that contribute to seismic resistance in a North American code for upgrading of masonry buildings. To witness how well de facto examples of this has already worked in RC frame buildings, see figures 13 and 14 above, and Figure 31 and 32 below.

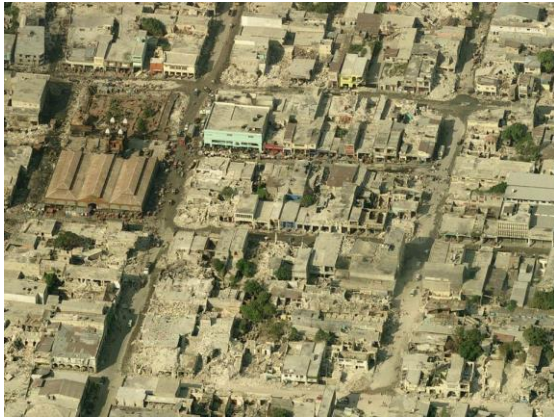
Figure 15. Aerial view of downtown Port-au-Prince after the 2010 Haiti earthquake showing the widespread numbers of collapsed buildings. *Oblique aerial photographs done by Pictometry International Corporation.*

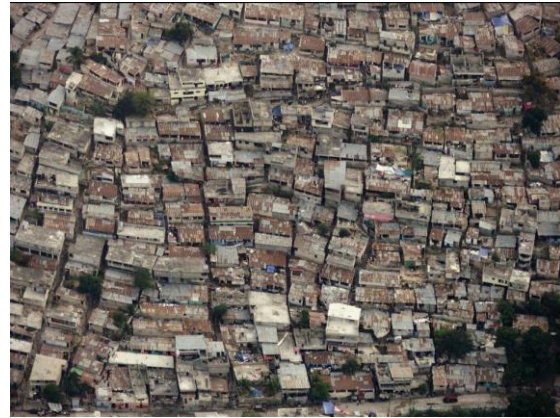
Figure 16. Aerial view of informal slum settlement near central Port-au-Prince showing slum housing that is almost entirely still standing after the earthquake. This was typical for most of these settlements except for those areas on steep slopes. *Photo: Pictometry International Corp.*

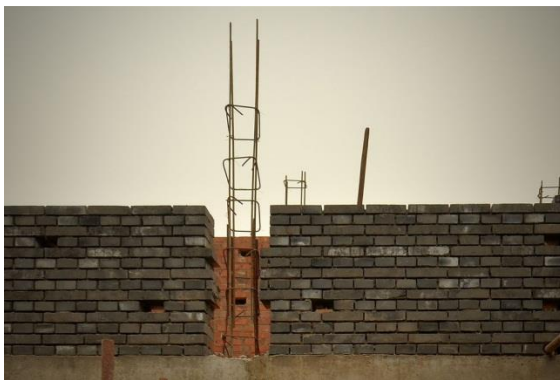
Figure 17. Typical detail of 'confined masonry' when under construction before the walls are topped out and the columns are poured. This example was photographed in Beijing, China.

Confined masonry buildings are, in effect, solid wall buildings, despite the fact that when completed they have reinforced concrete frames. In other words, these buildings are of mixed construction, but the walls are dominant. Frame action does not and cannot be expected to occur. Unlike moment frames where such frame action is dependent on the capacity, integrity, and high quality of the construction of the frame, particularly of its beam/column joints, confined masonry is reliant on a much simpler engineering concept – one that is harder to do badly and thus much more suitable for untrained builders without oversight.

By confining the masonry, the frame keeps in-plane and out-of-plane cracks in the masonry from rapidly expanding to the point of collapse of the walls. This allows the walls to help support the frame even while they crack and shift – that is to “work” and thus to dissipate energy. All of this contributes to preventing collapse of the building. (See www.confinedmasonry.org for more information.)

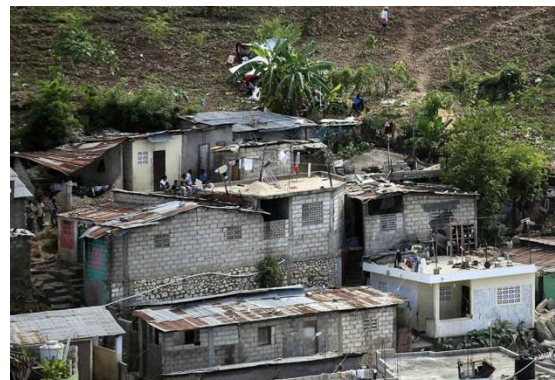
Figure 18. Typical view of informal slum houses of low quality concrete block confined masonry that survived largely undamaged, photographed in Port-au-Prince, Haiti after the 2010 earthquake. *Photo, Carlos Barria, Reuters.*

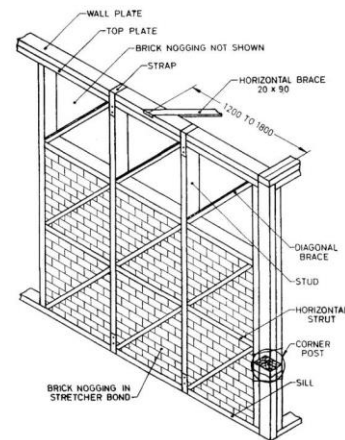
Figure 20. Illus. from Ministry of Home Affairs, *Guidelines for Earthquake Resistant Reconstruction and New Construction of Masonry Buildings in Jammu & Kashmir State* by A.S. Arya.

to the conventional wisdom expressed in the GEM quote in the second paragraph of 2.1 above, that it is easy to fail to fully grasp that some of the buildings constructed during the centuries prior to the existence of modern codes – even some of those constructed mainly of stone masonry – have actually shown a level of resilience in earthquakes that meets or exceeds the objectives of the codes for new buildings despite the fact that their archaic construction does not come close to conforming to that allowed by modern codes. (India and some other countries in South Asia have developed some codes which recognize traditional construction, but usually under very restrictive conditions (Figures 19 & 20). For more information, see Langenbach 2009.)

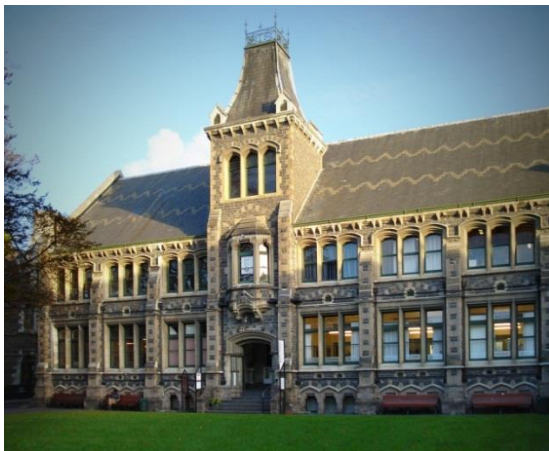
Figure 21. Chemistry block of the former Canterbury University Campus (now “Arts Complex”) in Christchurch viewed before the earthquake. Only the top of the central tower was significantly damaged in the earthquake while other unretrofitted buildings around it were collapsed.

More importantly, this approach can lead us to solutions to problems such as those revealed by the 2011 earthquake in Christchurch NZ, where certain seismically upgraded load-bearing masonry buildings failed while others did quite well (Figure 21 & 22). It appears from the available reports that those retrofits that did well embraced and augmented the existing masonry walls, whereas those that did worse had new structural framework that was structurally separate from the masonry.

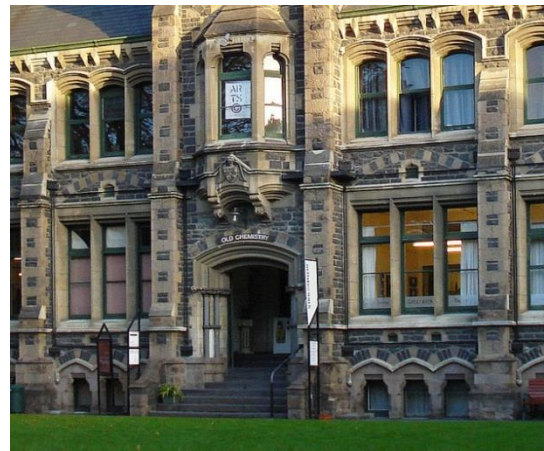
Figure 22. Detail showing the exterior steel rods and clamps that are part of the retrofit done during the 1980's. This retrofit was comparatively less expensive than other methods where new structural frames were added.

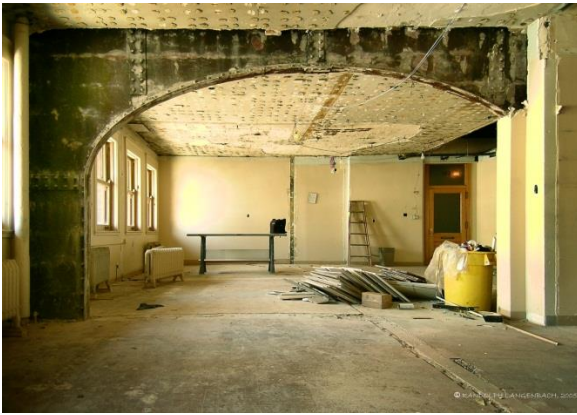
Figure 23. Portal frame arch in 1891 steel frame addition to Monadnock Building showing an element of design prior to use of contraflexure methodology.

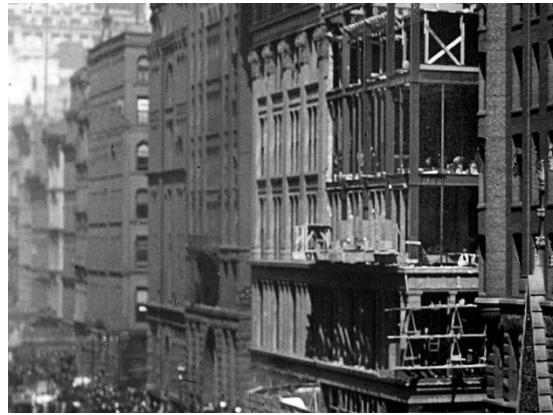
Figure 24. View of new skeleton frame buildings being constructed in Chicago after ca. 1900 adoption of contraflexure methodology allowed for thinner members with moment connections. Masonry provided most of the wind bracing. *Photo courtesy owners of Monadnock Bldg.*

While most of the historical focus is on the transition to the use of frames for taller buildings, the watershed event in this transition is not so broadly known – it is, within the field of structural engineering, the “invention” of a way of doing a portal frame analysis using the contraflexure methodology for isolating moments. In lay language, this method allowed the calculation of the bending stresses on multi-story frames by mathematically separating the frame into parts at each neutral point of bending reversal of the columns and beams. This then allows for the forces to be calculated using the three equations of equilibrium. Prior to that, the forces inherent in “frame action” could not be accurately calculated. As long as, in effect, columns were pin connected at the floor levels, this was not a problem (Figure 23), but as structures grew taller, this was structurally inefficient. Modern skyscrapers in every practical sense date their origin to this change in engineering analysis methodology (Figure 24). (Robison 1989)

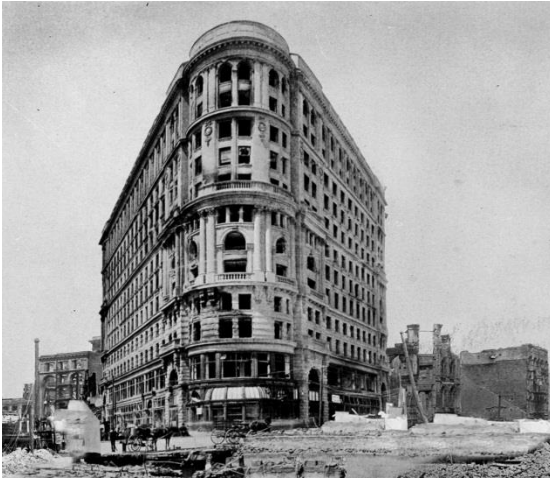
Figure 25. The Flood Building in San Francisco after the 1906 earthquake and fire. *Photo from A.L.A. Himmelwright. The San Francisco Earthquake and Fire, New York City, The Roebling Construction Company, 1906.*

Thus one must ask why did these first generation steel skeleton skyscrapers in San Francisco remain standing with undamaged frames and repairable damage to the masonry walls when so many frame with infill masonry buildings have been collapsed by earthquakes a century later? As clearly stated by Freitag, it was not the frame alone, but it was the masonry in effective partnership with the frame that is responsible. On the continuum, these are ‘mixed-wall dominant’ structural systems. Many of these buildings are now more than 100 years old, and despite having been burnt out by the subsequent fire, they were repaired and continue in service today (See Figures 25 & 26 for one of many examples).

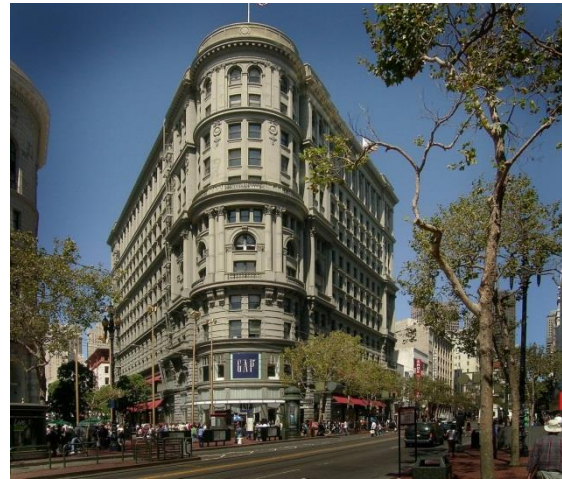
Figure 26. The Flood Building today. As of 2013, this building, constructed in 1904 and restored after the earthquake, is 109 years old. *Photo by © Randolph Langenbach.*

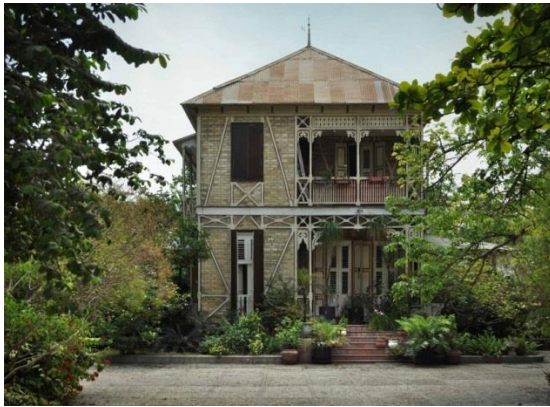
Figure 27. This house of *colombage* construction was in the heart of the 2010 Haiti earthquake damage district in Port-au-Prince. It suffered only minor damage while many RC buildings less than a quarter of its age collapsed on nearby lots around it.

How did the pre-modern and casually constructed timber and masonry infill *colombage* buildings survive so well – even in Haiti in the heart of the damage district (Figure 27), despite the fact that (1) they were of fair quality in terms of their original construction, (2) they were over 100 years old with little maintenance, and (3) some had advanced fungal decay and insect damage to their timbers? It is not because of their strength, but their flexibility. It is not only the framework that is flexible, but also the masonry itself. In the resilient examples seen in India, Pakistan, Turkey and Haiti, the masonry is laid with a soft mud or lime mortar, rather than a strong but rigid and brittle cement mortar.

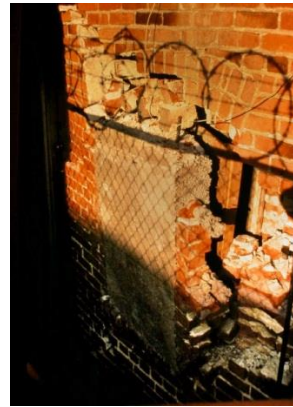
Figure 28. The concrete infilling of this former window opening was forced out of the wall during the 1994 Northridge earthquake in Los Angeles, Ca. USA.

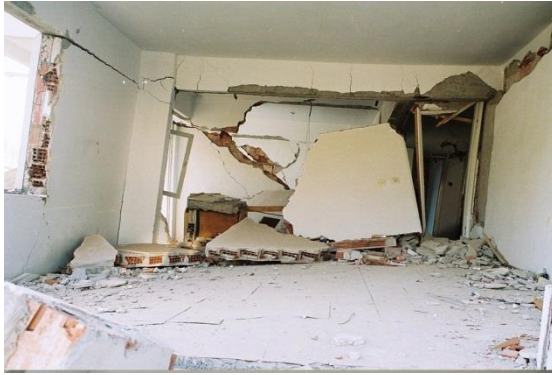
Figure 29. View of a collapsed infill masonry wall in a partially collapsed multistory building in Gölcük, Turkey after the 1999 Kocaeli earthquake. This kind of damage is typical when the infill walls are single layers of brittle masonry set in cement mortar without any sub-frame or other reinforcement.

without developing the destructive X cracks leading to collapse. The difference in performance can be seen by comparing figures 29 and 30.

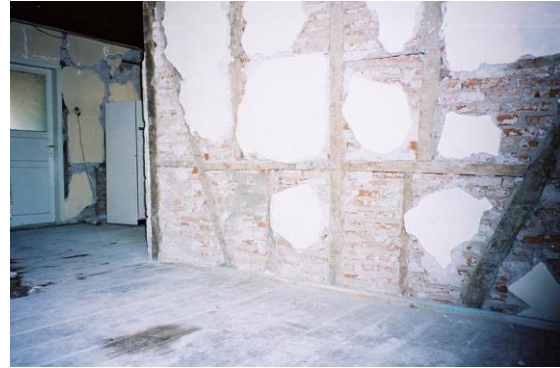
Figure 30. View of the typical timber frame with masonry infill of Turkish *hıms* construction. This photo was taken in a two and a half story dwelling in Düzce, after the 1999 Düzce earthquake. It was surrounded by collapsed RC multistory buildings. It is this kind of construction that forms the inspiration for the “Armature Crosswalls” concept.

The intention is that the infill walls, with their weaker mortar and multiple panels, would have less initial stiffness and more frictional damping than standard infill masonry walls. This reduced initial stiffness can avoid the potentially destructive “equivalent diagonal strut,” thus, allowing the frame-action on which the portal frame analysis relies to occur. In addition, the energy dissipation from the working of the combination of timber, bricks and mortar against each other serves to dampen the excitation of the building by the earthquake. (Langenbach 2008)

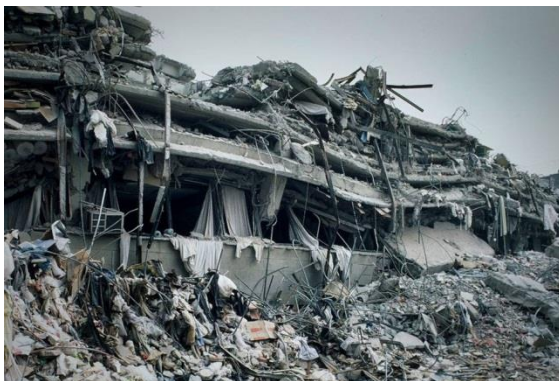
Figure 31. View of the Juarez Hospital after the 1985 Mexico City earthquake collapsed it trapping approximately 950 people, of which 561 were killed.

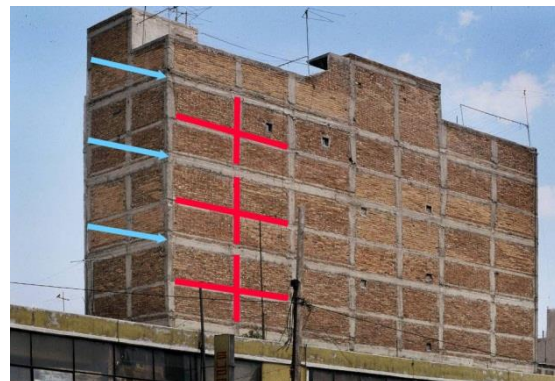
Figure 32. View of a RC building next to the Juarez Hospital with no visible earthquake damage. The floor levels are marked with blue arrows, and the infill walls have sub-frames marked in red. (See Sect 2.10 “Armature Crosswalls.”)
