## The earthquake resistant vernacular architecture in the Himalayas

Randolph Langenbach

*Conservation Consulting, Oakland, California, USA*

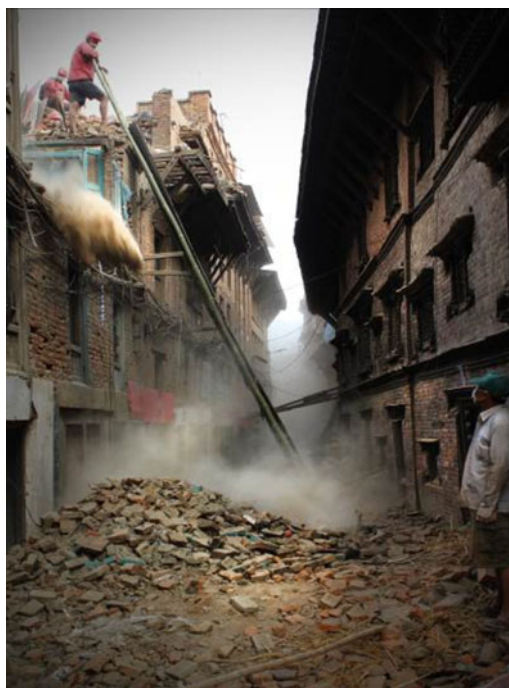
Figure 1. View of Bhaktapur, Kathmandu area, Nepal after the Gorkha Earthquake (Credits: Xavier Romão & Esmeralda Paupério).

Earthquake! When this chapter was written, the dust had not yet completely settled from the April 25, 2015 earthquake in Nepal (Fig. 1). The body count continued to increase with each day and the rescue efforts to find and free people entrapped beneath the ruins continued with more distress on the part of the survivors, as hope for those lost from sight continued to fade until rescue efforts were terminated a little over two weeks after the earthquake.

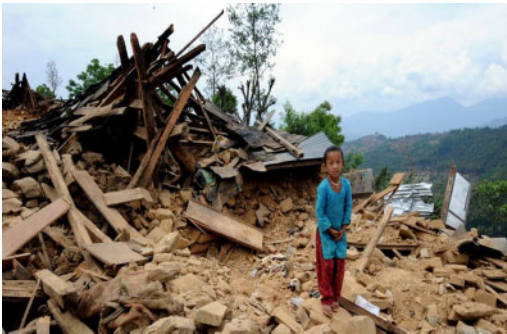
Figure 3. Typical view of ruins of destroyed stone masonry rural home, in Sangachowk Village, Sindhupalchowk District, Nepal (Credits: UNICEF/Chandra Shekhar Karki).

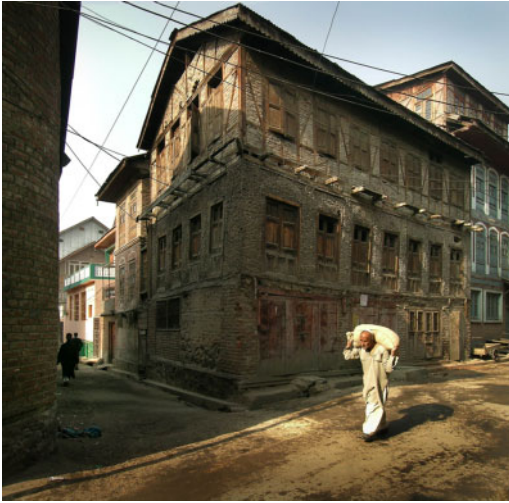
Figure 4. An older building in central Srinagar, Kashmir, India, that has *taq* timber-laced construction on the first two floors, and *dhajji dewari* infill frame construction above (Credits: Randolph Langenbach).

At the beginning of the 19th century the systems evolved into what are now the two main traditional construction systems: taq (timber-laced masonry bearing walls) and dhajji dewari (timber frame with masonry infill – like what in Britain is called “half-timber”). Most of the traditional buildings in Srinagar and the Vale of Kashmir can be divided into these two basic systems (Fig. 4). In Pakistan, timber-laced masonry is

*Dhajji dewari* construction was frequently used for the upper stories of buildings, with *taq* or unreinforced masonry construction on the lower floors (Fig. 4). Its use on the upper-floors is suitable for earthquakes because it is light, and it does provide an overburden weight that helps to hold the bearing wall masonry underneath it together.

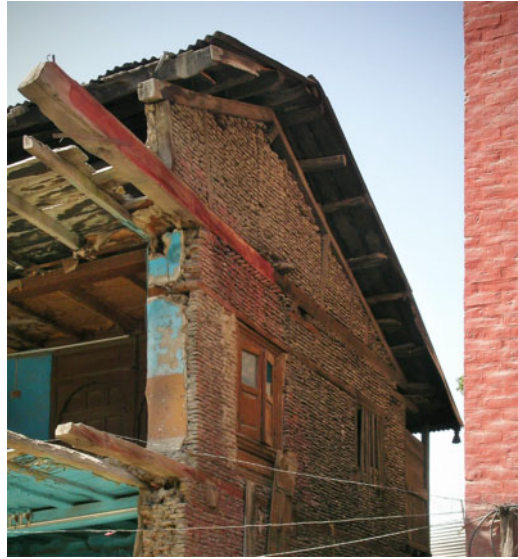
Figure 6. A three and a half story building in central Srinagar, Kashmir, India, of *taq* timber-laced construction partially demolished for a street widening (Credits: Randolph Langenbach).

**Taq (bhatar) Construction:** *Taq* (or *bhatar*), consists of load-bearing masonry walls with horizontal timbers embedded in them. These timbers are tied together like horizontal ladders that are laid into the walls at each floor level and at the window lintel level. They serve to hold the masonry walls together and tie them to the floors (Fig. 6).

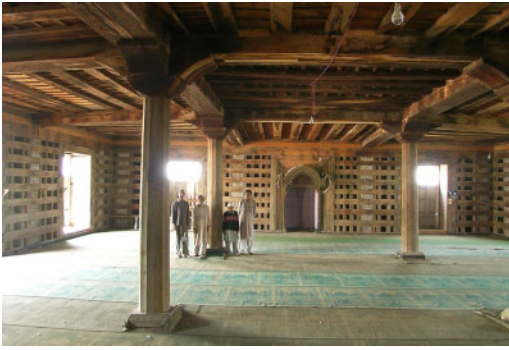
Figure 7. Example of cribbage construction, The Khankah in Pampore, near Srinagar, ca. 1600. When photographed in 2007, the interior was being clad with plywood in order to, as they stated, to “modernize” the interior (Credits: Randolph Langenbach).

**Cator and Cribbage:** Several of the historic mosques in Srinagar are of “cribbage” construction, a variation of timber-laced masonry construction that can be found in the Himalayan mountains of northern India, northern Pakistan near the Chinese border, and parts of Afghanistan (Fig. 7). This has proven to be particularly robust in earthquake-prone regions, but as wood supplies became depleted it must have been found to be extravagant. This may in part explain the origins of the *taq* and *bhatar* systems, where the timber lacing is limited to a series of horizontal interlocking timber bands around the building, thus requiring significantly less wood in its construction.

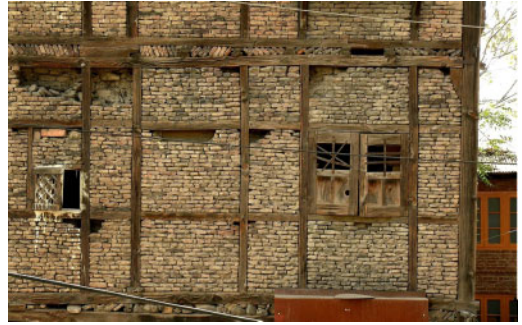
Figure 8. Example of dhajji dewari construction in Srinagar. This is an example with only rectangular panels. There is often in the present a belief that diagonals are necessary, just as they were in Lisbon in the *gaiola* that was invented after the 1755 earthquake, but there is increasing evidence that they are not necessary, and may even be counter-productive (Credits: Randolph Langenbach).

**Dhajji dewari Construction:** *Dhajji dewari* is a variation of a mixed timber and masonry construction type found in earthquake and non-earthquake areas around the world in different forms. While earthquakes may have contributed to its continued use in earthquake areas, timber and masonry infill frame construction probably evolved primarily because of its economic and efficient use of materials. However, its continued common use up until the present in Srinagar and elsewhere in the Vale of Kashmir most likely has been in response to the soft soils, and perhaps also to its observed good performance in past earthquakes (Fig. 8–9).

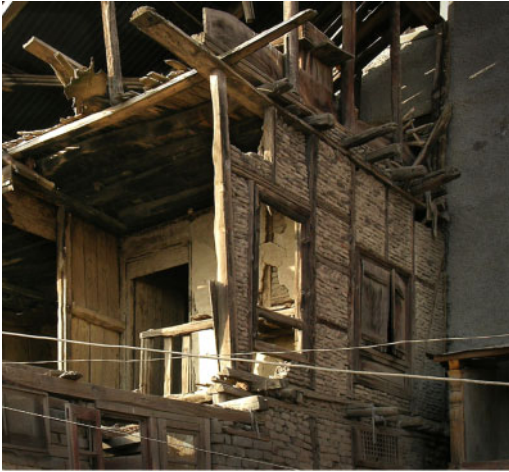
Figure 9. A cross-section of dhajji dewari construction revealed by a demolition for a road widening. Notice how thin the walls are in this form of construction. Despite this, it has proved to be remarkably resilient in earthquakes. (Credits: Randolph Langenbach).

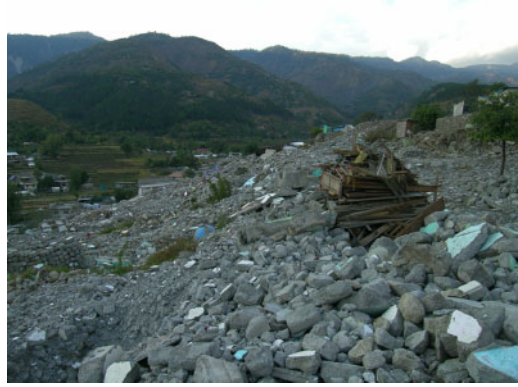
Figure 10. The debris left from the total collapse of almost all of the concrete slab and stone walled houses in Balakot, Pakistan in the 2005 earthquake (Credits: Randolph Langenbach).

The Kashmir earthquake was one of the most destructive earthquakes in world history. The death toll from this magnitude 7.6 earthquake was approximately 80,000 and over 3 million were left homeless. In a region known to be so vulnerable to earthquakes, it is reasonable to ask: Why did both the masonry and reinforced concrete buildings in the area prove so vulnerable to collapse? Why did over 80,000 people lose their lives in what is a largely rural mountainous region? Why did 6,200 schools collapse onto the children at the time of morning roll call in Pakistan alone? (Fig. 10)

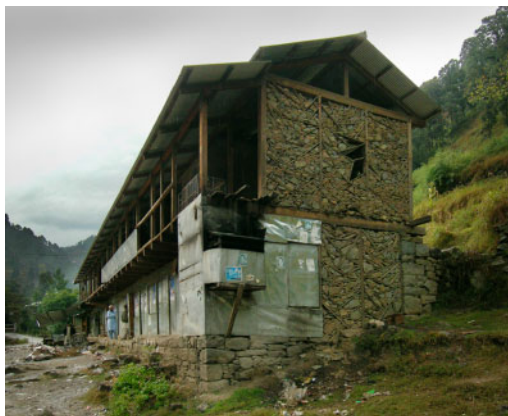
Figure 11. Country store of dhajji construction in Pakistan Kashmir near the epicenter of the 2005 earthquake. This and other buildings like it are what the local residents saw that inspired them to rebuild dhajji houses (Credits: Randolph Langenbach).

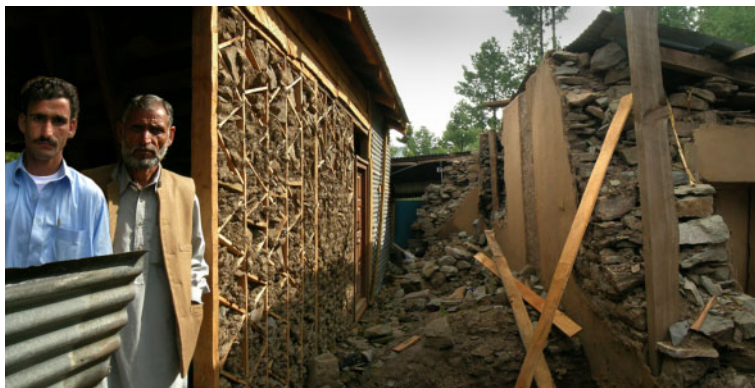
Figure 12. The owner and carpenter building a new dhajji house in Topi, near Bhag, Pakistan, to replace one of rubble stone on the right, which collapsed after seeing the survival of the building in Figure 11 and others like it (Credits: Randolph Langenbach).

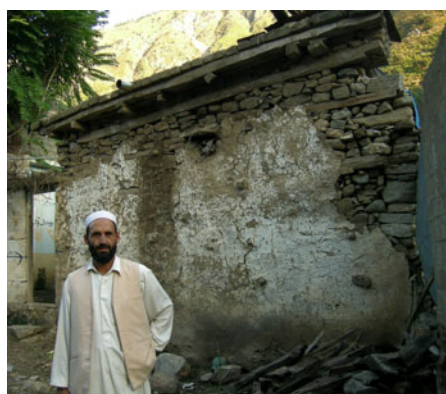
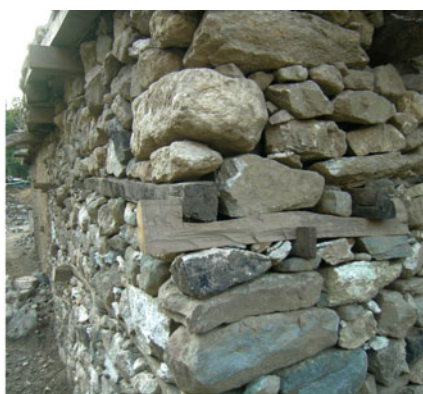
Figure 13. Villager standing near his house in a remote village between Batagram and Besham, in NWFP, Pakistan with bhatar construction which survived the earthquake. This inspired the new construction in bhatar seen on right (Credits: Randolph Langenbach).

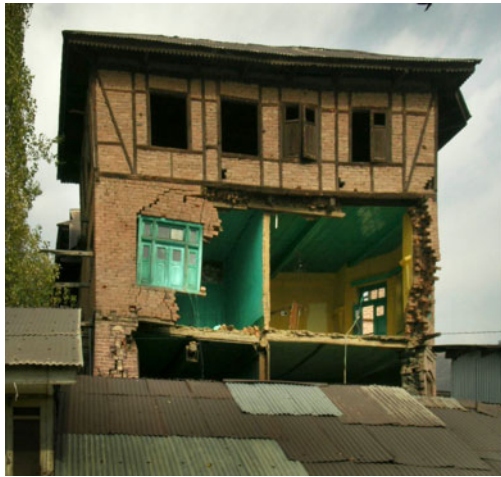
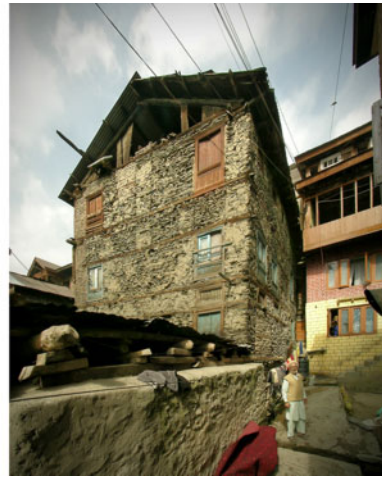
Figure 14. Four and five story residential buildings in the Indian Kashmir city of Baramulla showing how the unreinforced masonry collapsed, leaving the dhajji dewari bridging over the gap, while a tall rubble stone building reinforced with taq timber beams survived the 2005 earthquake undamaged (Credits: Randolph Langenbach).

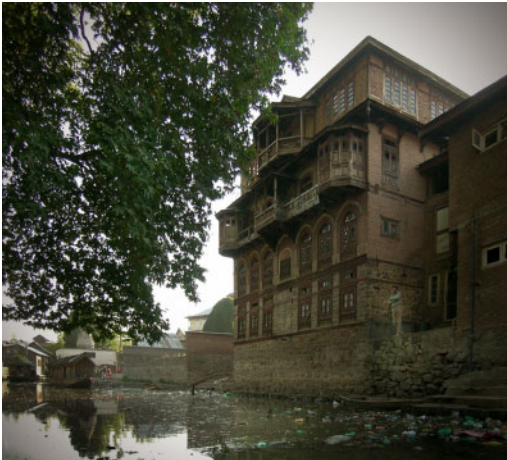
Figure 15. A grand four story bearing wall brick masonry house on the Rainawari Canal in Srinagar of timber-laced taq construction (Credits: Randolph Langenbach).

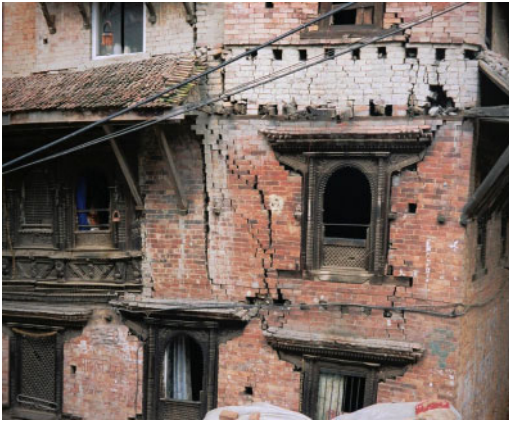
Figure 16. A photo taken in Nepal fifteen years before the 2015 earthquake showing the progressive structural deterioration of a masonry bearing wall building which lacks the timber bands of *taq* and *bhatar* (Credits: Randolph Langenbach).

than in Kashmir “*except in some of the palaces and temples*” (as, for example, in Figure 16).”

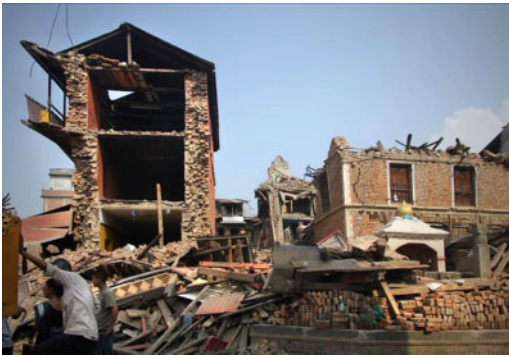
Figure 17. Unreinforced brick building collapses in Sankhu, near Kathmandu, Nepal showing the collapsed end of a row of dwellings, which lacked timber bands (Credits: Xavier Romão & Esmeralda Paupério).

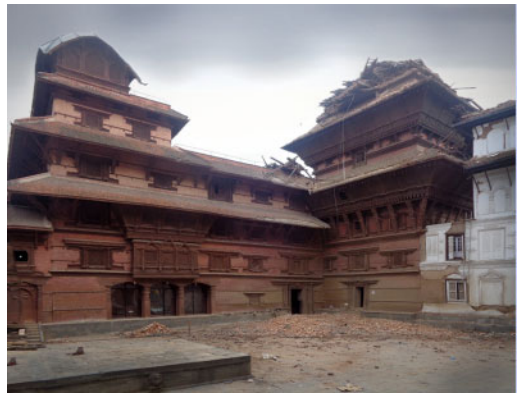
Figure 18. Hanuman Dhoka Palace, Kathmandu after the earthquake showing a section with timber bands – visible as horizontal lines on the brick façades (Credits: Kai Weise, Kathmandu, Nepal).

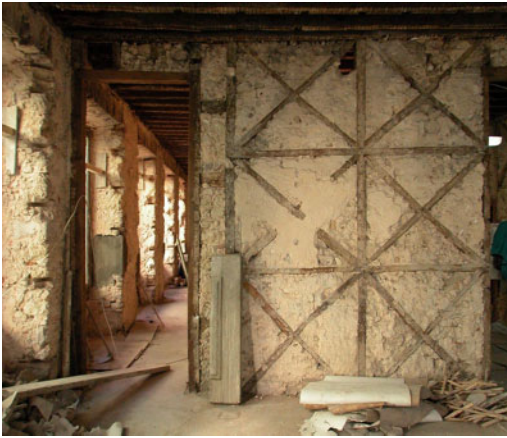
Figure 19. Interior of post-1755 Lisbon, Portugal, earthquake building in Baixa, Lisbon with interior walls of *gaiola* exposed during a remodeling (Credits: Randolph Langenbach).

The more important question is “What constitutes a seismic culture?” Is it simply a rise in construction quality and technological sophistication, or does it feature certain specific details the purpose of which can best be ascribed to resistance against earthquake forces? Or is the only proof of a seismic culture to be found in documents or in generations of knowledge and folklore of a known need for certain earthquake resistant details, such as was done so deliberately after the Great 1755 Lisbon earthquake with the invention and promulgation of the gaiola system of timber and masonry frame construction (Fig. 19)?

In a sense, this could be reminiscent of what happened in Lisbon, after the 1755 earthquake with the ‘invention’ of the *Gaiola*. This was a technology that was not new – but which was derived from the traditional form of construction which could be seen to have survived the earthquake – a form of construction that can be found around the world from Elizabethan
