# Traditional is Modern:

## Traditional Building Technology for Resilience in the Modern Era

Randolph Langenbach  
International Conservation Consultant  
Senior Analyst (retired) of Federal Emergency Management Agency (FEMA)  
www.conservationtech.com  
Photos, except as marked, © by the author

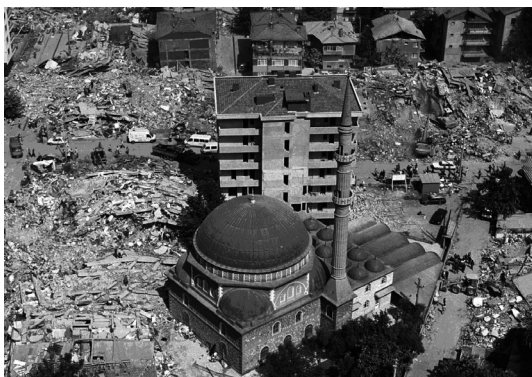
Fig. 1. Gölcük, Turkey after 1999 Kocaeli earthquake. (AP photo by Enric Marti (NY Times, Aug.20, 1999.)

The mosque that is entirely intact, including its tall minaret, is unreinforced stone masonry. All of the collapsed buildings surrounding it were of reinforced concrete (RC), like the one barely still standing. These at least should have conformed to the Turkish building code.

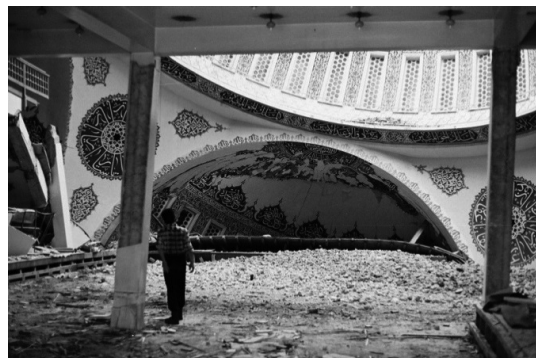
Fig. 2. Mosque in Adapazari, Turkey, 1999.

Not only is the minaret down but the mosque is down as well, in spite of the fact that Turkey has modern building codes for RC construction. To avoid relying only on the selection of pictures to make the point, I turn to a team of Turkish engineers who did a quantitative study of every single building in a sample of damaged areas to analyze the damage by building type (Figure 3). The white bars are the reinforced concrete frame buildings. All of those of traditional construction, including unreinforced masonry, are the darker bars.

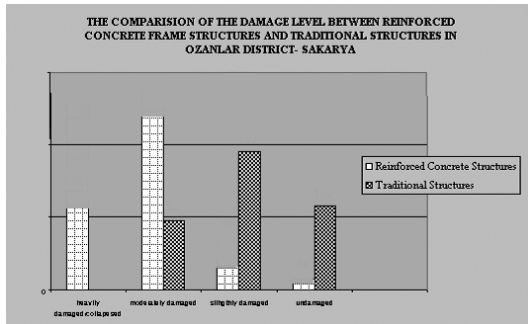
Fig. 3. Gulhan and Guney, 2000.<sup>2</sup>

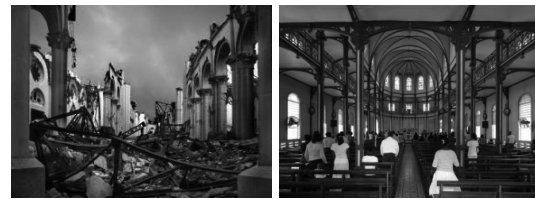
Fig. 5. Cathedral (l) and St. Louis de Gonzague Chapel (r) after 2010 earthquake in Haiti.

However, I am sure that few of you have seen photos of the Chapel of St. Louis de Gonzague on the right of Figure 5, standing as if nothing had happened. It is almost as big as the Cathedral used to be. It never shut down. Services continue there to this day. Its structure is a framework of steel or wrought iron imported from France at the end of the 19<sup>th</sup> century which embraces and reinforces walls of masonry panels.

The Palace and the Cathedral were constructed of reinforced concrete, and both were about a century old. The reason why they fell down is not because of bad construction, but because the rebar had rusted away. So we are now dealing with a modern material, RC, embraced around the world where its lifespan is based on a ferrous metal – steel – embedded into the core of the walls and columns.

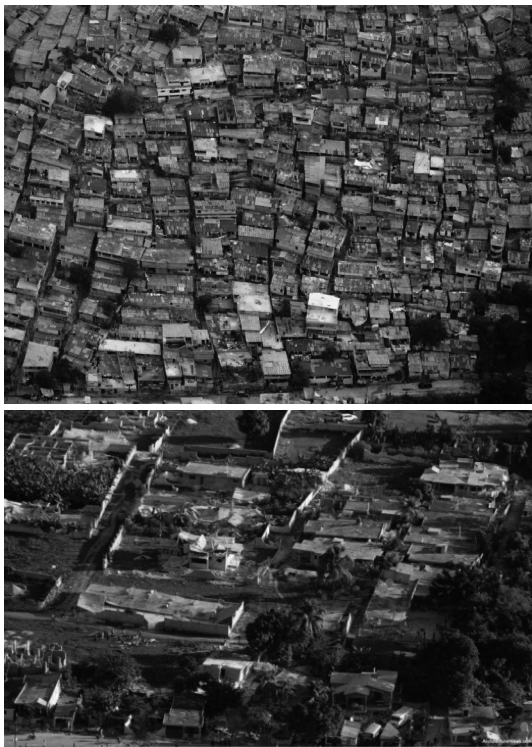
Fig. 6. Pictometry Int'l Corp photos of slum settlement (bidonville), and (bottom) upper-class houses, after 2010 earthquake.

When some months later ICOMOS was given access to an aerial survey of the entire damaged district by Pictometry Int'l Corp, I found that except on steep sites, the scene was consistently like that shown in Figure 6-top. The steep site collapses can be explained by the fact that poor people don't build retaining walls. On less steep slopes, most of the slum houses survived. This was true despite their being of bad construction done by untrained people.

is that the upper-class houses shown in Figure 6-bottom have collapsed, while the massive unreinforced masonry late 19th century "Gingerbread" house, now the Hotel Oloffson, suffered so little damage that it never closed (see endnote 5). Less than a stone's throw behind that hotel was another hotel, an 8-story RC building that completely pancaked.

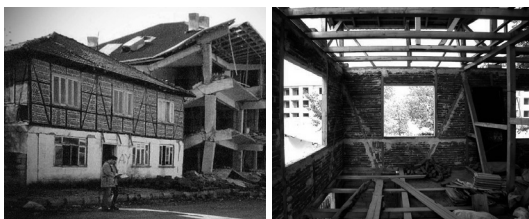
The first test of the findings from my research was in Turkey, after the large earthquakes in 1999. There I was able to witness the timber and masonry *hımış* construction next to RC frame construction as seen in Figure 8-left.

Fig. 8. *Hımış* next to collapsed RC (by ©Adem Doğanün) (l), and new *hımış* house in Duzce (r).

I even found one family where, at the time of the earthquake, the husband was building a new building out of RC. When he saw the collapsed RC frame buildings compared to the almost no damage to the *hımış* house which his father had built, he stopped and started over with the traditional *hımış* construction seen in Figure 8-right.

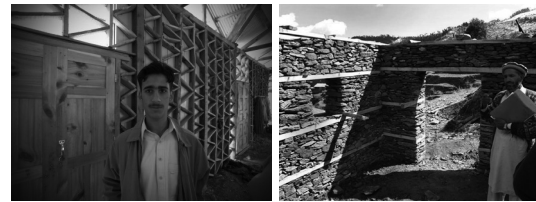
The 2005 Kashmir earthquake was the next earthquake to test these kinds of buildings. It mainly struck the Pakistan side of the border. 80,000 people died in northern Pakistan, including downtown Islamabad. In one of the towns to which I was taken to by my colleagues, Maggie Stephenson of the UN-Habitat and Tom Schacher of SDC, rubble stone houses had fallen, but the local residents could see that the one building that had survived was of *dhajji* construction. As a result, the people of this town, contrary to the government’s early edict saying they had to use reinforced concrete or concrete block, they proceeded to build *dhajji* houses (Figure 9-left). In Figure 9-right is new post-earthquake stone construction with timber ring beams, which in Pakistan is called *bhatar*.

A year after the earthquake, the government of Pakistan was persuaded (in part by my colleagues listed above) to approve *dhajji*, and the following year *bhatar*. Now, a decade later, there may be as many as quarter-of-a-million new houses constructed in these traditional forms of construction throughout northern Pakistan.<sup>9</sup>

Fig. 9. New *dhajji* house (l) and *bhatar* houses in rural Pakistan after 2005 Kashmir earthquake.

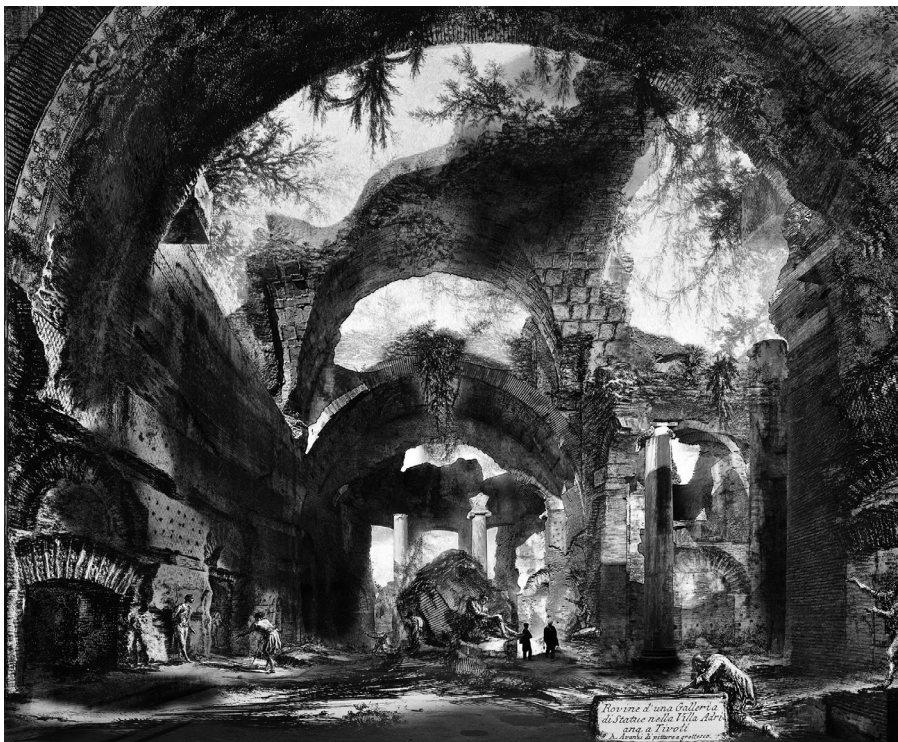
In closing, I want to give homage to concrete where it is due. Here shown in Figure 11 is a building shown in a drawing by the 18th century Italian artist Piranesi combined with a photo of it taken by me only a decade ago.

It is 2000 years old, and it has probably not seen any maintenance for probably 1800 of those 2000 years. This roof is of concrete – unreinforced concrete! It gives real pause to look at this example and think about buildings, and about what we can learn from what people have done in the past. Thank you.

Fig. 11. Grandi Terme in Hadrian's villa, near Rome, Italy, with engraving by Piranesi, ca. 1750.
