# Nonconventional and Vernacular Construction Materials

Characterisation, Properties and Applications

# What we learn from vernacular construction

*Randolph Langenbach*

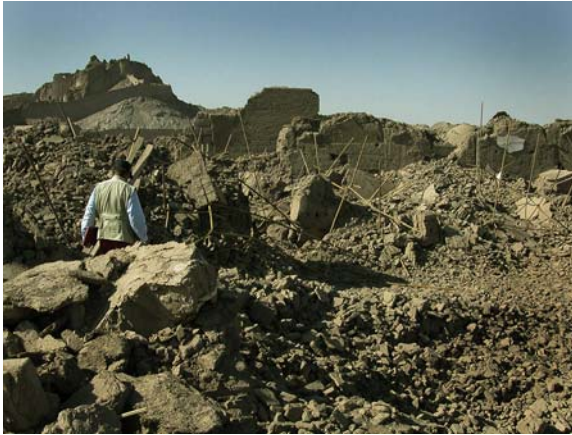
**Figure 1.2** Earthquake destruction of the restored parts of the Arg-e-Bam photographed four months after the earthquake.

At first glance, after entering the Arg-e-Bam there was little to be seen to disabuse one of such an opinion. The devastation was vast. However, on traversing the site more than one time, there were increasing visual signals that being made of unfired clay could not alone explain the nature and extent of the damage. First, there was almost no evidence of diagonal tension cracks in the collapsed or still-standing walls. Instead, almost everywhere the walls looked as if they collapsed vertically — like a slump test with too much water in a concrete mix [1].

Looking further, it became evident that some walls and structures had appeared to survive almost entirely intact, while others were only a pile of rubble. As I continued to look a pattern began to emerge. This was particularly evident when I came upon an area that had *not* been restored. The standing walls of unrestored structures, abandoned for more than a century and a half, had survived with little damage, while those that collapsed were almost always the ones that had been restored in recent decades. In addition, when examining the military fortifications, counterintuitively, the thicker the wall the *more* likely it was to have been collapsed by the earthquake.

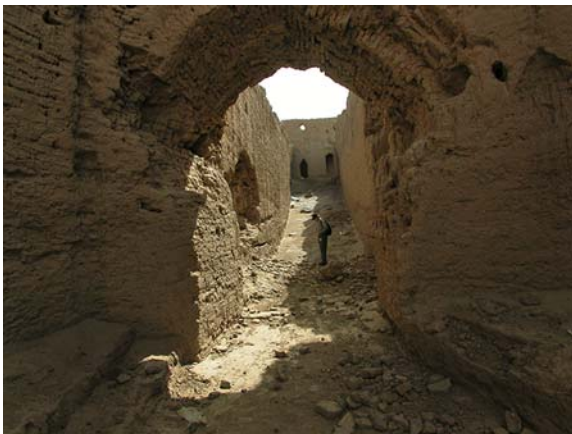
**Figure 1.3** View of an archeological site in Bam with high walls that came through the 2003 earthquake with very little damage.

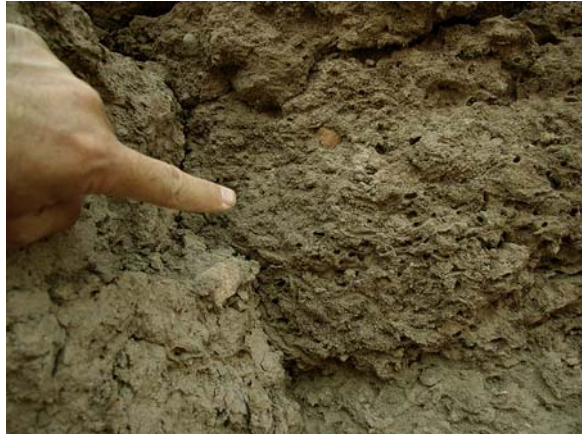
**Figure 1.4** Evidence of termites in a wall in the Arg-e-Bam.

As I continued to look, I also discovered that in a random sampling of the cracked open sections of the collapsed or broken walls, there was frass (insect excrement) in practically every single one. The Iranian archeologists told me this was from a local species of termites. *Termites*? In an archeological site with walls dating back 2000 to 8000 years? This comment launched me on a study that in the end had more to do with materials science than with structural engineering (Fig. 1.4).

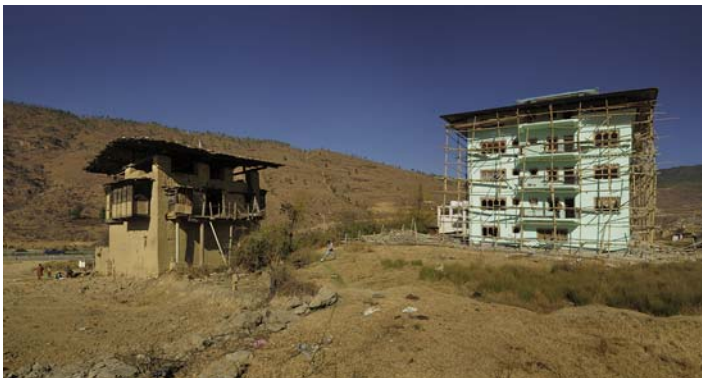
**Figure 1.6** New construction in reinforced concrete next to a traditional earthen house near Thimphu, Bhutan, 2010.

“Vernacular architecture” according to the Oxford English Dictionary is “Architecture concerned with domestic and functional rather than monumental buildings.” It is interesting to find that it is described in part as “contrasted against polite architecture which is characterized by stylistic elements of design intentionally incorporated for aesthetic purposes which go beyond a building’s functional requirements” [6]. This raises the question of aesthetic intentions within the domain of vernacular architecture. One can argue that vernacular architecture — particularly that which remains universally loved by people from most walks of life — shows evidence of many deliberate aesthetic intentions, such as are found in an English Cotswold cottage, a traditional Turkish Ottoman house, a farmstead in Kerala, India, or a shop house in Pingyao, China. The differences with “polite” architecture are not the presence or absence of aesthetic intentions but rather the predominant manifestation of time-honored locally based cultures (Fig. 1.6).

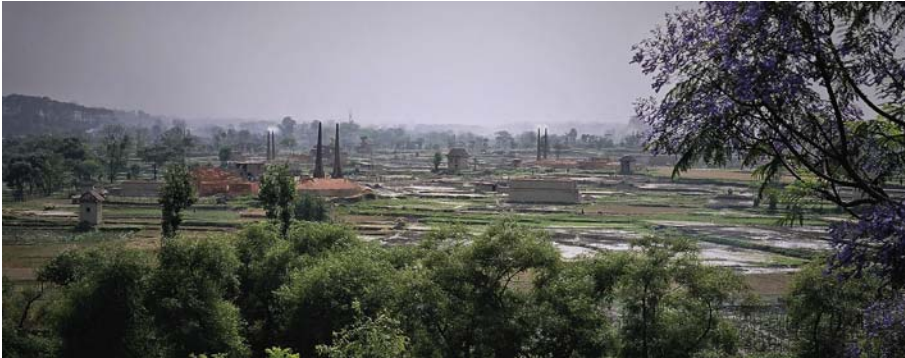
**Figure 1.7** Traditional brick kilns near Kathmandu, Nepal, 2000.

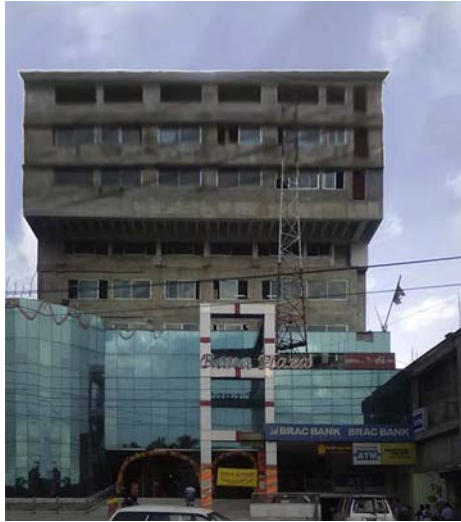
**Figure 1.10** Front façade of the *Rana Plaza*, Bangladesh before collapse. Elevation view of front façade of *Rana Plaza* near Dhaka, Bangladesh. This rectified image was constructed by author from a combination of news media TV video images to show the façade prior to collapse. This photo reconstruction of the building serves to bring into focus a fact that, in addition to its structural failings, it was unremittingly ugly as a work of architecture. I would say that these two aspects of building design are actually closely related — the developer Sohel Rana’s grotesque failure even to grasp the truth of his own engineers’ warnings of imminent collapse are of a piece with his ignorance and even contempt for architectural expression that is in any way responsive to the local and national culture (see TEDxAmoskeagMillyard talk [11]).

Today, one can only reflect on the fact that if the *Rana Plaza*, an eight-story reinforced concrete frame industrial building near Dhaka, Bangladesh, had instead been supported on timber columns, the 1,129 people who lost their lives in the 13th of May 2013 collapse of the structure would still be alive. Thus, one can also say that an important additional definition of vernacular construction is that it is more easily understood by local owners and builders than is construction that is dependent for structural reliability on complex scientific processes and theoretical analysis with differential equations, as is reinforced concrete (Figs. 1.10 and 1.11).

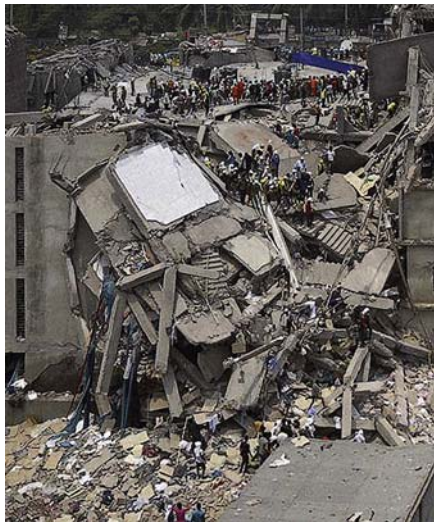
**Figure 1.11** *Rana Plaza* after 2013 pancake collapse that killed 1,129 people. Photo by Rijans, Wikimedia CC.

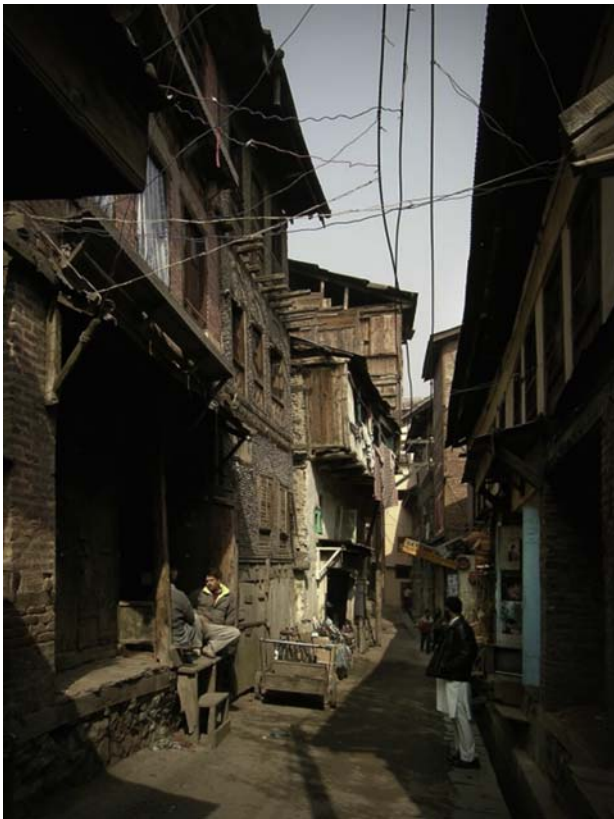
**Figure 1.13** Narrow lane with timber-laced masonry bearing wall buildings in central Srinagar, Kashmir, 2005.

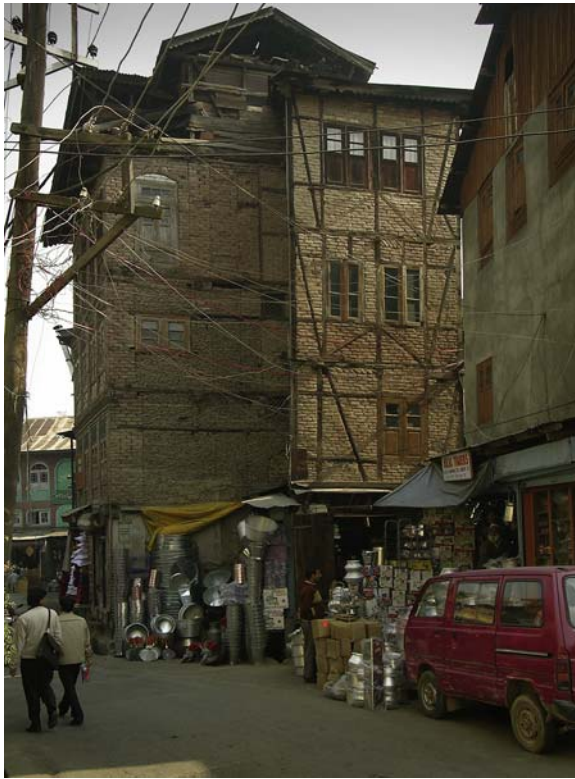
**Figure 1.14** View of four- and five-story buildings of traditional *taq* (on the left) and *Dhajji dewari* (on the right) construction in the city center of Srinagar, Kashmir, 2005.

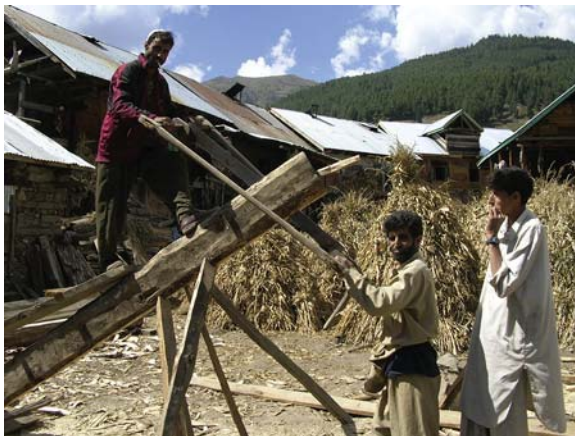
**Figure 1.15** Contemporary continuation of preindustrial technique of sawing timbers into boards in Kashmir.

Wood in the Himalayan region was comparatively plentiful before the modern era, but it had to be sawn by hand as there were no saw mills. Also, nails were hand forged rather than purchased by the box. Thus, the primary locally available building material in the Vale of Kashmir was clay, which was fired into bricks or used for mortar. Timber, however, was used not only to support the floors and roof but also to reinforce the masonry (Fig. 1.15).

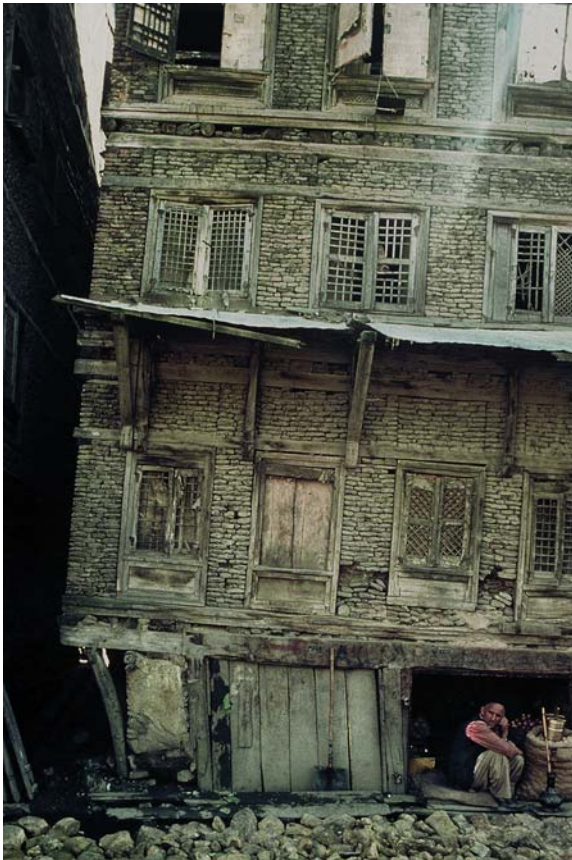
**Figure 1.16** Canalside building of *taq* construction in central Srinagar, showing the timber-laced masonry construction, photographed in 1981. Notice that the windows do not line up vertically and that the masonry is divided into panels and piers, which is only possible structurally because of the timber ring beams in the masonry walls.

(Fig. 1.16). These separate sections of masonry walls and piers are then laced together with timbers that form ring beams around the exterior walls and are held together with wooden ties that pass through the walls at each floor level. This timber lacing is configured like ladders laid horizontally in the wall. They are laid below and above the joists at each floor level, which then tie the walls together with the floors because of the friction provided by the overburden weight of the masonry above.

What is important to note regarding this system is that there are no vertical timbers or any other form of vertical tension reinforcement. This is something that seems counterintuitive to most engineers today, including the engineers in India who produced the otherwise remarkably forward-thinking Indian Building Code IS 13828 for “non-engineered” construction that is based on this system [14]. As a result of their insecurity with having only horizontal reinforcement: this code recommends that a cement grout-encased steel reinforcing bar be embedded in the masonry in each exterior corner. My concern is that this column of steel-reinforced concrete over time is likely to prevent the natural changes in dimension of the surrounding load-bearing masonry laid in soft mud mortar. In the event of an earthquake, it could disrupt the masonry in such a way that it will be much more difficult or impossible to repair [15].

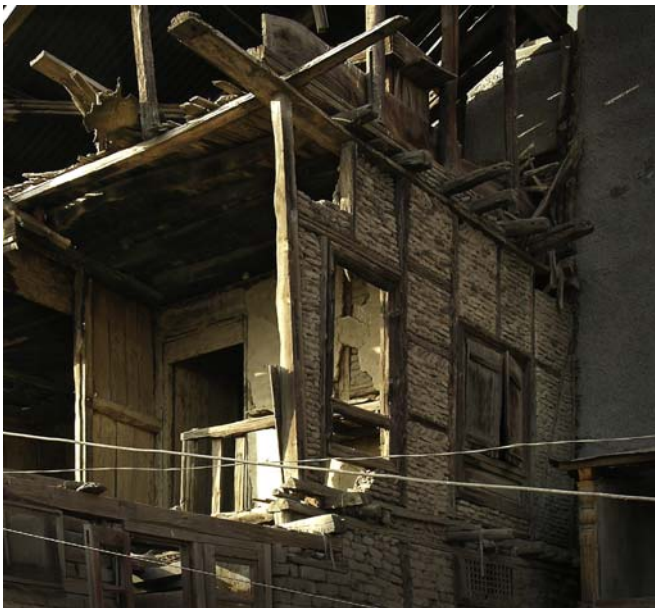
**Figure 1.17** *Dhajji-dewari* building showing the single-leaf construction of the walls. The building was under demolition for a road widening, 2005.

The second system, known as “*dhajji dewari*” construction, consists of a braced timber frame with masonry infill. It is brick-nogged timber-frame construction that in Britain is known as “half-timber.” *Dhajji-dewari* comes from the Persian words for “patch quilt wall” (Figs. 1.17 and 1.18). It is similar to what in Turkey is called *hıms* [16].

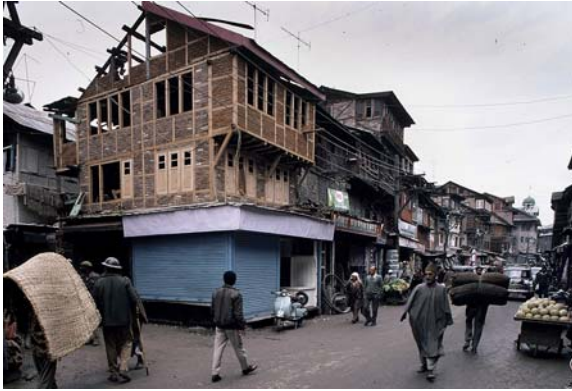
**Figure 1.18** New construction in *dhajji-dewari* photographed in 1989. More recently, this form of construction has largely gone out of use, in favor of reinforced concrete.

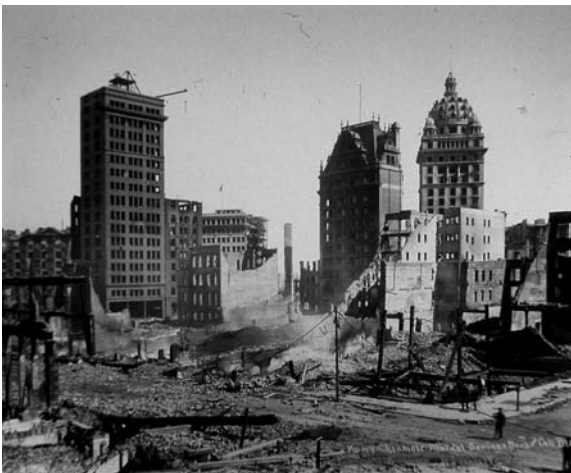
**Figure 1.19** View of San Francisco showing three of the steel skeleton frame buildings after the fire had burned them out. These included the 315 foot high steel skeleton frame Call Building constructed in 1890. All of the surrounding buildings, except for the skeleton frame structures, were completely destroyed. These three skeleton frame structures, as well as most of the others in the city from that time, were repaired and about half of them still exist today.

The invention of the skeleton-frame skyscraper fits well with the other remarkable inventive engineering feats of the age, such as bridges and towers. The most remarkable of these towers at the time was most certainly the Eiffel Tower. However, there was a profound difference: unlike bare steel bridges and towers, buildings require interior and exterior walls. Also, as a consequence of the flammable nature of their contents, the steel frame itself must be protected against collapse from the heat of a raging fire inside a building (Figs. 1.19–1.21). For more on 1906 Fire, see Ref. [28].

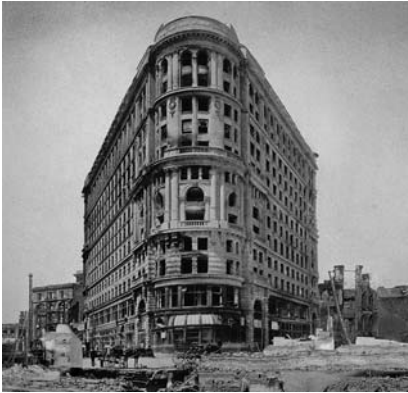
**Figure 1.20** View of the 1904 steel skeleton frame with infill masonry Flood building after the 1906 San Francisco earthquake and fire.

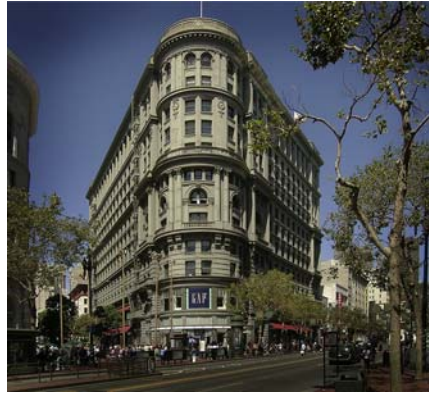
**Figure 1.21** The same view shown in Fig. 1.20 but 100 years later. Most of the steel skeleton-frame buildings were repaired after the earthquake despite the fact that all were burnt out by the fire.

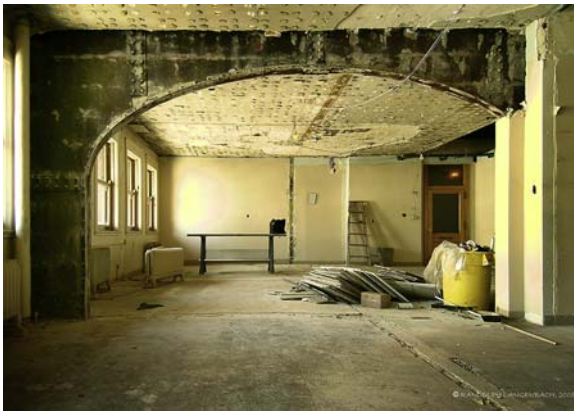
**Figure 1.22** An office interior remodeling project in the south wing of the 1891–1893 steel-frame Monadnock Building in Chicago briefly revealed this view, an example of what Freitag defines as the “table leg” portal arch. The photograph was taken in 2005.

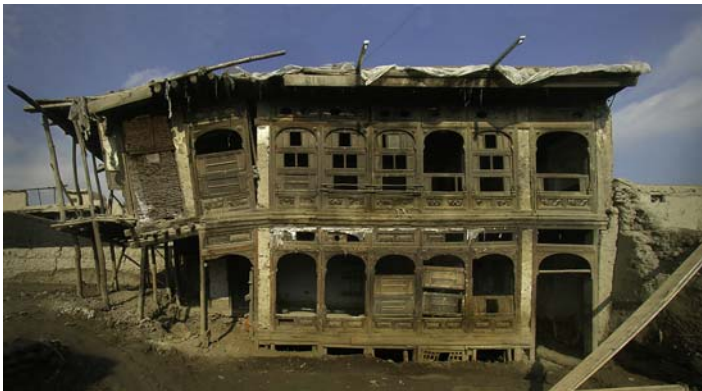
**Figure 1.23** The Peacock House, Murad Khane, Kabul, Afghanistan, before and after restoration.

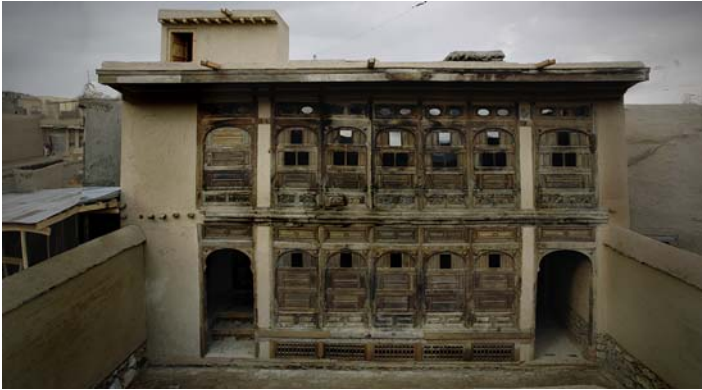
**Figure 1.24** The same house shown in Fig. 1.23 after restoration by the Turquoise Mountain Foundation.

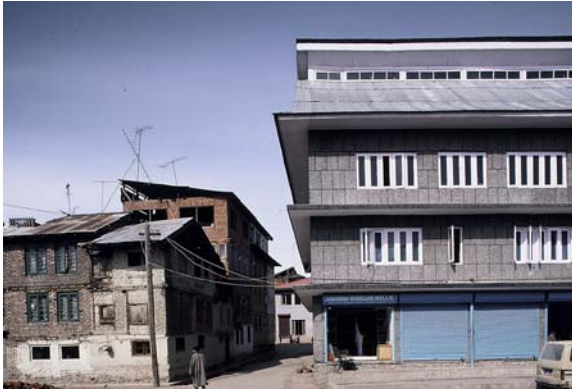
**Figure 1.25** Srinagar, Kashmir, photographed in 1981 showing the collision of scale, architectural language, and construction technologies in the historic city after the construction of a large reinforced concrete building. In the three decades that have followed, many more buildings of similarly disruptive scale and design have been constructed in what had been a remarkably well-preserved historic city center.

dominant reinforced concrete construction has become, and the alien scale and visual language of the resulting architecture in many parts of the world, it is clear that something has been lost and not replaced (Fig. 1.25). What has disappeared has everything to do with the “*knowledge, culture and wisdom*” that had been unique to the particular regions and communities.

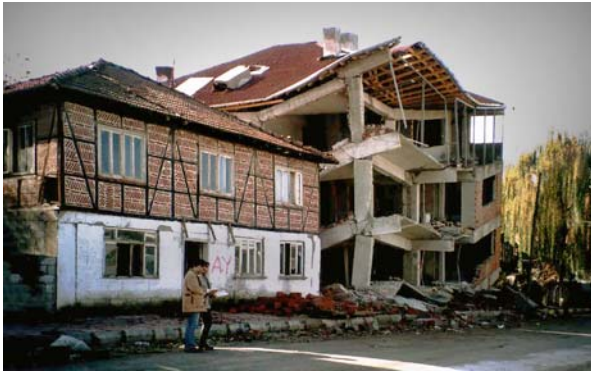
**Figure 1.26** View after the 1999 Düzce, Turkey, earthquake showing collapsed reinforced concrete building immediately adjacent to a traditional *humuş* residence with only one panel of brick infill missing. Photographer unknown, image provided courtesy of Adem Dogangun.

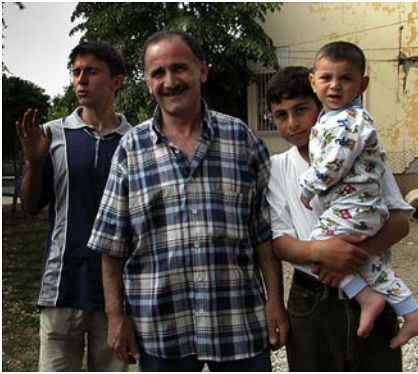
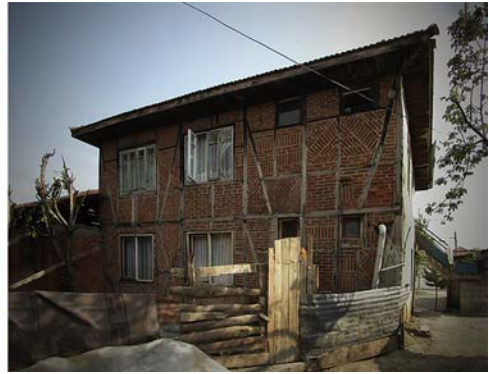
**Figures 1.27 and 28** This family were living in Düzce, Turkey, in the house in [Fig. 1.27](#) at the time of the 1999 Düzce earthquake. At that time he was constructing a new house of reinforced concrete. After the earthquake, when he saw that so many RC buildings had collapsed, he stopped the construction and began instead to build a house in *humuş* construction shown in [Fig. 1.28](#).

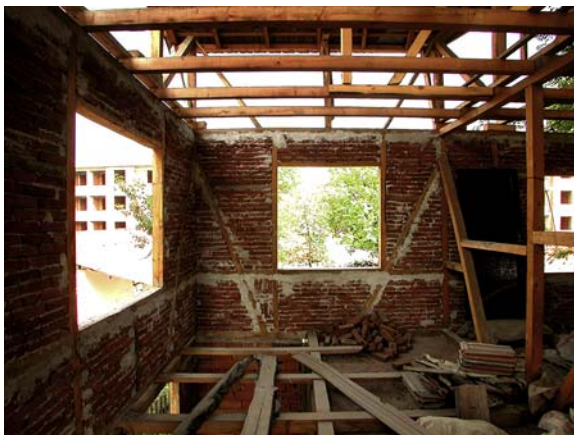
**Figure 1.29** The interior of the new house being constructed by this family shown in [Figs. 1.27 and 1.28](#) being built of traditional Turkish *humuş* construction.

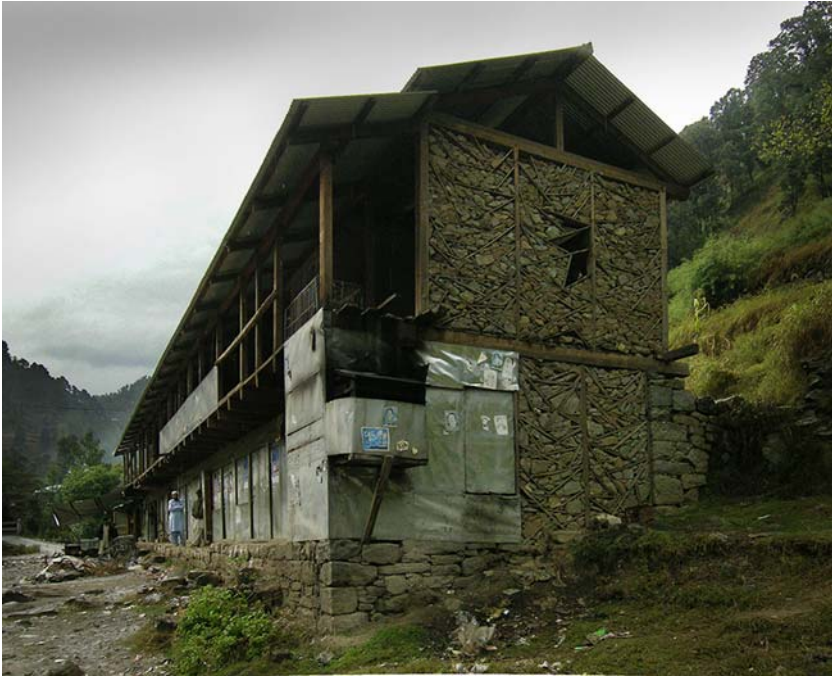
**Figure 1.30** *Dhajji-dewari* building in rural Pakistan, Kashmir, after the 2005 earthquake, showing the few missing wall panels of infill masonry.

Earthquakes are the ultimate test of buildings, and thus, the growing interest among engineering students in technologies that were spurned and totally absent from university curricula less than a decade ago gives a chance to revisit some of those same questions that confronted the engineers who climbed over the ruins of San Francisco in 1906, just as their predecessors had in 1755 in Lisbon, Portugal, and 1783 in Calabria, Italy. More recently, it is also just as the itinerant builders and residents have observed in Turkey after the 1999 Kocaeli and Duzce earthquakes (Figs. 1.26–1.29), and in Pakistan after the 2005 Kashmir earthquake (Fig. 1.30).

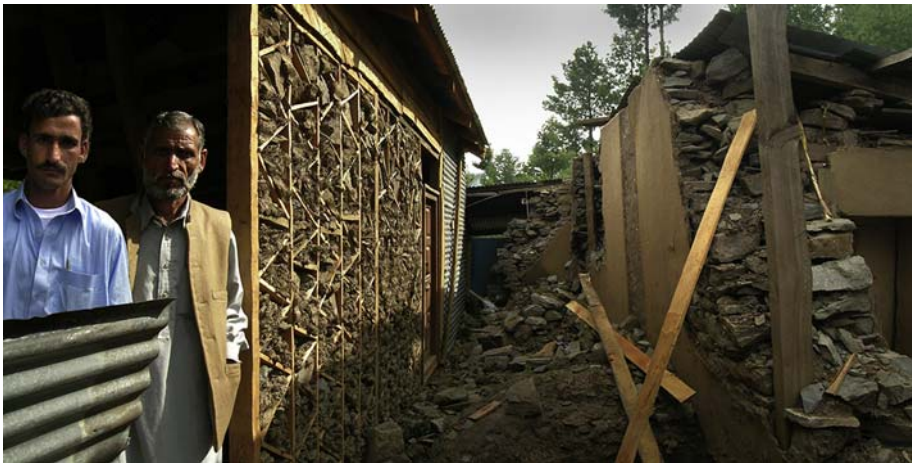
**Figure 1.31** The owner and carpenter of a new house under construction in rural Pakistan near to the building shown in Fig. 1.29 after the earthquake destroyed the owner's original rubble stone home, the ruins of which are on the right. The decision to reconstruct in *dhajji* construction was because the one home in the village that did not collapse was of that construction and the reinforced concrete village store collapsed.

Following the example in Fig. 1.31 and other spontaneous examples, the government of Pakistan approved *dhajji* 1 year after the earthquake and *bhatar* 2 years after the earthquake for government assistance. By 2009, a mere four years after the earthquake, there are “*at least 150,000 new homes*” constructed in northern Pakistan in either of these two traditional typologies [49].
