OPUS nuova serie

Earthquakes and Masonry: What can be learned from Nepal?

Terremoti e murature: cosa si puo imparare dal Nepal?

Randolph Langenbach

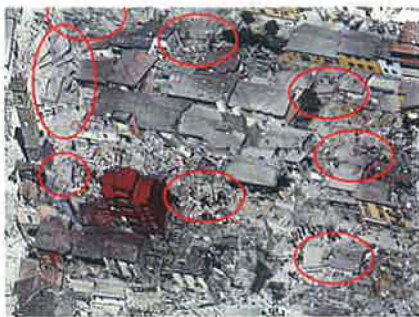
II Amatrice after the 24th August 2016 earthquake showing evidence of reinforced concrete slabs in debris (AP photo).

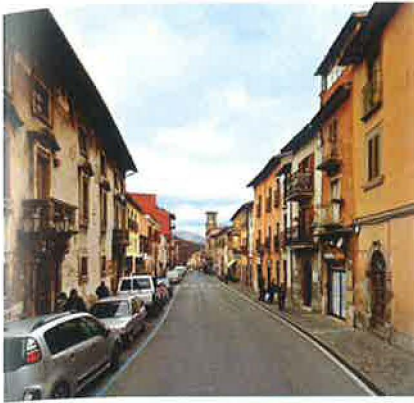
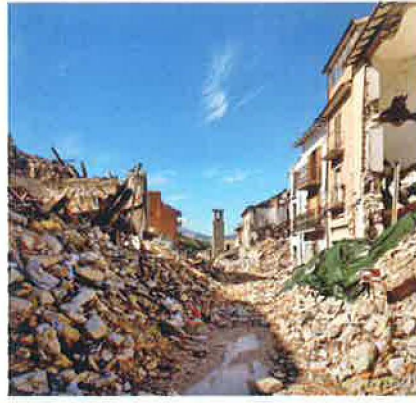
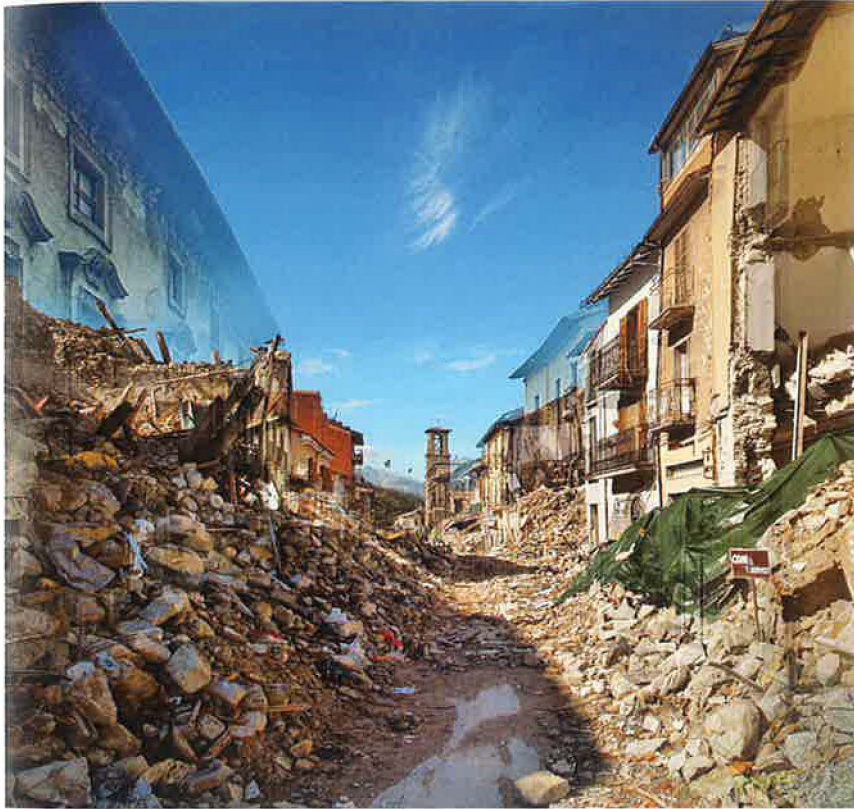
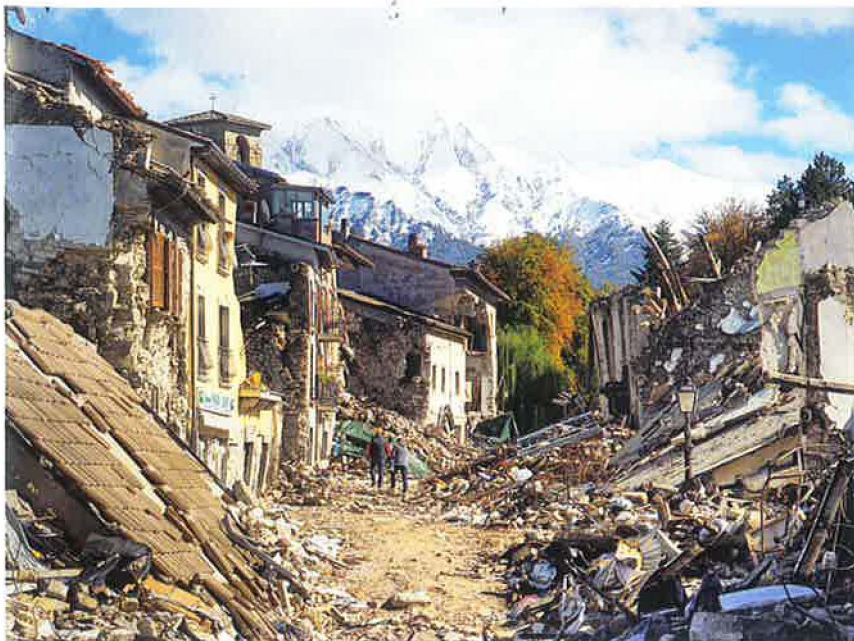
2a, 2b, 2c, 2d/Amatrice before and after the earthquake of 24th of August 2016. The photo 2c shows the round rock rubble with the image of the pre-earthquake buildings standing above the ruins. 2016).

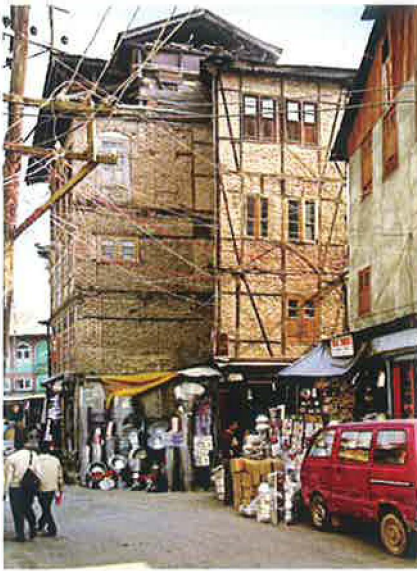
3/Srinagar; Kashmir showing taq on left, and dhajji dewari on right.

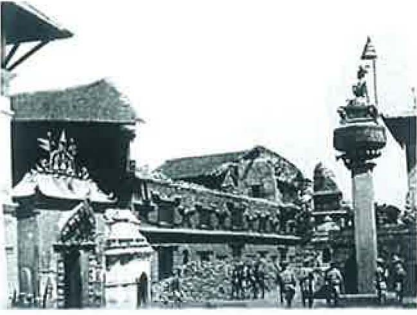
5-6-7 / Fifty-five Windows Palace (18th century), Bhaktapur, after the 1934 quake (6a); in year 2000 (6b) showing tilted and deteriorated front brick wall with the windows after being rebuilt without their historic projection after the 1934 earthquake, but prior to the full restoration in 2005; view after the 2015 earthquake (6c) showing no damage. Photo's source: Images of a Century, Editor: Andreas Proksch, Deutsche Gesellschaft für Technische Zusammenarbeit (GTZ) GmbH, 1995

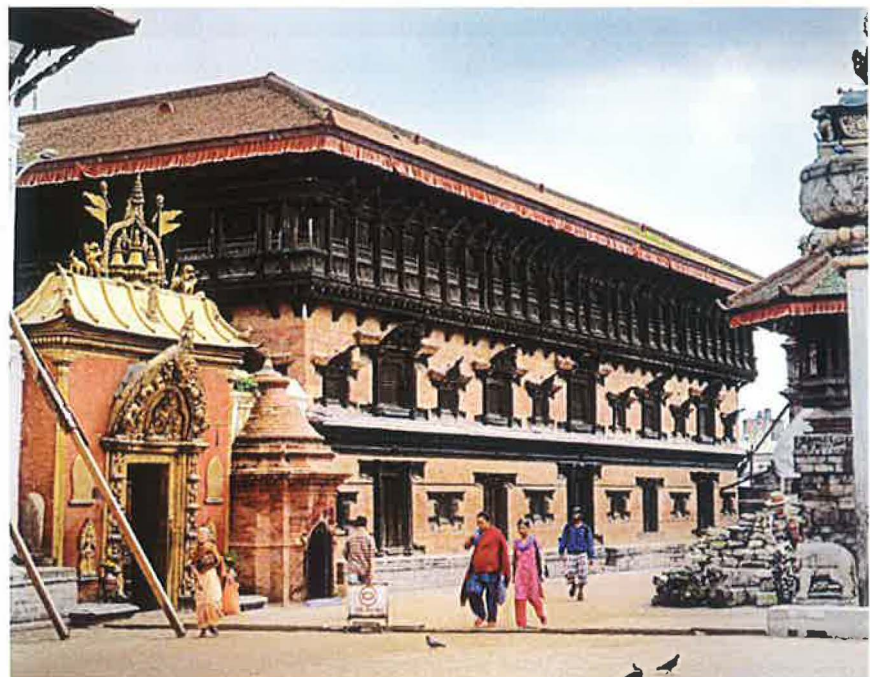
10 / Temple in Kathmandu, Durbar Square showing the brick wall with a convex bowing after the earthquake from the wedge shake bricks.

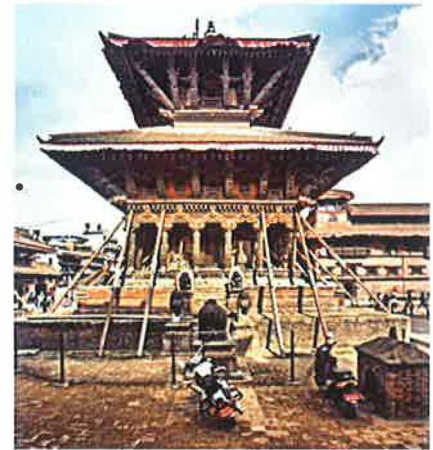
The wedge shaped bricks have an unfortunate side effect during earthquakes. The compression forces on this exterior brick layer from the rocking of the whole structure serve to compress the bricks, which forces them into a convex curvature that separates them from the core of the wall - essentially weakening the wall by removing one layer of masonry (figs.11-12). This prob-

An earthquake - particularly with the long period motion experienced in Kathmandu in these two earthquakes - can cause the whole structures to rock back and forth, which causes the outer wedge-shaped brick outer layer to fall away, and then the softer inner core of the wall crushes from the overburden weight of the rocking mass above, leading to the overturning of the entire structure¹⁶.

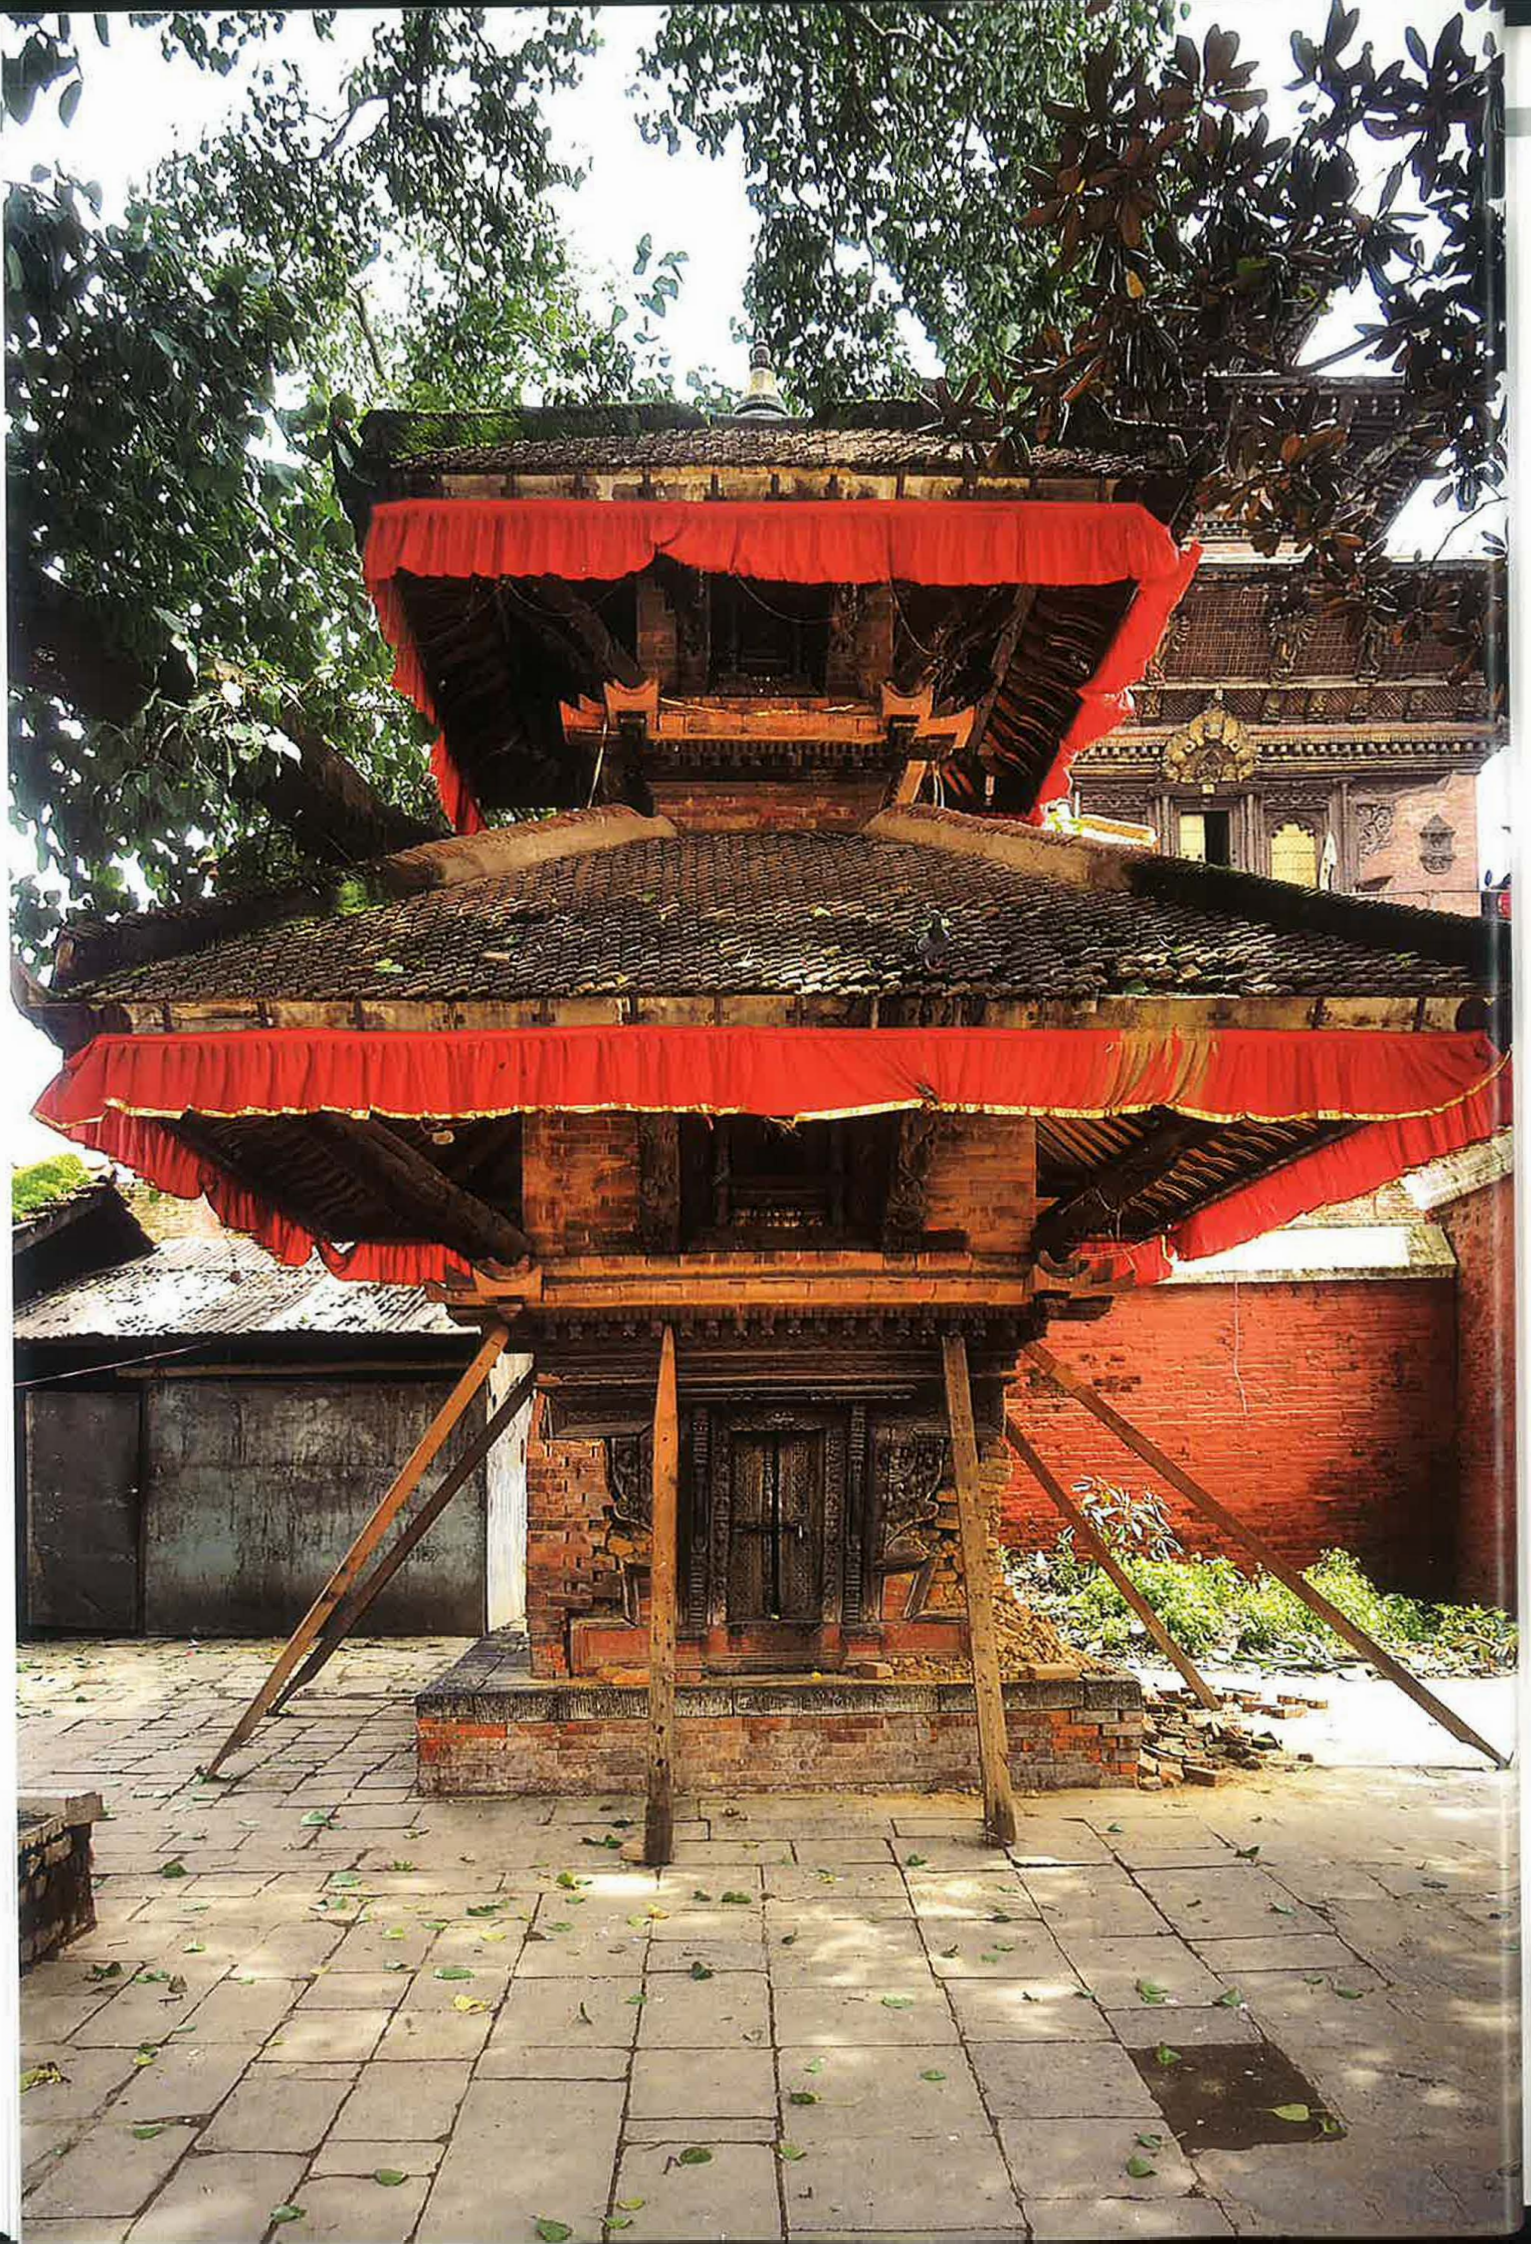
Another even more unusual artistic feature found in the masonry work of the more important monuments, but which was not found on more ordinary buildings, is the manufacture and use of wedge-shaped bricks for the exterior brick layer (fig. 10). The purpose was to enable the pencil-thin mortar joints that contribute so much to the visual quality of the Nepal historic architecture of the temples and palaces. Such thin joints would otherwise be impossible, particularly with mud mortar, without a method to make for an enlarged space behind for the mortar. The same level of refinement cannot be achieved simply by putting a "frog"¹⁵ in the brick.

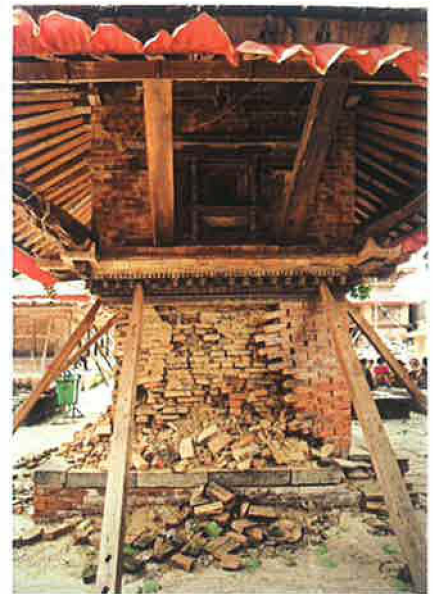
11-12/ Small pagoda temple in Kathmandu Durbar Square which almost was toppled by the earthquake, showing the shedding of the wedge shaped face bricks which lack bond courses and bow outwards when compressed during an earthquake.

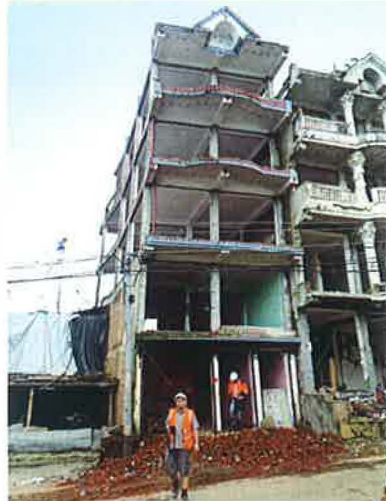
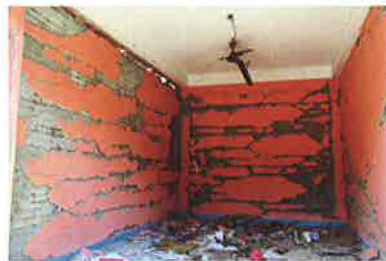
18a (top left) | 13b (bottom, left) | Chautara, Sindhupalchok, four months after the earthquakes. This building did not collapse during the earthquakes, but it is condemned and under demolition. In this building, the infill brick masonry was only one brick thick, but the kind of crack patterns seen in the upper right view is unusual when compared to recent earthquakes in other countries, which demonstrates the advantages of having soft; slightly underfired bricks laid with a weak rather than a strong and brittle mortar. The evidence of this is the tremendous amount of movement and cracking that occurred along the mortar joints. It is unusual to see such walls subjected to these forces without developing the characteristic diagonal tension "X" cracks which often leads to the collapse of the buildings as seen in Fig 15 (Photos courtesy of Jason Ingham & Dytro Dizhur)

In this area, even though in many cases the concrete frames were ruptured very badly (figs. 13a, 13b), the single-brick-thick walls of soft brick masonry in this compromised condition did not collapse out of their frames and may account for why these buildings did not pancake collapse. My hypothesis is that in Nepal in 2015 the bricks saved many of the reinforced concrete frame structures in Kathmandu, even though the frames, not the walls, were constructed first as the term-of-art "confined masonry" is meant to signify. The frames in much of the Nepali construction can be found to have acted much as they would in confined masonry - particularly in the taller buildings which

have two layers of masonry infill. This is of importance exactly because there is often very little quality control in the construction of the reinforced concrete frames in Nepal, and almost no bending resistance and ductility to their beam/column intersections. Why did the infill walls work so well, even if, they were only one brick thick? It is because in Nepal (as in India) the brick making technology is pre-industrial. The bricks are still handmade, that is they are thrown into molds and dried in the open air, and then they are fired at a lower temperature than in fully industrialized kilns (fig. 16). This produces a comparatively soft but solid brick. In addition, the mortar, even if mixed with Portland cement, probably is still very weak because cement is expensive and thus used sparingly. Because the bricks are soft and the mortar is weak, the strain on the walls results in a crazing across the whole wall surface in the event of an earthquake, rather than with the more characteristic diagonal tension "X" cracks seen in most other earthquakes around the world. The building then is much more likely to remain standing on its brick walls confined by the concrete frame, despite the cracks in those walls as shown by the comparison between figs. 13a, 13b and fig. 15.

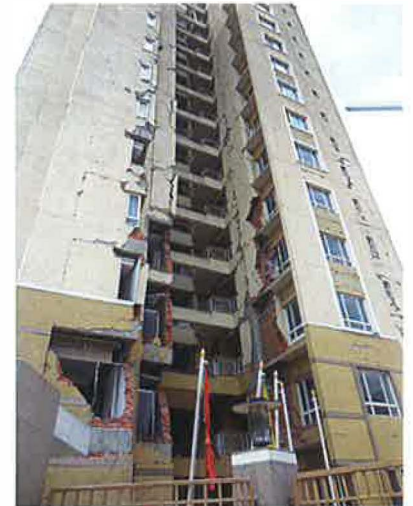
14 (top right) | Golden High Rise Condominium Complex, Kathmandu, showing that the brick infill wall thickness is two layers. These failures are concentrated in walls that are outside of the concrete frame so that the bricks were not confined as they are in other parts of the building. The confined masonry contributed to the survival of the structure from collapse. (Photo courtesy of Miyamoto International)

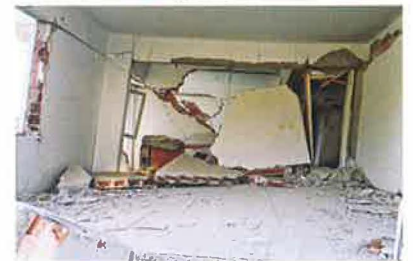
15 (bottom right) | 1999 Kocaeli earthquake, Golcu.k, Turkey: A view of an infill wall in a building in which the stories below collapsed after the infill walls suffering brittle failure which is manifested here by with the development of diagonal tension ; cracks in the high fired, but brittle, hollow clay tile "ti.la" block infill masonry. These "tula" blocks are now common in Turkey for infill walls. They are made in large modern factories such as that seen in Fig. 17.

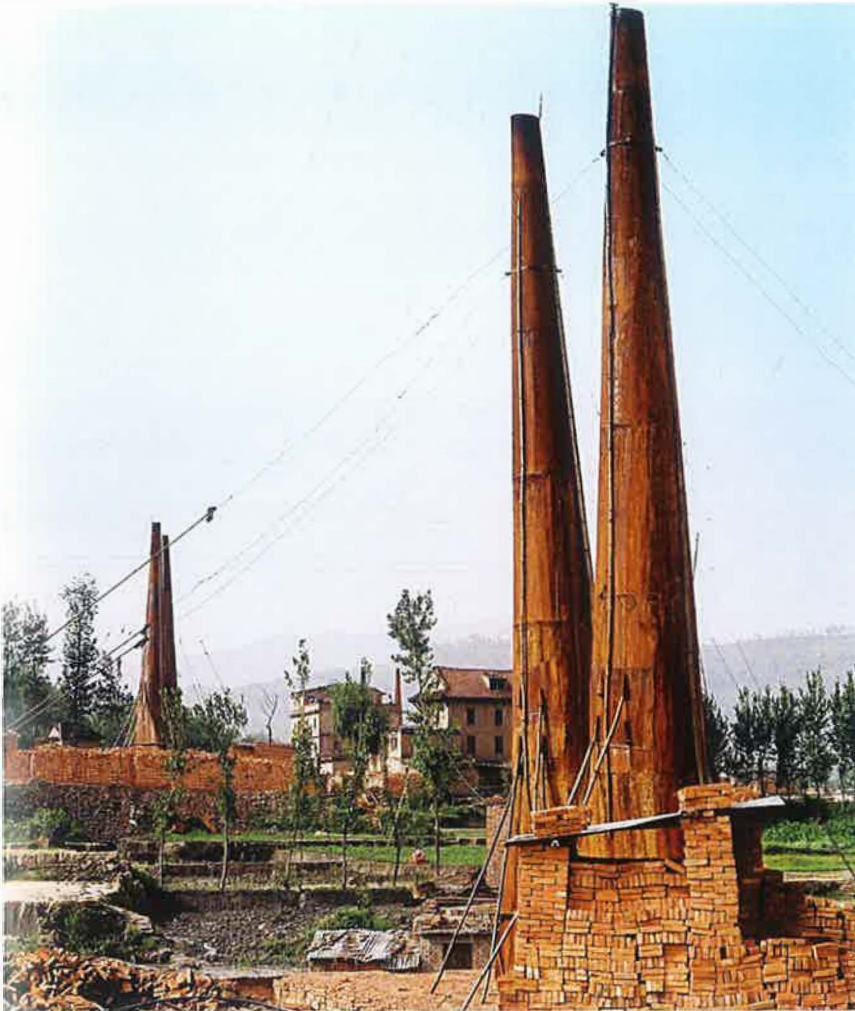
16/Brick kilns photographed in 2000 near Bhaktapur in the Kathmandu Valley. There are now reports that controlled development is leading to disappearance of the land from which the clay for bricks is made in the Kathmandu Valley.

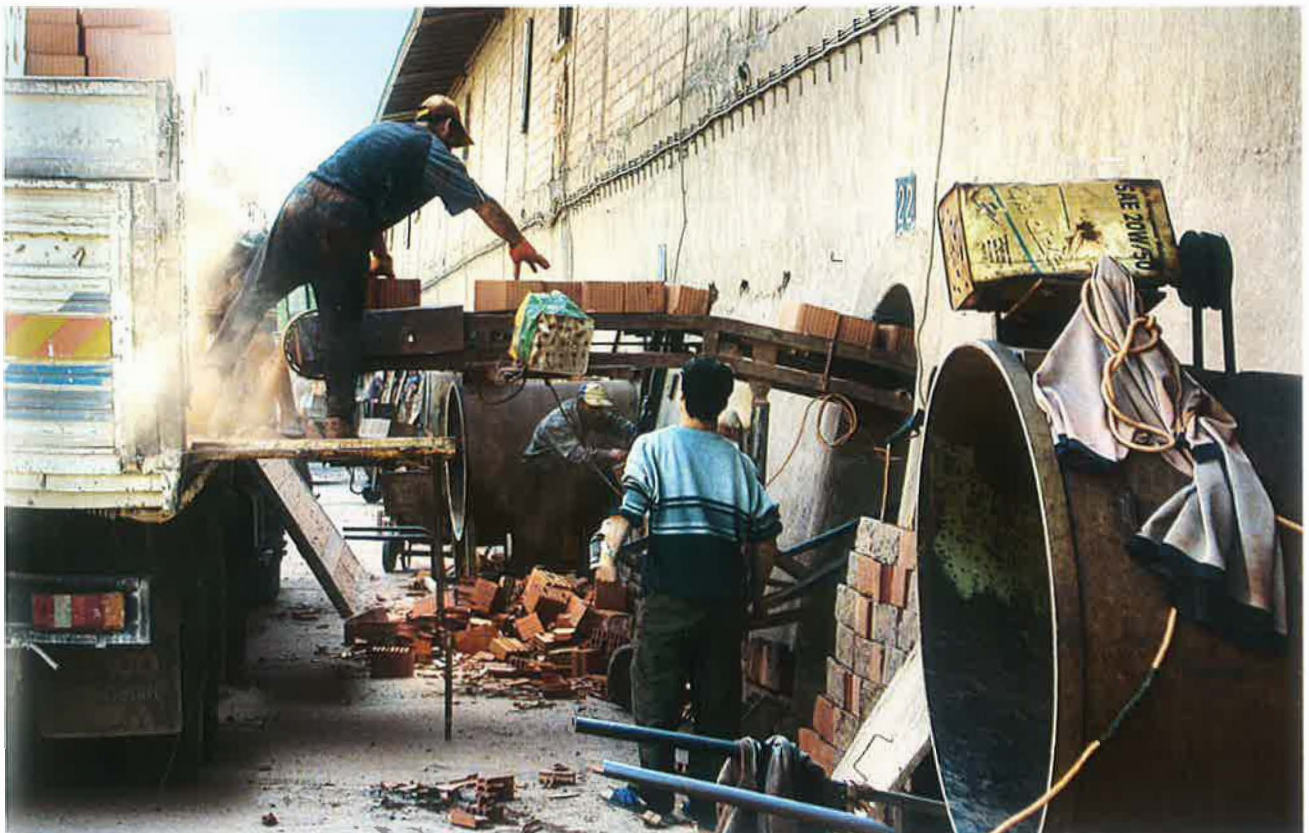
171A "tula" (hollow clay tile block) factory near Akyon, Turkey, photographed in 2003, showing the tula blocks being loaded onto a truck. The broken blocks below the conveyor belt provide convincing evidence of how brittle the blocks are.
