*First South Asia Conference on Earthquake Engineering  
(SACEE'19)  
21-22 February 2019, Karachi, Pakistan*

*10<sup>th</sup> International Civil Engineering Conference (ICEC'19)  
"Technological Transformation of Civil Engineering"  
February 23-24, 2019, Karachi, Pakistan.*

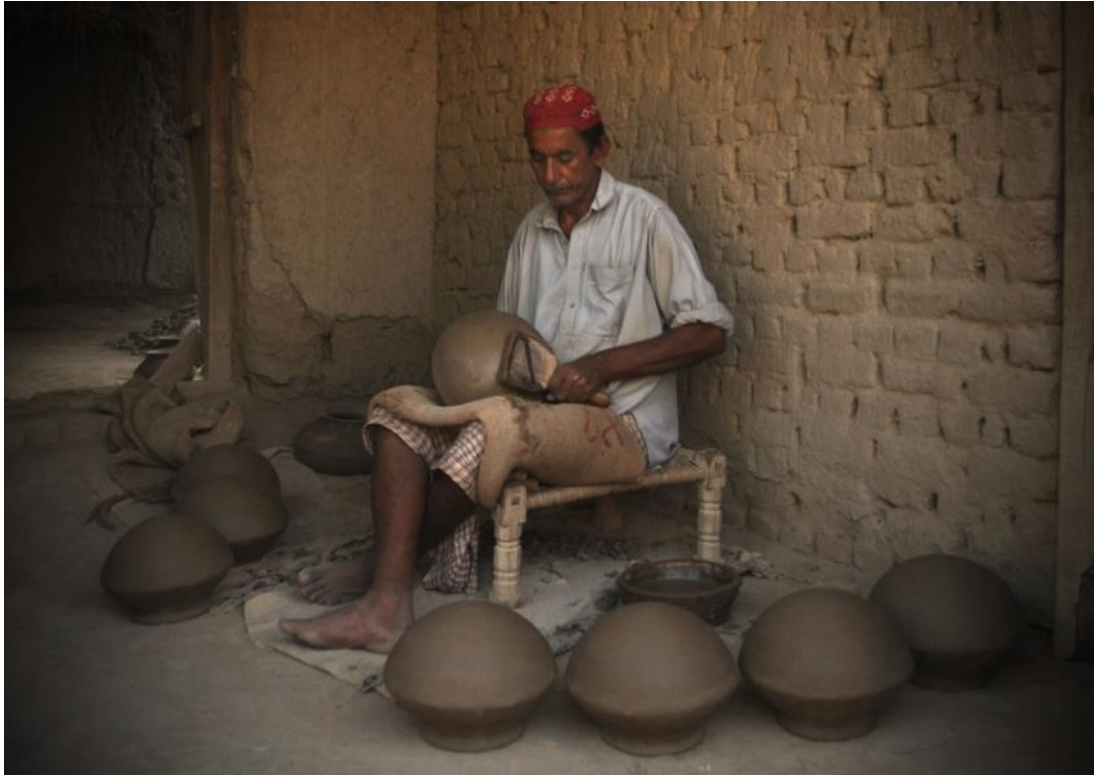
**Figure 1: Potter in village near Mohenjo-Daro**

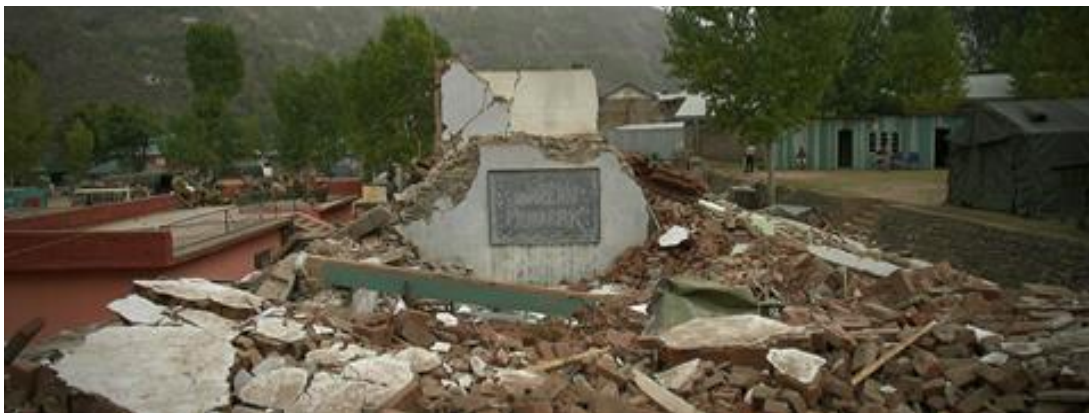
**Figure 3: Collapsed School, Uri, Indian Kashmir. Written on the blackboard before the earthquake, is “*Ramazan Mubarak*” (Blessed Ramadan), which now is all that remains.**

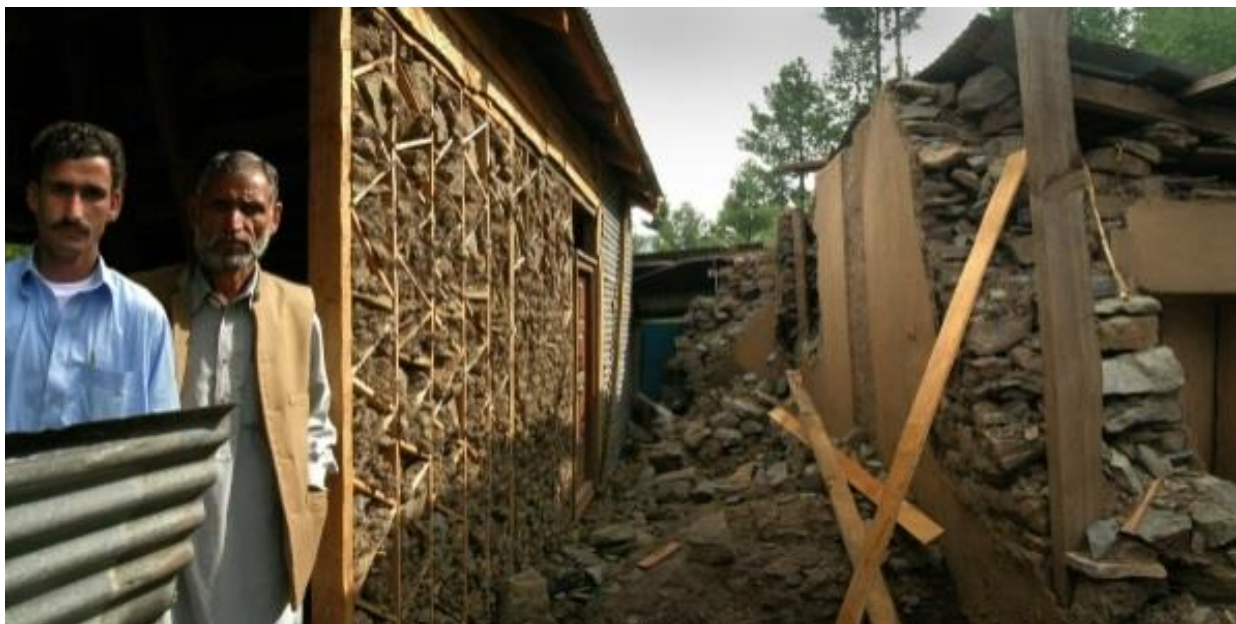
**Figure 6: New *dhajji* next to ruins of URM house**

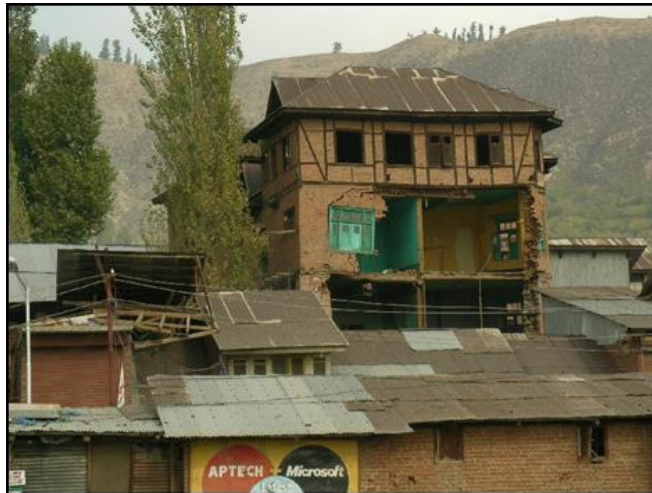
**Figure 12: *Dhajji dewari* top floor showing ability of *dhajji* to span the wide gap left by collapse of unreinforced brick wall below in Baramulla**

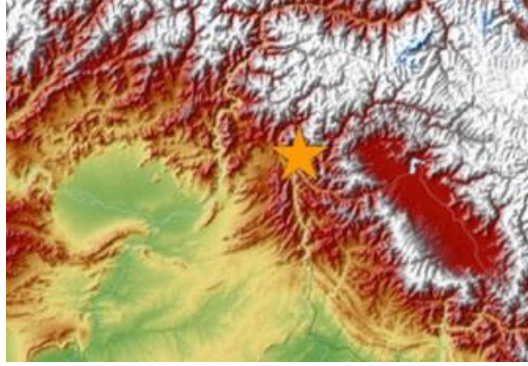
**Figure 13: Geography of Indian and Pakistan Kashmir. The large red area between snow covered peaks is the Vale of Kashmir. The star is the EQ epicenter**

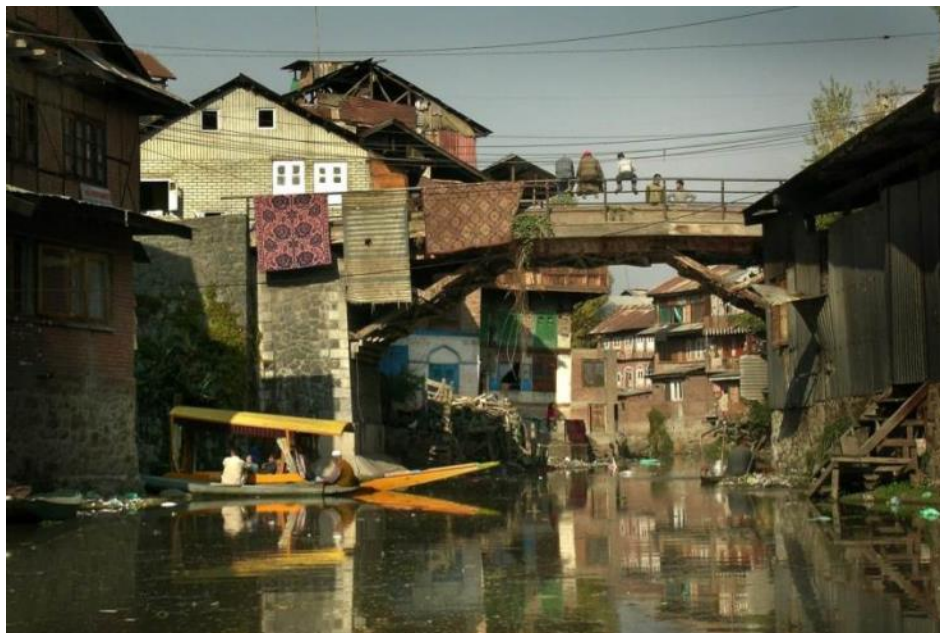
**Figure 16: Rainiwari Canal, the only canal not filled in and turned into a road in central Srinagar**

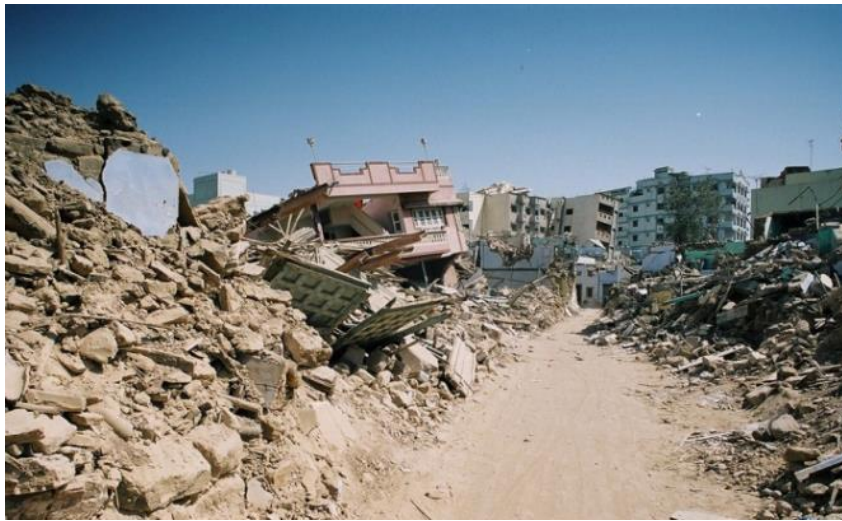
**Figure 22: A view within the historic walled city area of Bhuj after the 2001 Gujarat earthquake. Most of the historic buildings were of rubble stone masonry construction and the modern buildings were of reinforced concrete. The earthquake destroyed many of both types of construction**

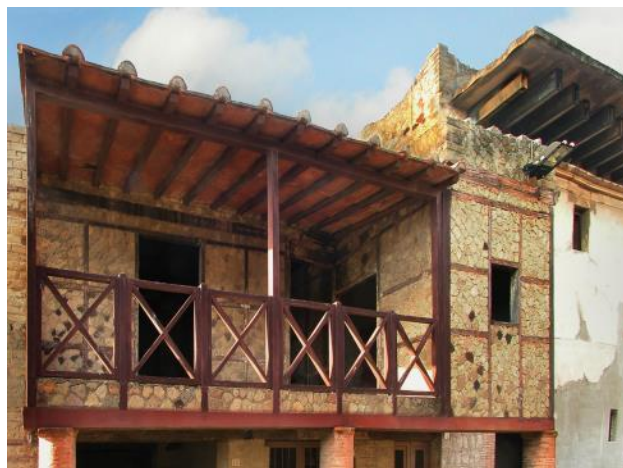
**Figure 23: House of the Opus Craticium, Herculaneum, Italy**

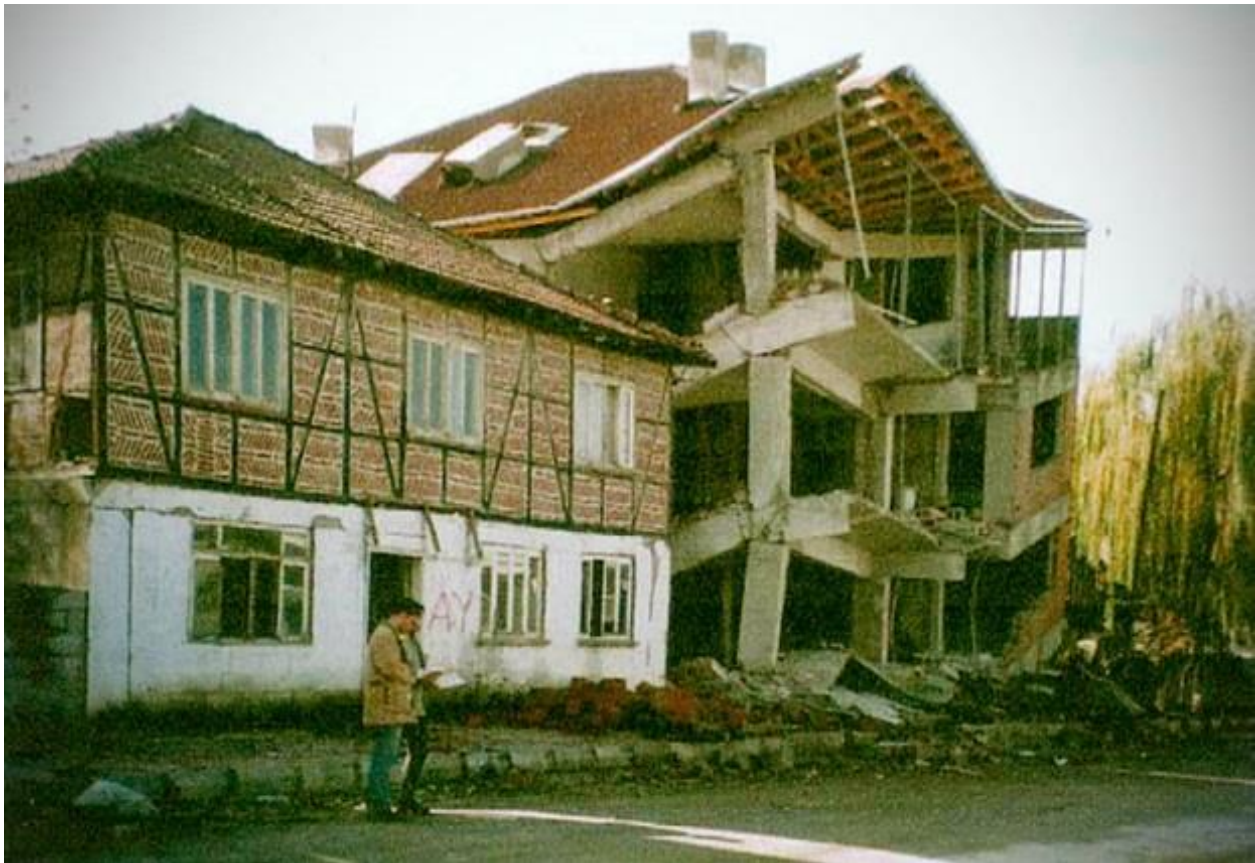
**Figure 26: Formerly 4 story RC building next to dhajji building with very little damage from 1999 earthquake. (reproduced with permission from Adem Doğangün (Doğangün et al., 2006))**

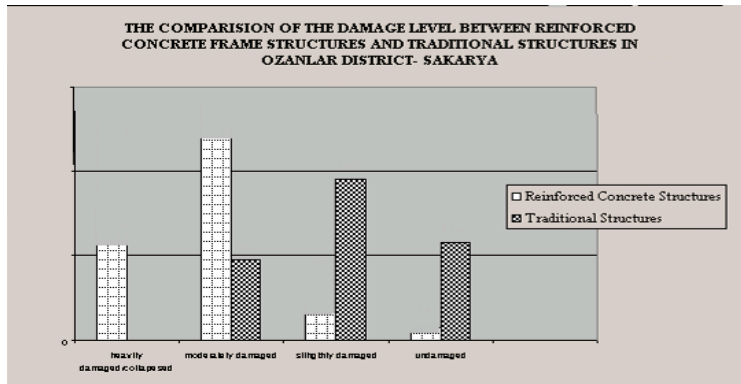
**Figure 27: Comparison by Gülhan and Güney of damage to RC buildings with traditional timber and masonry buildings of all types**

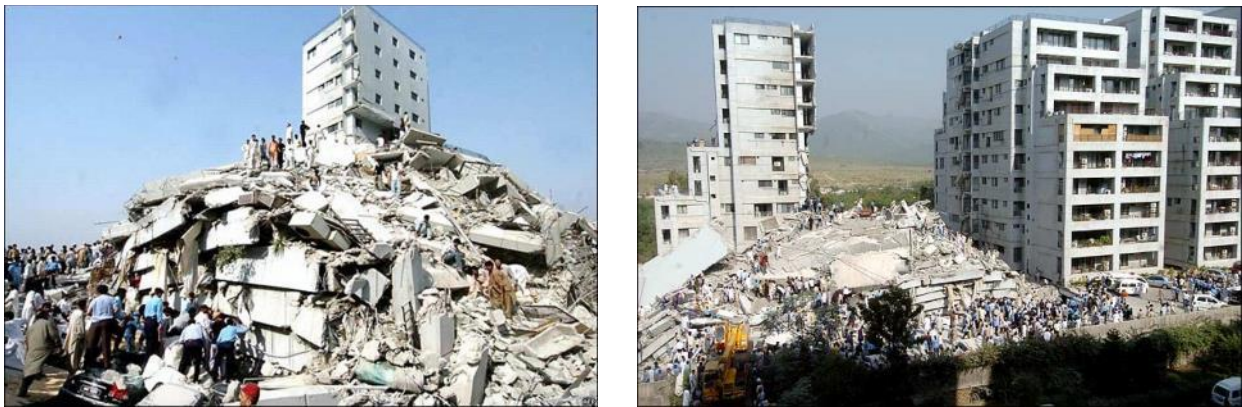
**Figure 28: Margalla Towers, Islamabad (courtesy of Express Tribune)**

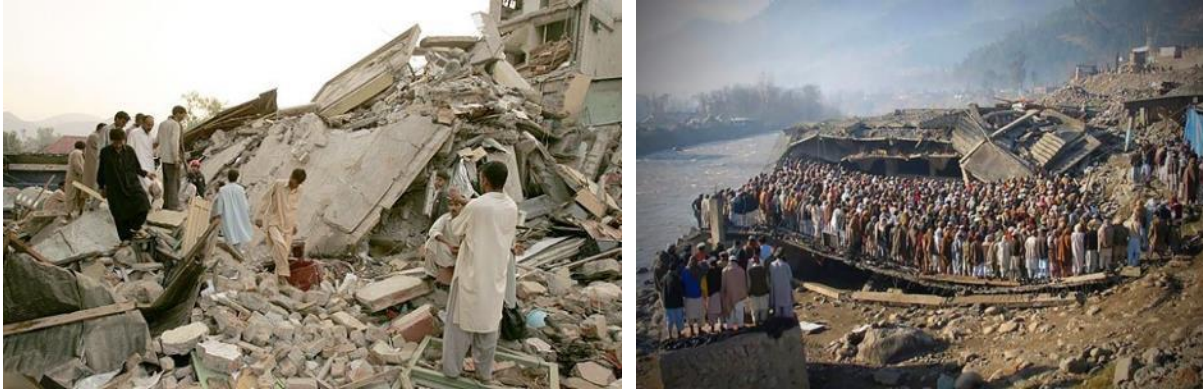
**Figure 29: This is a remarkable photo taken in Balakot of an open air prayer meeting on the floor slab of the collapsed main Balakot mosque. Every building in the city was reported to have been destroyed, but the strength of this reinforced concrete floor slab to hold this many worshippers is amazing (courtesy IIEES)**

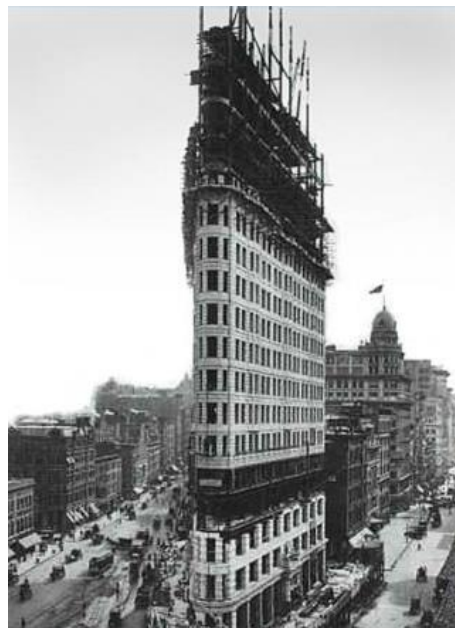
**Figure 32: Flatiron Building in New York City under construction in 1902 showing the stone masonry façade resting on the steel frame. The upper walls are constructed separately from the walls below, most probably to ensure their weight is bearing on the steel frame rather than the lower masonry walls.**

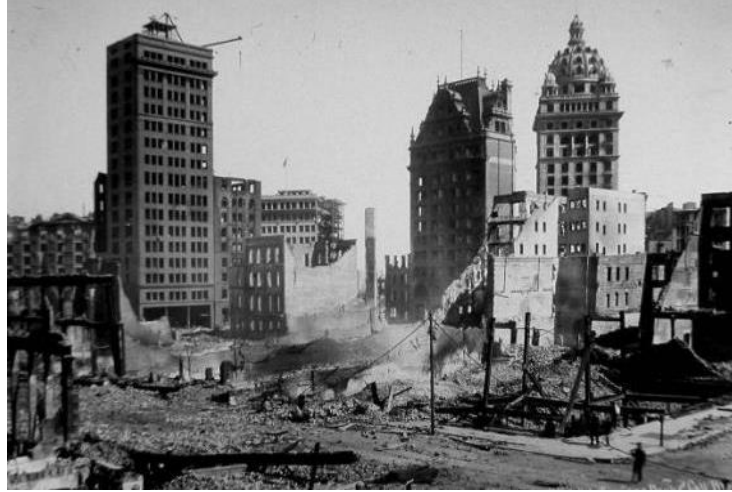
**Figure 33: View of San Francisco after the 1906 earthquake and fire. The three tall buildings in this view were burned out by the fire that followed the earthquake, but all were in good enough condition despite this to be repaired, and they are still extant today.**

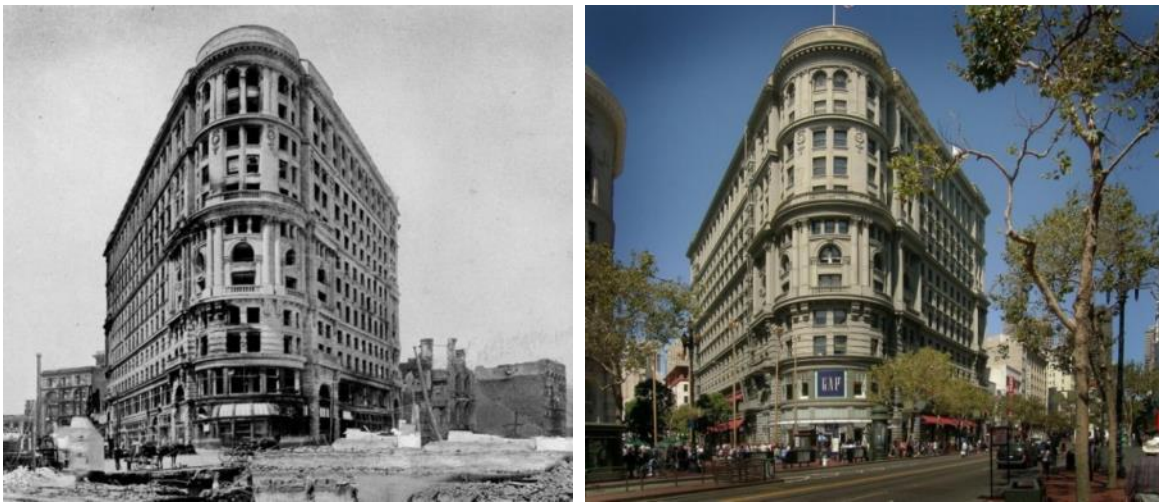
**Figure 34: The Flood Building, San Francisco, constructed in 1904, It is twelve stories with a steel frame and thick infill masonry. (Left) after the Great 1906 earthquake and fire, and (right) its appearance today. It was simply repaired from the earthquake and fire damage after the earthquake. It did not have to be rebuilt.**

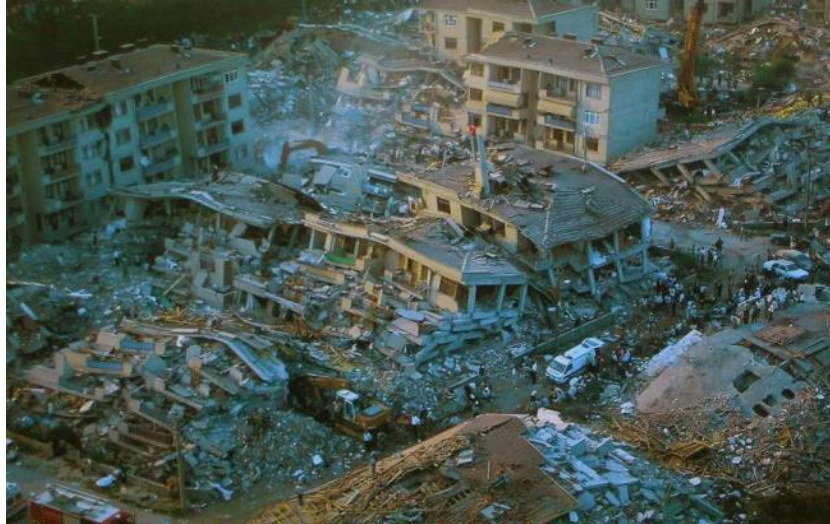
**Figure 35: Collapsed RC Buildings in Gölcük, Turkey after 1999 Kocaeli earthquake**

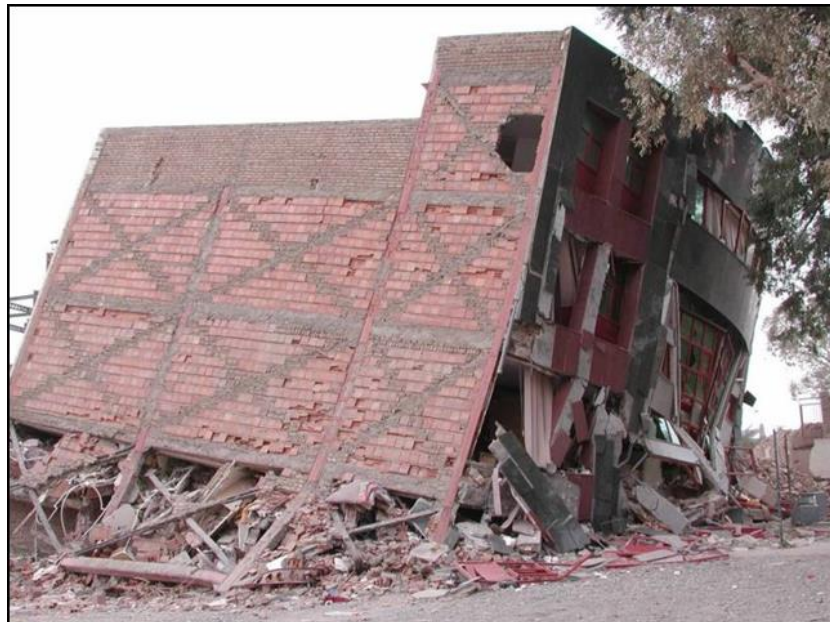
**Figure 36: Collapsed steel frame building after 2003 Bam, Iran earthquake**

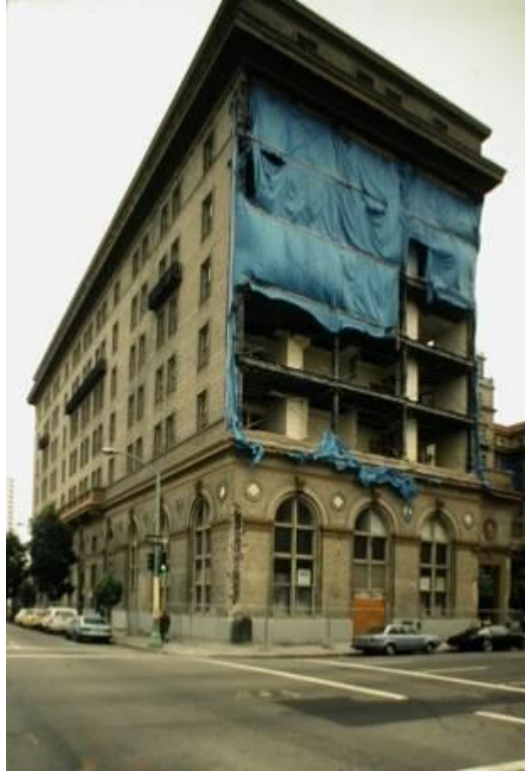
**Figure 37: Hotel Oakland, Oakland, California after 1989 earthquake which caused much of this end façade to fall off**

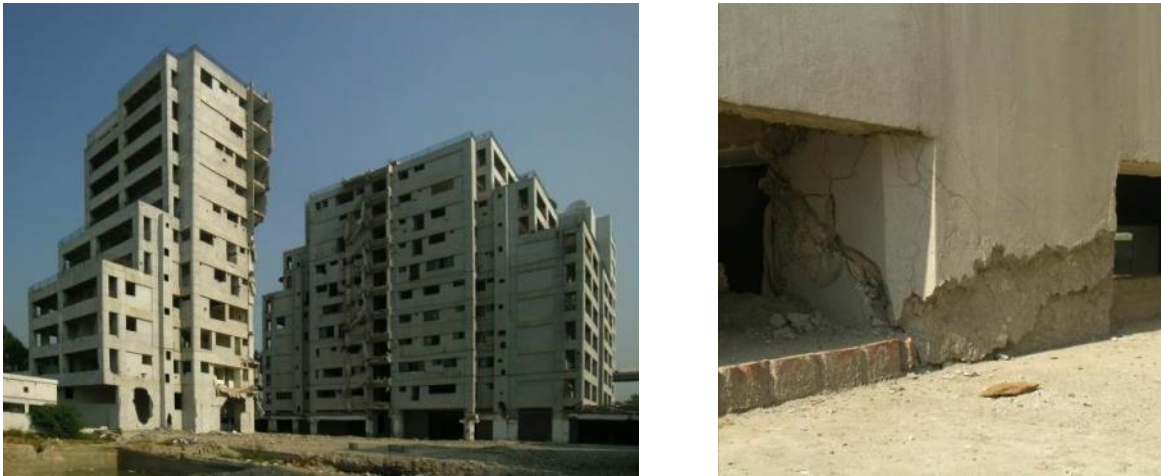
**Figure 38: Margalla Towers, Islamabad (middle) after debris removal exposes the basement level 'soft story' and (right) base of the section next to that which collapsed showing evidence of onset of short column failure**

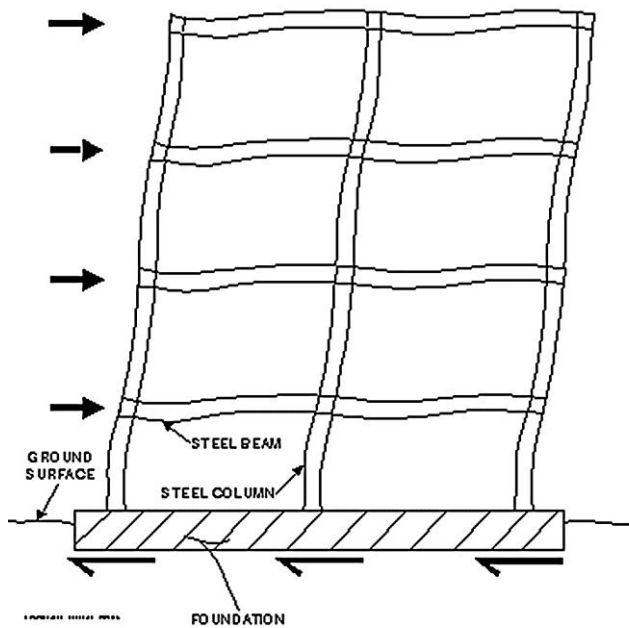
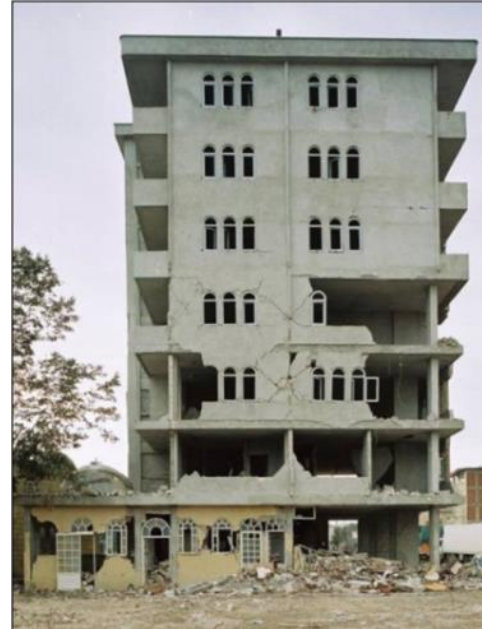
**Figure 39: Moment frame under lateral load showing the rigid connections of the beam/column connections which then produce the flexural shapes of the beams and columns. This is an idealized shape of the ‘frame action’ which engineering calculations are predicated on, whereas the beams are often much deeper, which can more easily lead to rupture of the beam/column connections.**

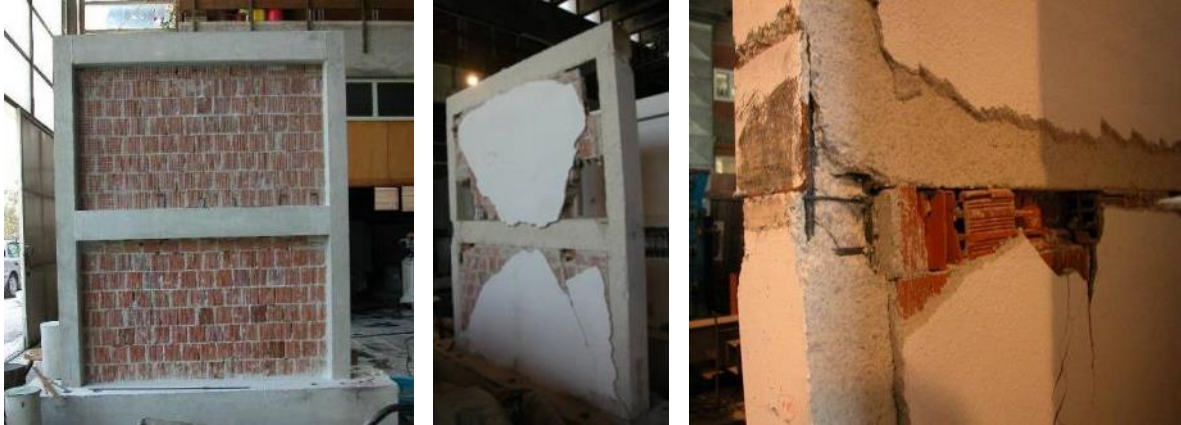
**Figure 41: Research on the effects of conventional infill walls at Middle East Technical University, Ankara, Turkey. The photos on the right show how the infill can cause the rupture of the surrounding RC frame when pushed laterally parallel to the wall**

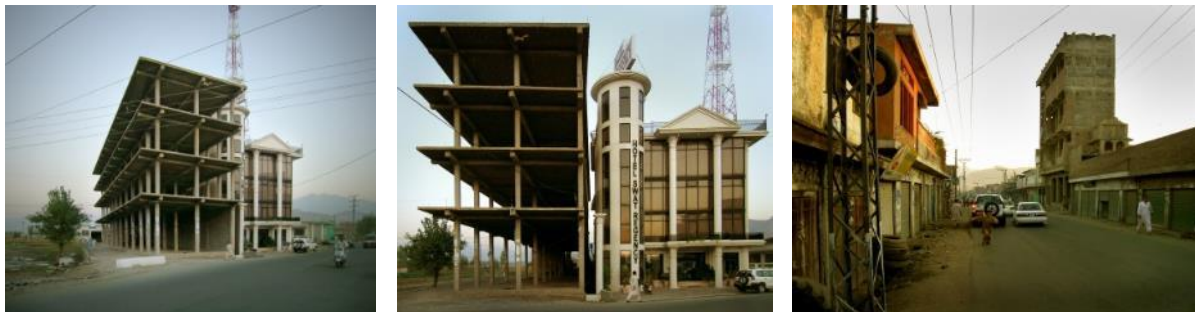
**Figure 42: Buildings in Mingora, Pakistan. On left, what appears to be a very weak RC frame building under construction, and on the right an infill wall building with no visible attempt to give it a cultural or architectural quality**

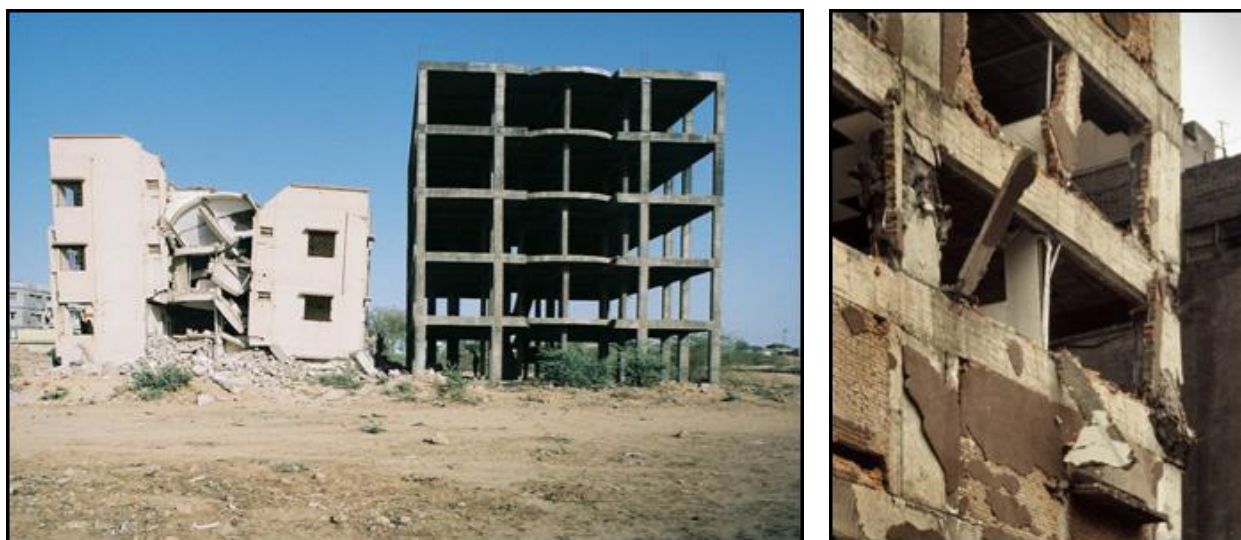
**Figure 43: Buildings that were intended to be identical when finished, located near Bhuj, India after the 2001 Gujarat earthquake**

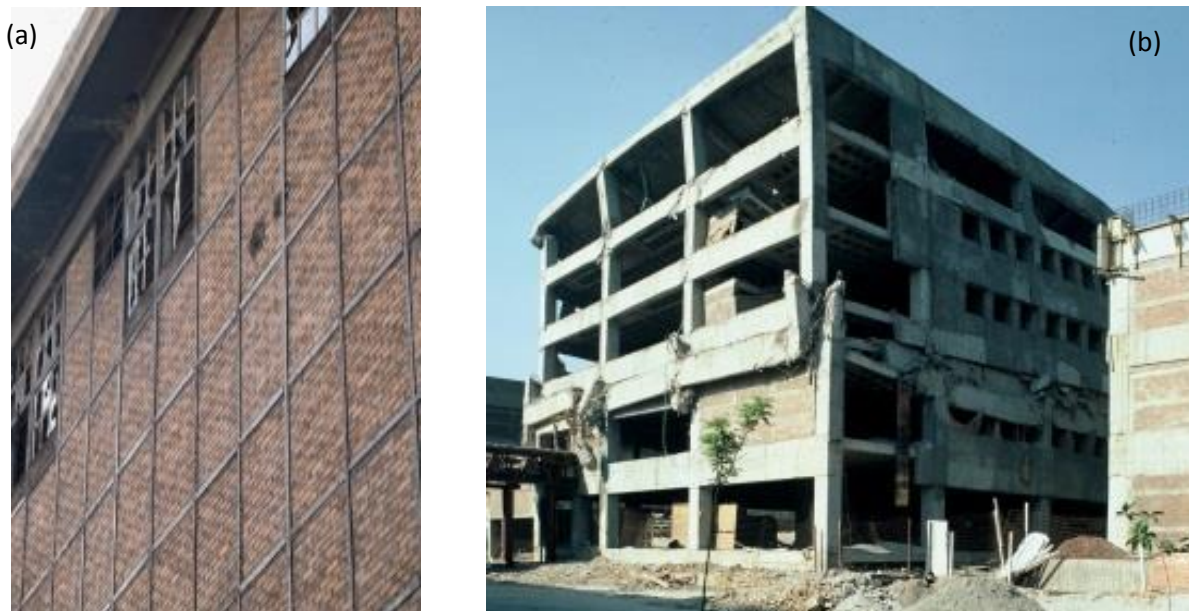
**Figure 45: The brick wall of a power station showing an ‘armature’ of light steel reinforcement that subdivides the wall into panels. This building suffered no damage in the 1985 Mexico City earthquake while Figure 45 (b) shows RC building under construction just across the street has collapsed.**

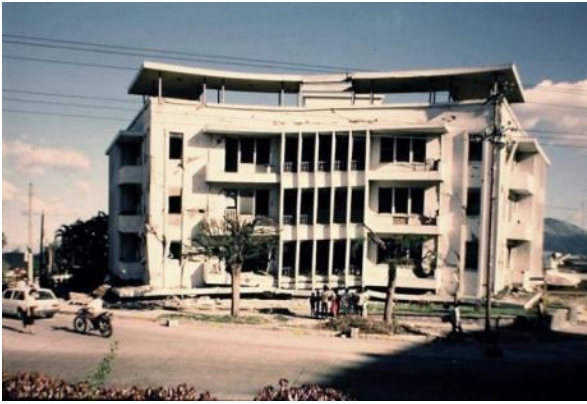
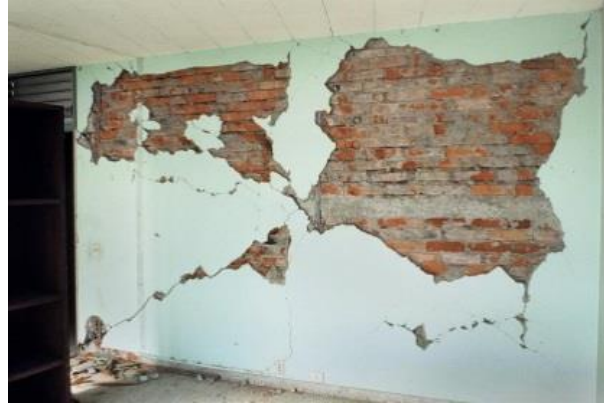
**Figure 46: Photos of a soft story collapse of an apartment building in El Salvador in the 1987 earthquake**

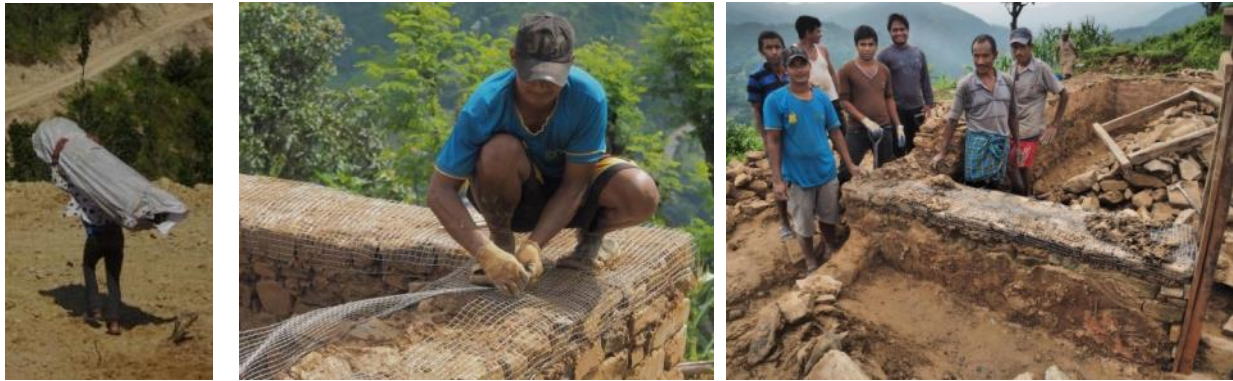
**Figure 51: A role of Polypropylene geogrid sufficient for a small house is this easily carried on one's back, making the Gabion Band technology practical for reconstruction of houses remote from the roads high in the Himalayan foothills**

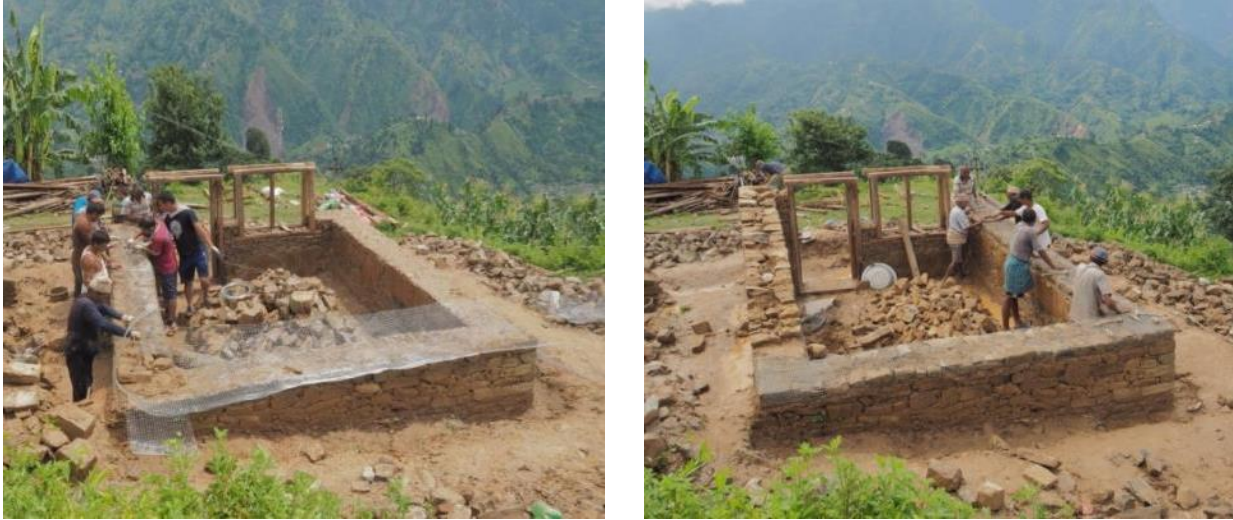
**Figure 53: Construction of the 1st Gabion Band house in Mankhu, Nepal showing the laying of the mesh and after it is wrapped around one course. (see also Figure 52)**

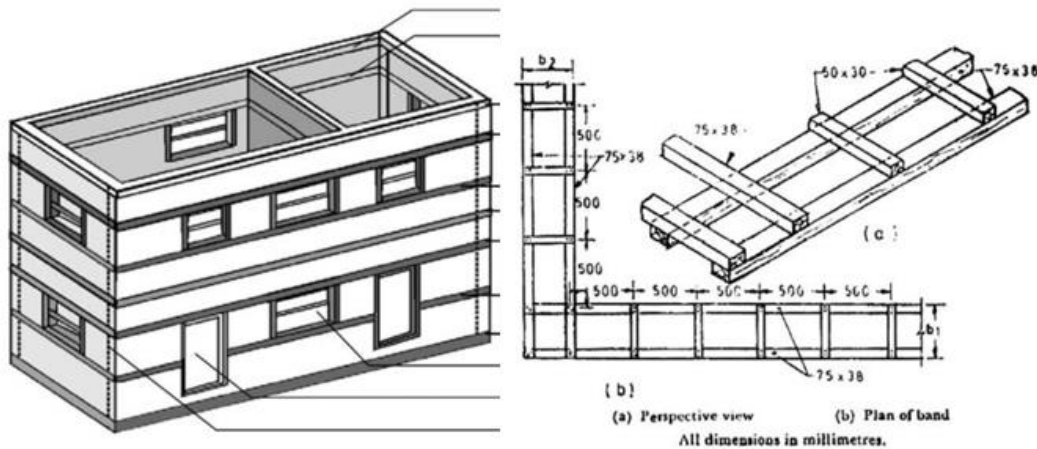
**Figure 54: Illustration of timber bands from the Indian and the Nepal Building Codes for non-engineered buildings**

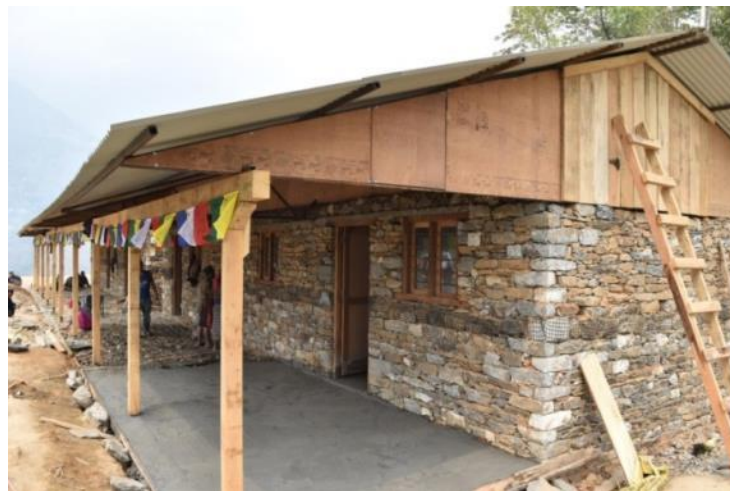
**Figure 55: After learning of my Gabion Bands technology when it was featured on the US Public TV science documentary NOVA about the earthquake, a former Peace Corps volunteer John Vavruska of Santa Fe, NM, with Nepali expats from the village of Chupar, Nepal constructed this school building**

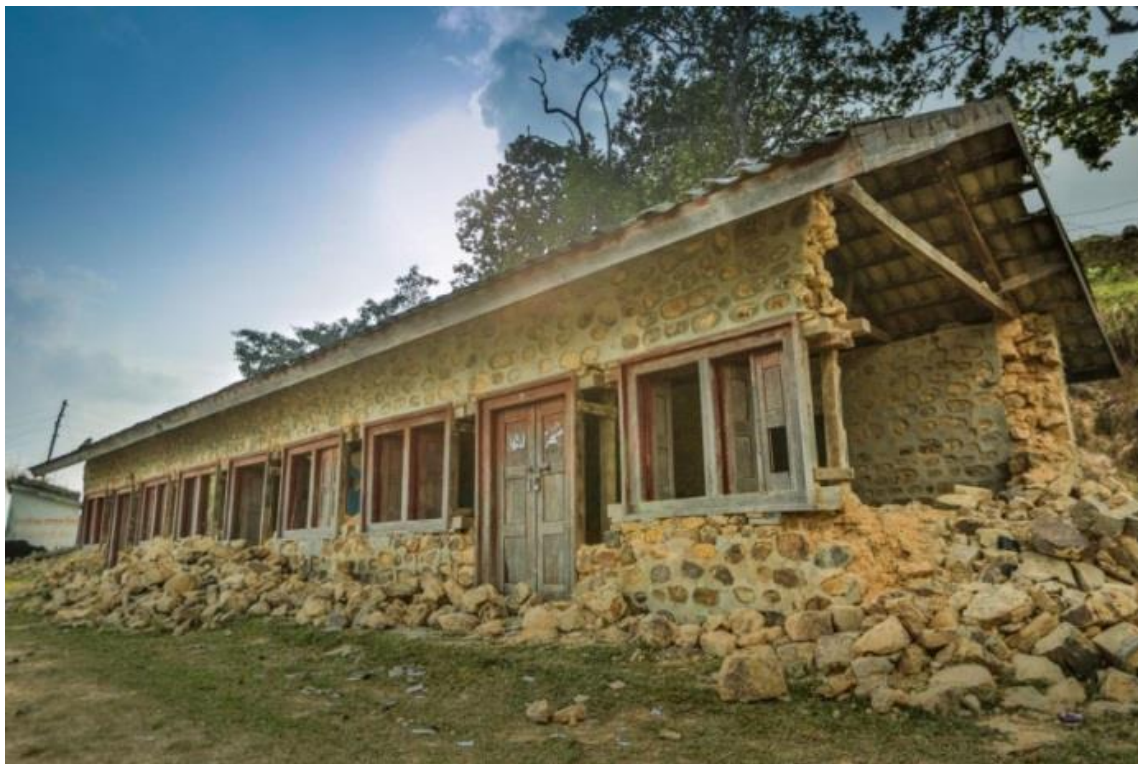
**Figure 57: School building with front and rear walls still standing with a ceramic tile roof. (photos courtesy Nepal School Projects NGO)**

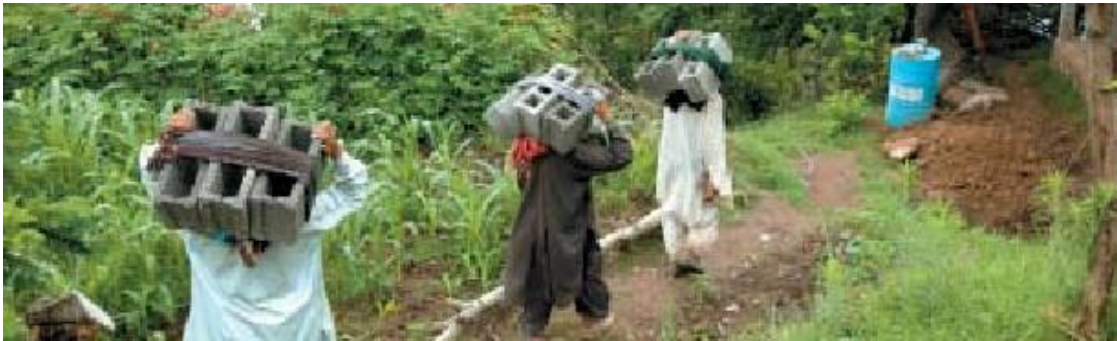
**Figure 58: Hand carrying of cement blocks to a reconstruction site remote from the road in Pakistan after the 2005 earthquake (Photo courtesy of ERR)**

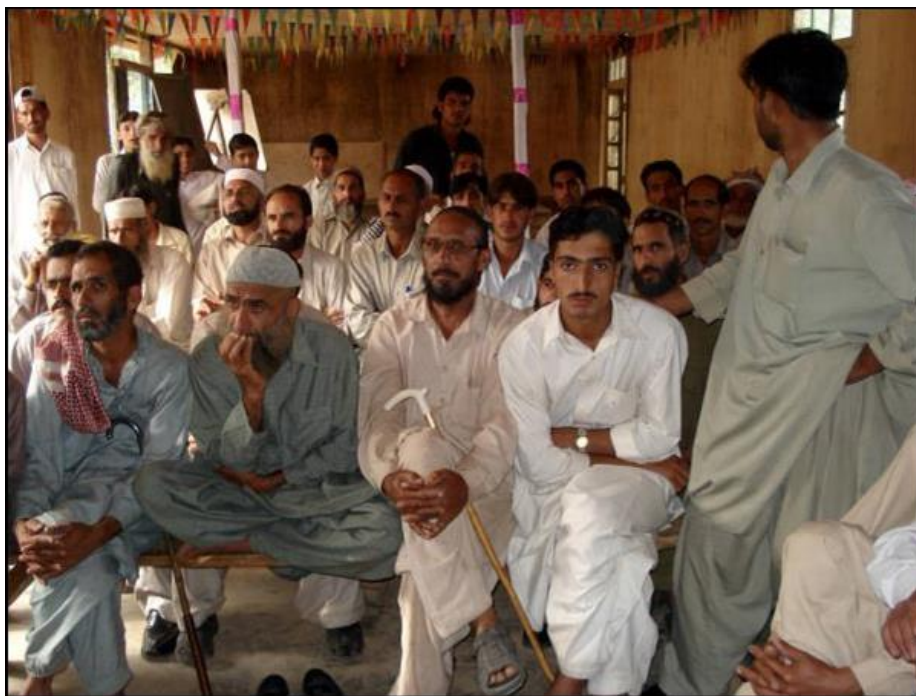
**Figure 59: Teaching improved anti-seismic masonry construction to rural masons in Pakistan by SDC and UN-HABITAT with support from ERR**

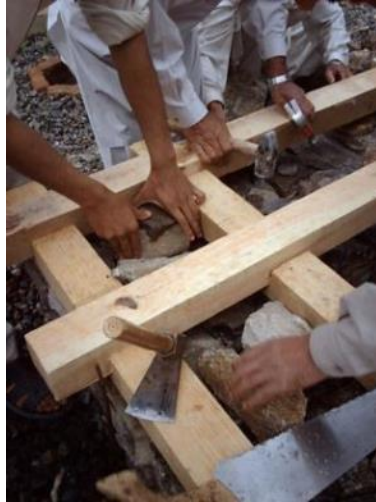
**Figure 60: Sample *bhatar* structure for masons training as described for Figure 59**

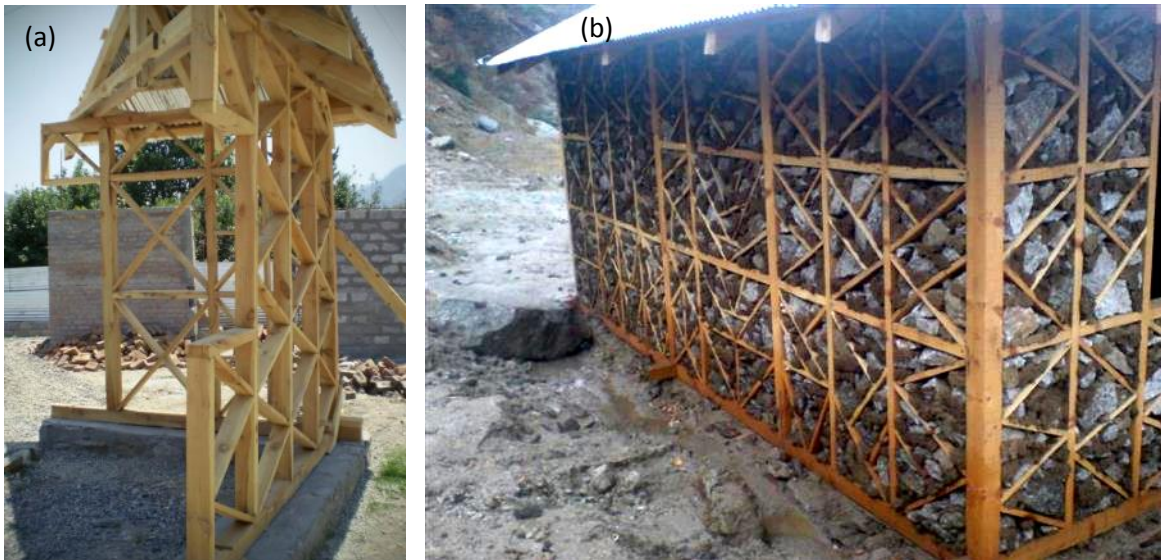
**Figure 61: Samples dhajji structure for masons training as described for Figure 59. As mentioned in the paper, I have recommended against the use of such rigidly inserted diagonals as seen in (a), in preference to those which are less likely to jack apart the corners as seen in (b) and also in the traditional construction shown in Figure 4 allows more lateral movement of the masonry infilled frame without breaking apart of the frame**
