A P T B U L L E T I N

Volume XXI

Bricks, Mortar, and Earthquakes, Historic Preservation vs. Earthquake Safety

Randolph Langenbach

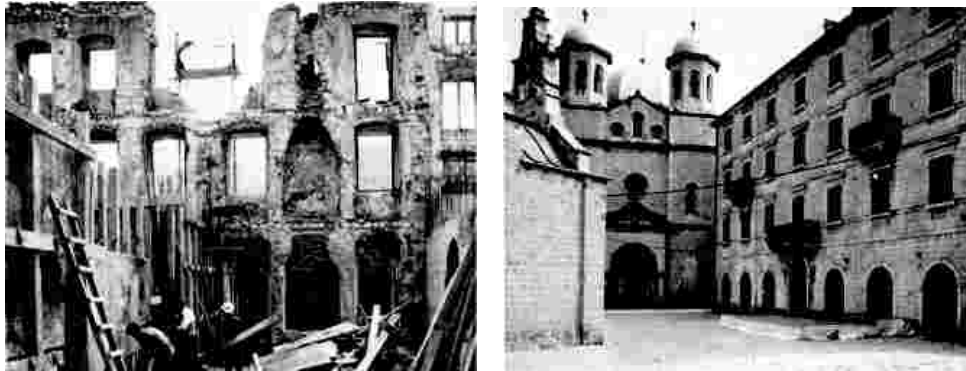
After the 1979 earthquake in Kotor Yugoslavia many buildings were completely gutted. Although the historic masonry was reattached the historic interiors have been completely destroyed

Gutting structures for seismic strengthening is not limited to the United States. For example after the 1979 earthquake in Montenegro, Yugoslavia, many structures in the

historic cities of Kotor and Budva have been reconstructed with reinforced concrete floors, replacing the original heavy timber. In some of these structures reinforced concrete columns have been cut into the masonry forming completely new reinforced concrete structures, with the historic masonry attached. In addition to the destruction of all of the historic interiors, another tragic consequence of this costly and time-consuming reconstruction is that all of the local residents have had to be resettled. Now, a decade after the earthquake, many buildings are still unprotected and rotting, awaiting reconstruction, and massive government investment is needed. In the end, these historic towns will never again be genuinely alive or real. Now they serve only as tourist attractions, with the shuffle of countless visitors replacing the evidence of generations of life and use.

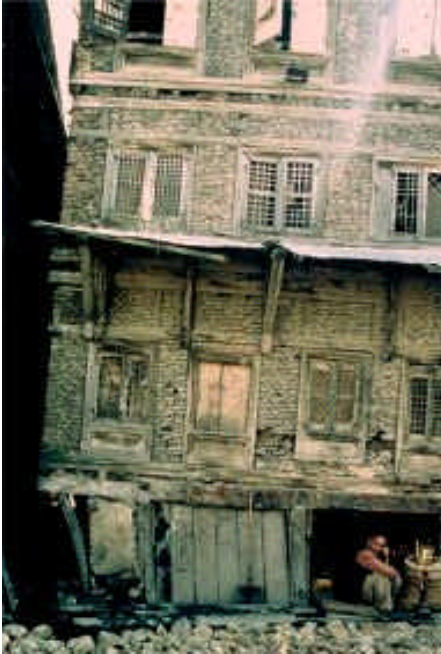
An eighteenth or early nineteenth-century canal warehouse in Srinagar illustrates the Taq system of construction. The alternating timber "runners" and brick infill create a "woven" appearance.

The timber beams used in buildings in the Taq system do not constitute complete frames. Instead, large timber "runners" rest along the load-bearing masonry walls, with the floor beams and the "runners" for the cross walls lapping over them. The wood serves to tie the walls of the structure together with the floors. The weight of the masonry serves to "prestress" the wall, contributing to its resistance to lateral forces.[xxi\[21\]](#)

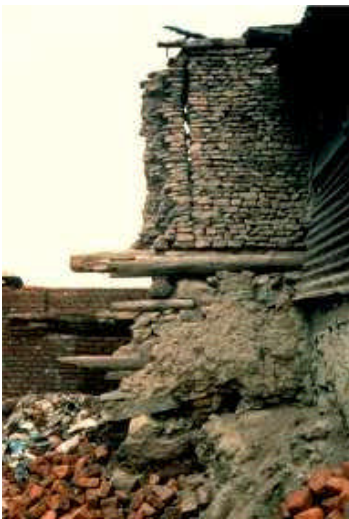
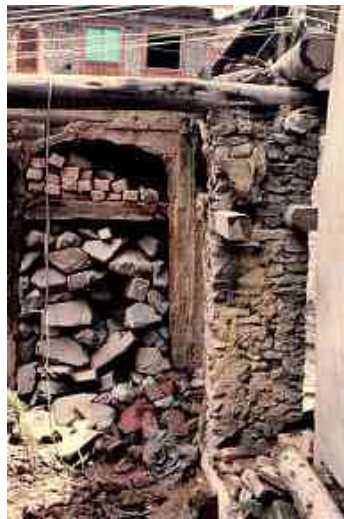
Srinagar House being demolished showing the *Taq* timber and masonry construction with timbers imbedded into the wall lengthwise and cross-wise.

The timber runners ... tie the short wall to the long wall and also bind the pier and the infill to some extent. Perhaps the greatest advantage gained from such runners is that they impart ductility to an otherwise very brittle structure. An increase in ductility augments the energy absorbing capacity of the structure, thereby increasing its chances of survival during the course of an earthquake shock. This was substantiated by the observation that dhajji-dewaris in which a larger volume of timber was used were comparatively safer.[xxiv](#)[24]

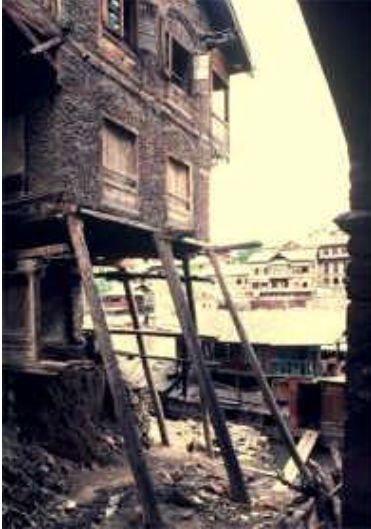
Also in Srinagar, this wood and brick house under repair shows the timber "runners" supporting the masonry. The masonry walls are light enough to be supported temporarily by the thin wooden piers.

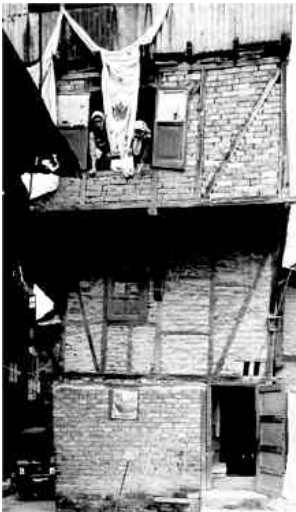
DHAJJI-DEWARI construction, shown here, differs from the TAQ system in that the beams form a complete braced timber frame.

The half-timber, brick-nogged type known locally as *Dhajji-Dewari* exists side by side with the Taq system in Kashmir. *Dhajji-Dewari* construction continues to provide an efficient and economical use of materials. The use of wood was kept to a minimum, but it still enabled the 1/2-brick-thick walls to resist out-of-plane collapse, while it restrained

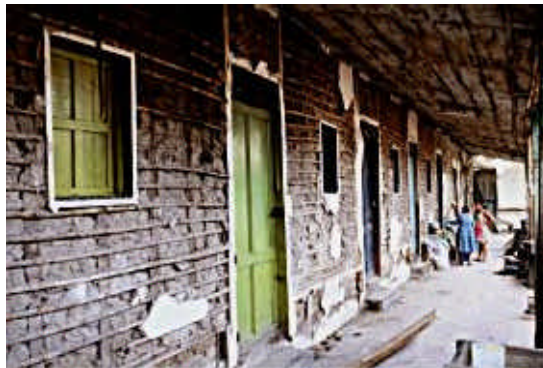
An example of BAHAREQUE construction, a native method in El Salvador, this building withstood the quake with little damage apart from plaster falling off the walls.

If we can explain the failures of this system by rotten wood, what can we learn from those buildings which did not suffer heavy damage? Looking more closely at the exterior plastered walls of those standing after the earthquake is revealing. In the 1931 earthquake in Managua, Freeman notes that practically all of the plaster was shaken off. In San Salvador in October 1986, there were many *Bahareque* buildings where the plaster had fallen off, but there was little or no evidence of damage in the structure of the walls themselves.

The dislodging of the plaster from practically the entire surface of the walls is evidence of the distribution of the earthquake stress throughout the wall, rather than its concentration in one localized area. The shedding of the plaster, therefore, draws attention to the fact that the earthquake stress is dissipated throughout the wall with small movement of the masonry and wood, so that no one major destructive crack occurs. The buildings which did survive showed that the walls were able to dissipate a significant amount of energy through the working of the material, rather than by rigid strength.

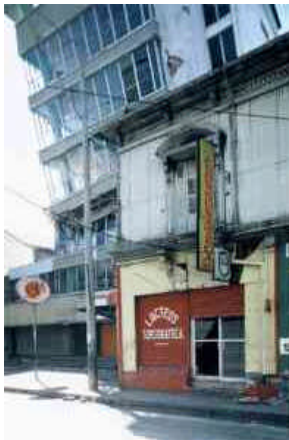
In contrast, witness the dramatic partial collapse of a reinforced concrete structure nearby in central San Salvador.

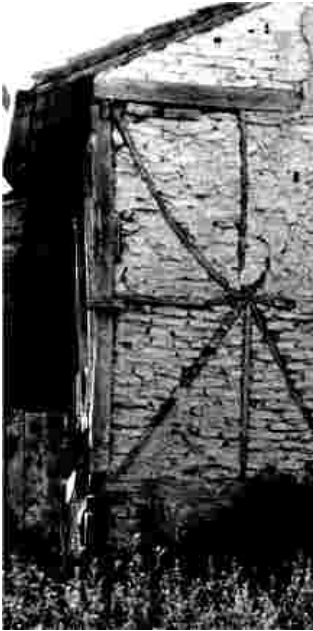
The brick-nogged construction shown here survived the great earthquake of 1963 in Skopje, Yugoslavia.

If the masonry infill with its equivalent diagonal strut is a danger to the modern reinforced concrete frame, why is it not more hazardous to the weak timber frames found in Kashmir, and Yugoslavia? The most plausible explanation is that the precompression stress provided by the load bearing weight of the wall, combined with the weak and non-brittle behavior of the mortar, enables the stresses to be spread throughout the wall rather than being concentrated along the diagonal. Instead of one large tension crack, with crushing failure at the corners, the softness and give of the mortar encourages a more wide-spread, small-scale cracking across the mortar joints of the whole panel. This also allows the building to dissipate energy, and thus perform in a ductile rather than a brittle manner.

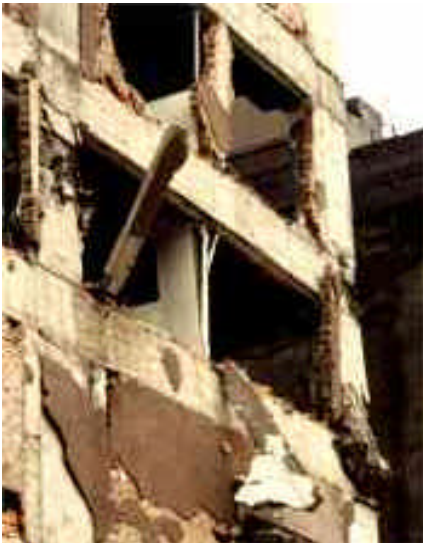
Victims of the 1985 Mexico City earthquake, the reinforced concrete columns on the right of this building have been damaged almost to the point of collapse by the "equivalent diagonal strut" effect of the infill masonry.

In engineering terms, research has shown that the behavior of these infill walls is often equivalent to that of a "diagonal compression strut."[xxxiii\[33\]](#) When the frame deflects, it bears upon the infill wall on its upper corner. The stresses in the wall become concentrated along a narrow zone diagonally across the face of the panel. As a result, until the wall collapses, all of the resisting pressure is delivered to the top of the column just below the intersection with the beam. This can be sufficient to cause the reinforced concrete column to fail in shear, again leading to the progressive collapse of the structure.[xxxiv\[34\]](#)

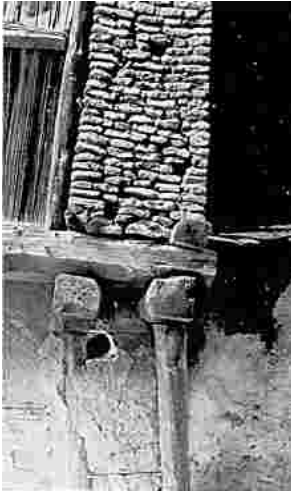
A typical masonry-wood connection in Kashmiri construction. These wood brackets are ubiquitous in both TAO and DHAJJI-DEWARI structures. The masonry simply rests on top of the wood beams.

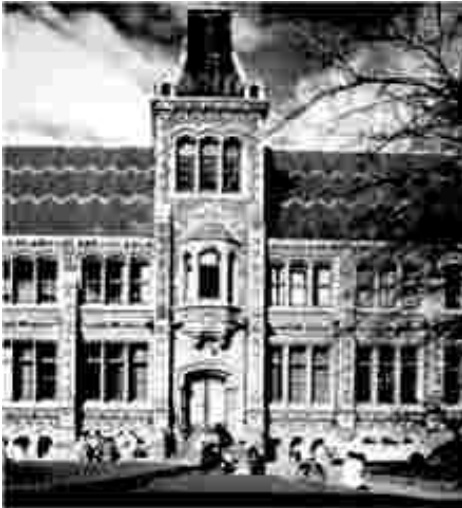
This building in New Zealand was strengthened by cables wrapped around the masonry structure. The cables function similarly to the runners in the TAO system.

At least in terms of historic conservation, there are examples which show promise of progress in this direction. In Greece, other parts of Europe, and even in New Zealand, some strengthening projects have been carried out using cables wrapped around the masonry structure. Utilizing the strengthening effect caused by tying the masonry together to create horizontal bands similar in their purpose to the timber runners of the Kashmiri Taq system, these buildings continue to bear their own weight on the existing masonry. [xxxix\[39\]](#)

Such systems have the advantage of causing little disruption to the historic masonry surface. The condition of the cables can be readily inspected, and they can be removed and replaced without damaging the historic masonry. What is radical about this and other surface mounted strengthening systems is the acceptance of visible changes to a
