Historical Earthquake-Resistant Timber Frames in the Mediterranean Area

Editors

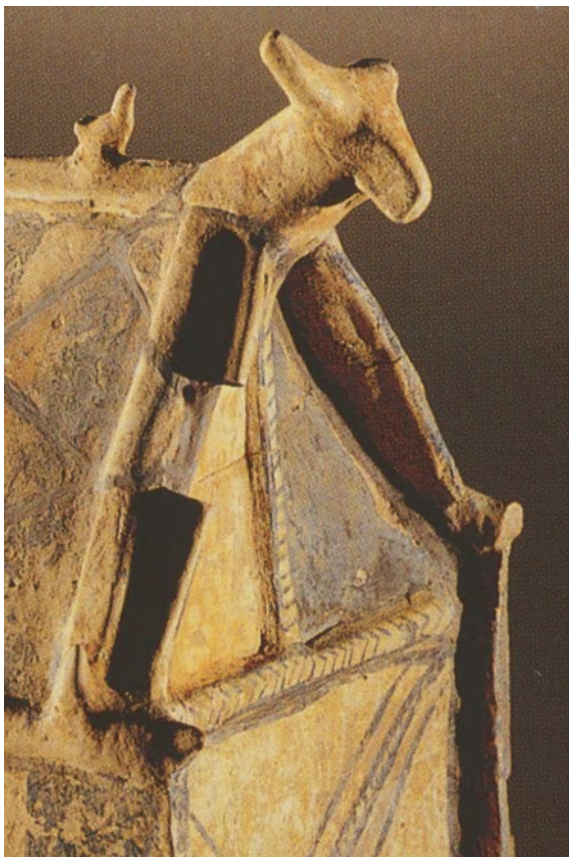
Fig. 1.6 Model “B”, joints detail. The presence of ropes entails the increasing of the junction stiffness (reproduced with permission of “Ministero dei Beni e delle Attività Culturali e del Turismo Direzione Regionale per i Beni Culturali e Paesaggistici della Basilicata”—“Soprintendenza per i Beni Archeologici della Basilicata”)

strictly indispensable to connect the two elements by means of a rope thanks to the contrast performed by the frame constituted by post and transversal timber. Any clear data characterizes the foot of the king post representation, the latter seems simply bearing on the tie-beam. The joints, relatively to the ridge beam-rafter-kingspost-rafter and the tie beam to kingpost connections are, in a way, preserved from biotic decay with a correct aeration and contemporaneously with a rain water protection. On the contrary, the tie beam-rafter-purlin joint continues outward, beyond the crossing members, and consequently it is exposed to the inclemency of the weather. This arrangement generates favourable conditions for a biotic attacks, mycotic and entomatic, that can easily spread also to the internal surface and therefore interesting the whole junction in a short time (Fig. 1.6).

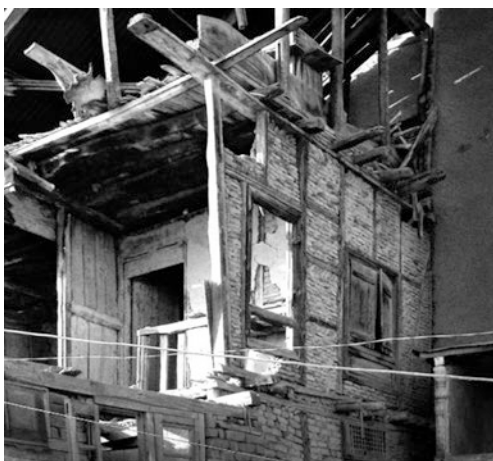
Fig. 3.4 A partially demolished *dhajji dewari* building showing timber frame with typical single layer of infill masonry construction. Photograph by © Randolph Langenbach

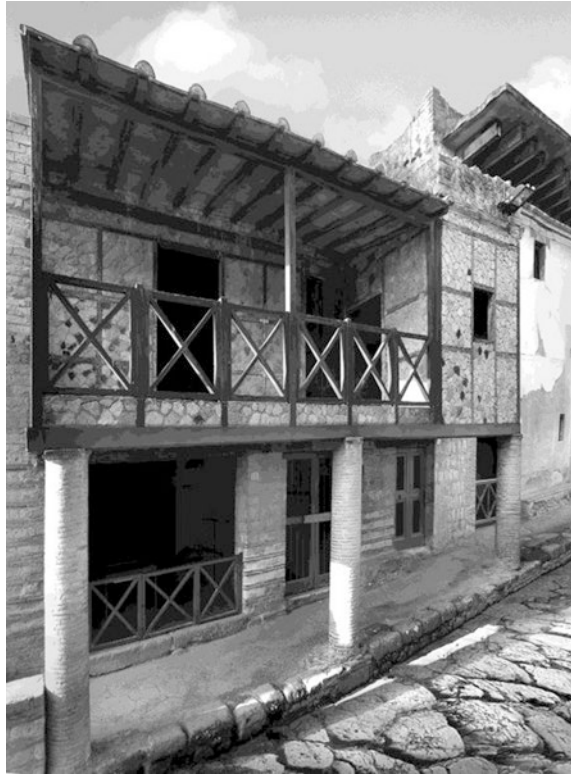
Fig. 3.5 A building in the ancient Roman town of Herculaneum uncovered after having been buried in the eruption of Vesuvius showing an example of timber frame with masonry infill that is thought to have been called *Opus Craticium*. Photograph by © Randolph Langenbach

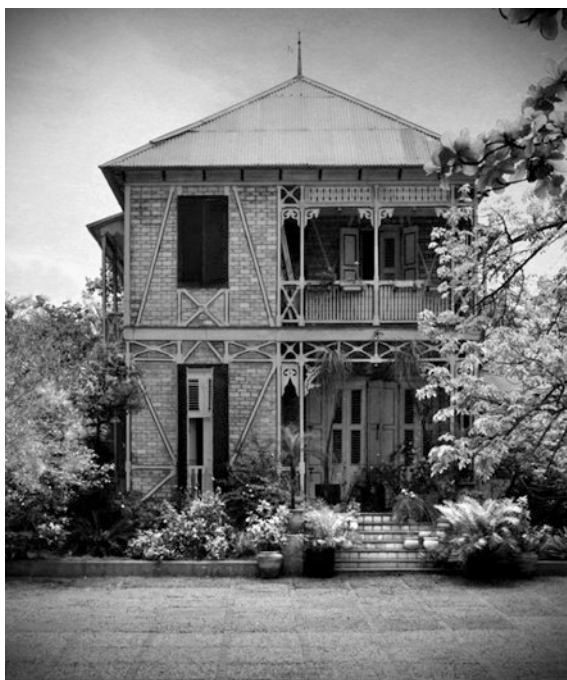
Fig. 3.6 A single family middle class house of colombage timber frame with single layer infill masonry construction near downtown Port-au-Prince photographed after the 2010 earthquake. This house was in the heart of the damage district with collapsed reinforced concrete buildings nearby. Photograph by © Randolph Langenbach

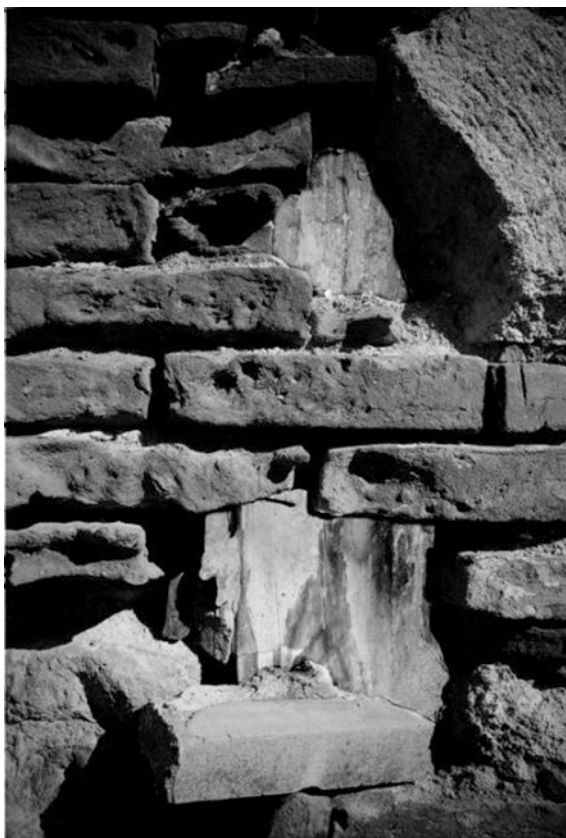
Fig. 3.8 A vertical column of the timber frame in the building in Fig. 3.7 showing through holes in the brickwork. Photograph by © Randolph Langenbach

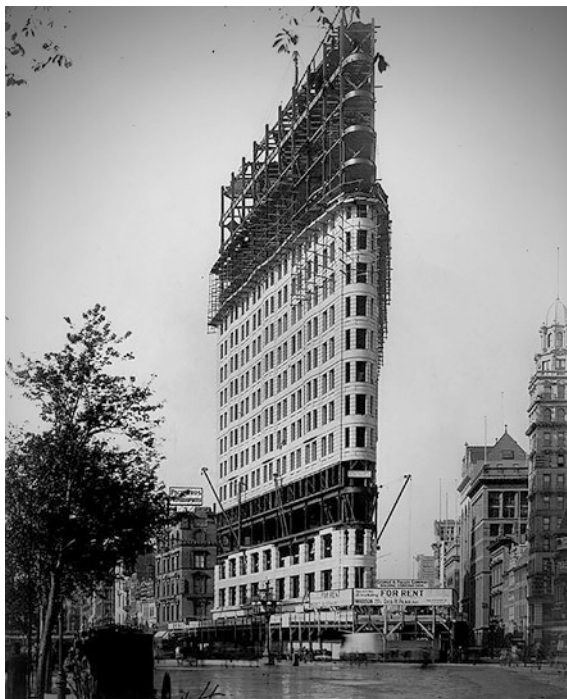
Fig. 3.12 Flatiron Building in New York City under construction in 1902 showing the heavy stone masonry façade resting on the steel frame. The upper walls were constructed separately probably to ensure the weight is bearing on the frame rather than the lower masonry walls. U.S. Library of Congress Photograph

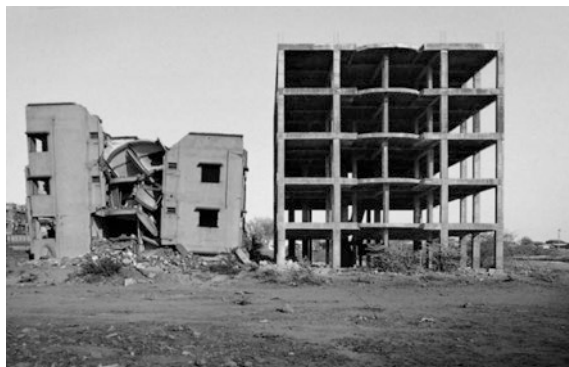
Fig. 3.16 Two RC frame buildings in Bhuj, India after the 2001 Gujarat earthquake. The building on the left had been completed, while the frame only of an identical building had been completed on the right. The earthquake collapsed the one where the frame was restrained by the masonry infill walls, while the bare frame survived. Photograph by © Randolph Langenbach

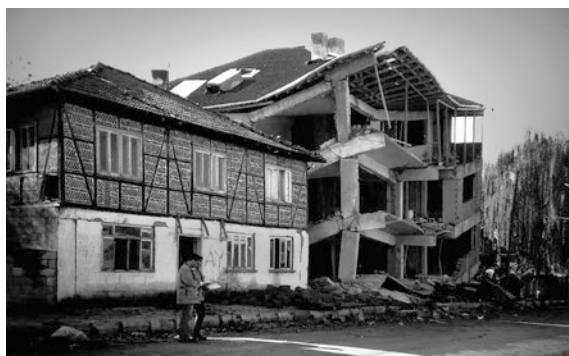
Fig. 3.17 A collapsed RC building next to a surviving *hıms* building in Turkey after the 1999 earthquakes showing the resilience of the timber frame with masonry infill compared to that of a new RC frame building of modest height next door. It is interesting to compare this view with Fig. 3.16, where the infill probably caused the collapse, while here the infill and timber frame worked well together. Photograph courtesy of Adem Doğangün

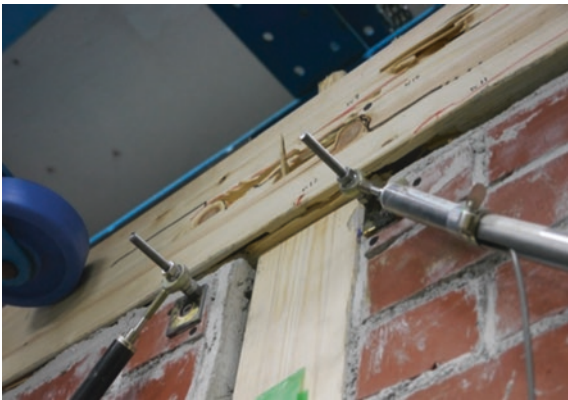
Fig. 6.18 Damage of the *right* column, which failed in shear (*back side*)

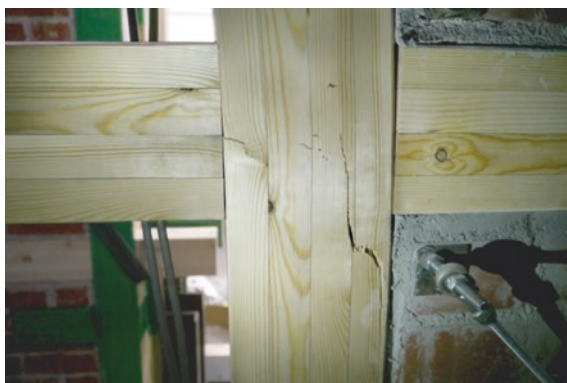
Fig. 6.19 Damages in the *middle* joint

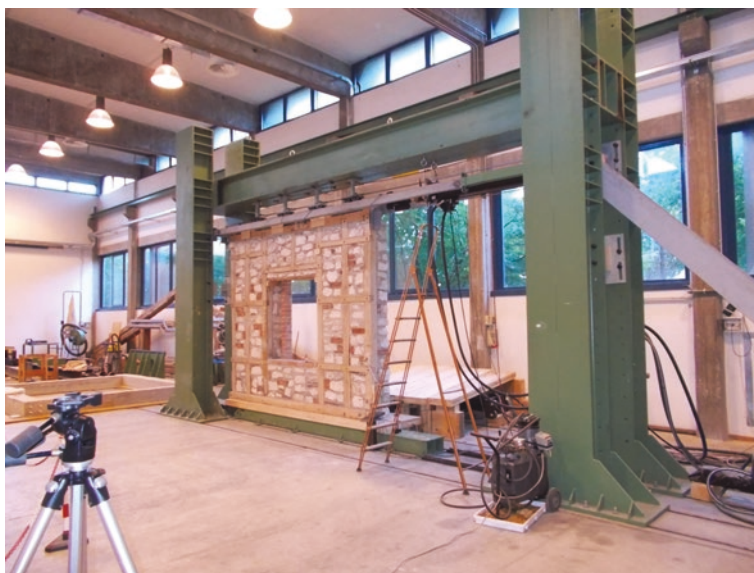
Fig. 8.1 The specimen under cyclic loading in the CNR-Ivalsa laboratory

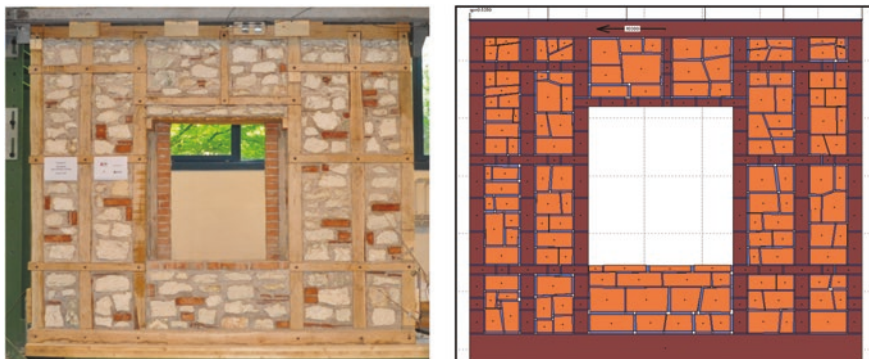
Fig. 8.6 Mechanical modelling of the masonry wall built according to the Borbone constructive system

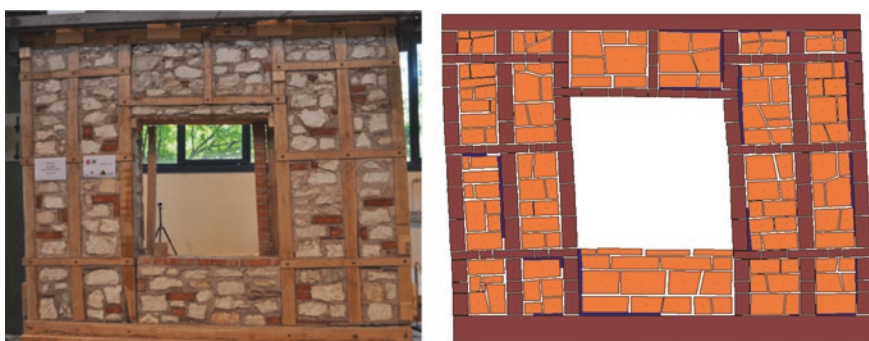
Fig. 8.7 Ultimate deformed shape and cracking pattern. Comparison between experimental test and numerical model

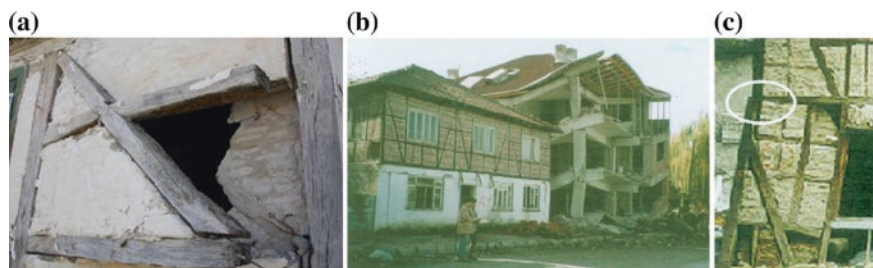
Fig. 10.3 Examples of damages in timber frame buildings, **a** out-of-plane collapse of masonry infill (Lefkada, Greece) [6], **b** comparison of damages to traditional and modern building after the 1999 Duzce earthquake, **c** failure of connection in timber frame (1999) Kocaeli earthquake [14]

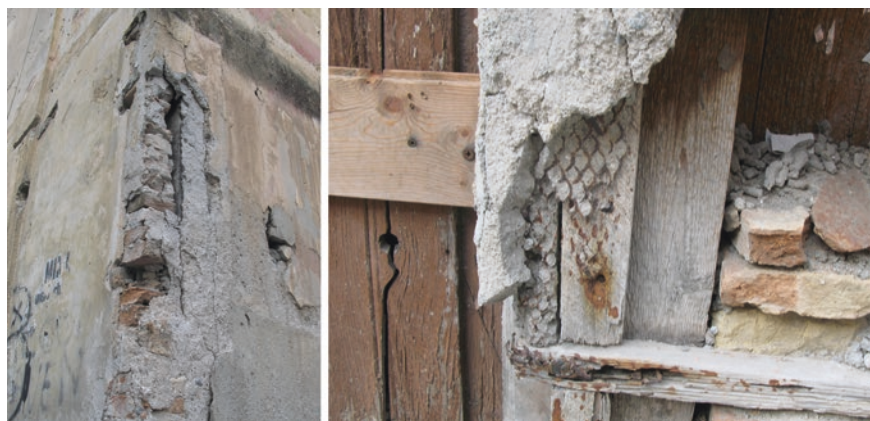
Fig. 13.17 Deterioration of the brickwork
