### From "Opus Craticium" to the "Chicago Frame": Earthquake-Resistant Traditional Construction

## FROM “OPUS CRATICIUM” TO THE “CHICAGO FRAME”: EARTHQUAKE-RESISTANT TRADITIONAL CONSTRUCTION

**Randolph Langenbach**

*Conservationtech Consulting, USA*

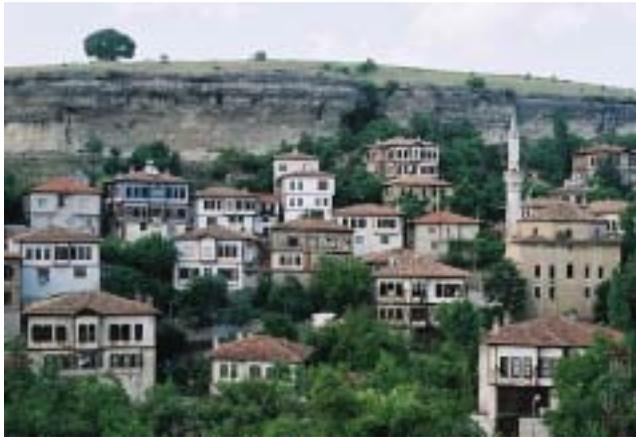
**Figure 1.** Characteristic timber-laced masonry traditional houses in Safranbolu, Turkey, 2004. © Randolph Langenbach, 2007.

The Turkish Ottoman-style house, with its tiled roof and overhanging timber-and-brick bays above a heavy stone ground floor wall, has become an icon known worldwide (Figures 1, 2, and 11). The jetties provided more than extra space and light; they strengthen the buildings because the joists that cantilever over the walls below hold those lower-story walls firmly in place with the help of the weight of the infill masonry overhanging upper story. This upper story is almost always of *humuş* construction. This construction utilizes a weak mortar of mud or lime holding a single wythe of masonry into a timber framework of studs and horizontal dividers rarely more than 60 cm (25 inches) apart. Because the masonry is only one wythe in thickness, the walls are light enough to be supported on the cantilevered timbers.

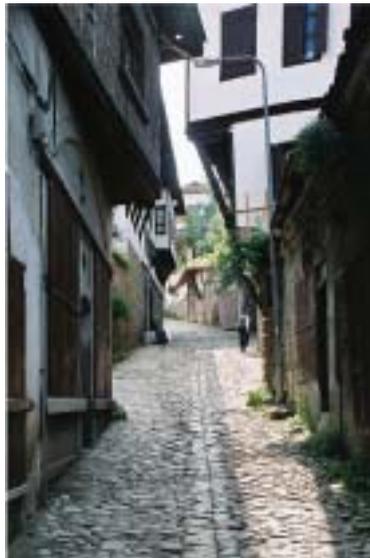
**Figure 2.** Upper-story jetties of *humuş* construction in Safranbolu, Turkey, 2000. © Randolph Langenbach, 2007.

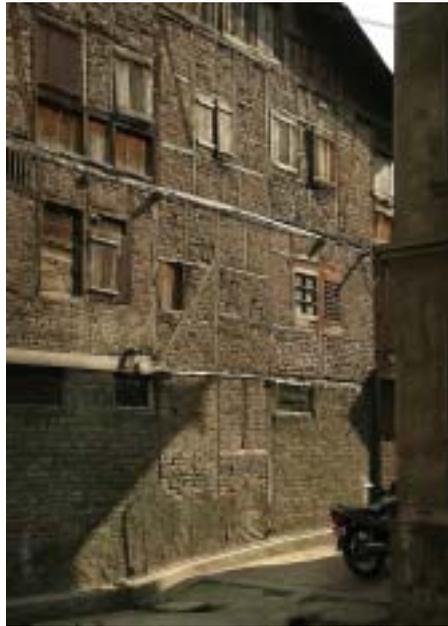
**Figure 5.** *Dhajji-dewari* construction, Srinagar, Kashmir, India, 2005. © Randolph Langenbach, 2007.

Arriving in the City of Srinagar, India, in 1981 was like being catapulted back in time — not a century, but half a millennium. When seen in 1981, Srinagar had, for the most part escaped the rampant modernization that had erased similarly unprotected historic city centers in other parts of the world (Figures 3 and 4). Most of the traditional buildings in Srinagar can be divided into two basic systems of construction. The first system, sometimes referred to as *taq*, consists of load bearing masonry piers and infill walls, with wood "runners" at each floor level used to tie the walls together with the floors, all of which is locked together by the weight of the masonry (Figure 4). The second system, known as *dhajji-dewari*, consists of a braced timber frame with masonry infill. With its thin, one-wythe thick walls, it provides an efficient and economical use of materials, which helps to account for its use even for new construction until about two decades ago (Figure 5) (Langenbach, 1989).

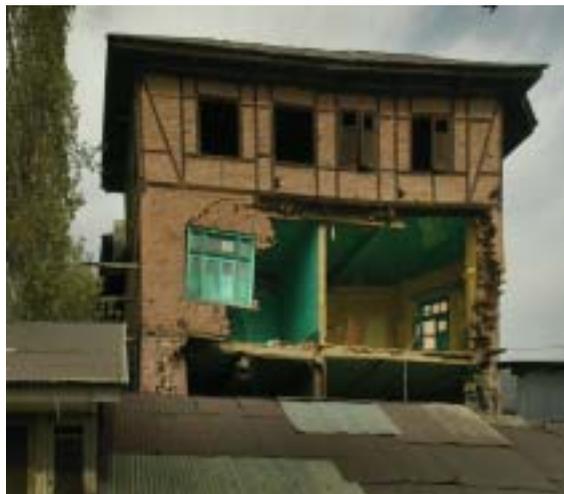
**Figure 6.** House in Baramula, Kashmir, Pakistan, damaged in 2005 earthquake showing how unreinforced masonry collapsed, leaving the top story of *dhajji-dewari* in place. © Randolph Langenbach, 2007.

On October 8, 2005, an earthquake devastated the mountainous area of the Pakistan section of Kashmir, killing more than 80,000 and rendering most of the remaining people homeless. On the Indian side of the border the damage was much less, but another difference was noticeable — the traditional construction as described previously was rarely to be found in the worst affected urban areas on the Pakistan side of the border, where the massive death toll occurred. On the Indian side, however, a number of examples of traditional construction were found in the damage district. The performance of this timber-laced traditional construction confirmed earlier findings (Figure 6). Professors Durgesh Rai and C.V.R. Murty reported:

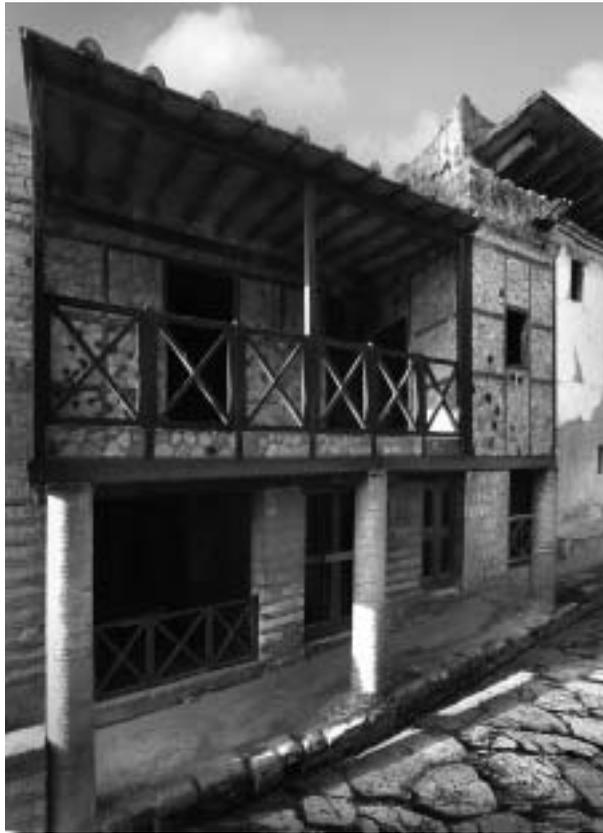
**Figure 7.** House of the *Opus Craticium*, Herculaneum, Italy, 2002. © Randolph Langenbach, 2007.

When archeologists dug up the port town of Herculaneum, Italy that had been buried in a hot pyroclastic flow from Mount Vesuvius in 79 AD, they found an entire two story *half-timber* house which they identified as one of the masonry construction typologies described by Vitruvius as *Craticii* or *Opus Craticium* (Figure 7). This example in Herculaneum may provide the only surviving example of the form of construction that had been used in ancient Rome for the *insulae* — the term for the seven- or eight-story tenements that filled that city of 1.5 million people. Masonry bearing walls would have been too thick at the base to fit on the known footprints of these ancient buildings with space for rooms left over, so it is likely that the Romans constructed many of these tall buildings with timber frames and infill masonry.

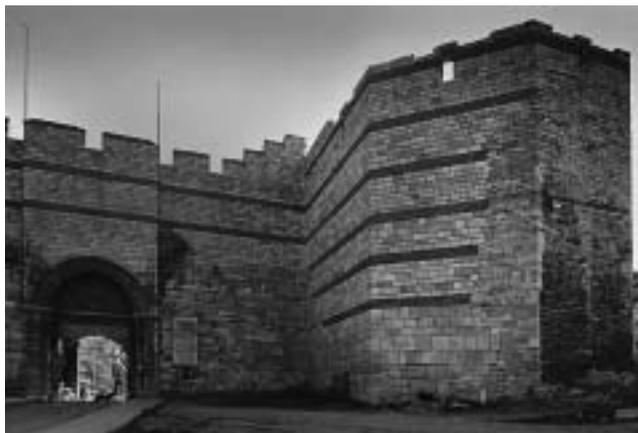
**Figure 9.** City wall showing modern “restoration” with stripes of red brick attached as a veneer, demonstrating the artificial look that results when the work is conceived without its original structural rationale. © Randolph Langenbach, 2007.

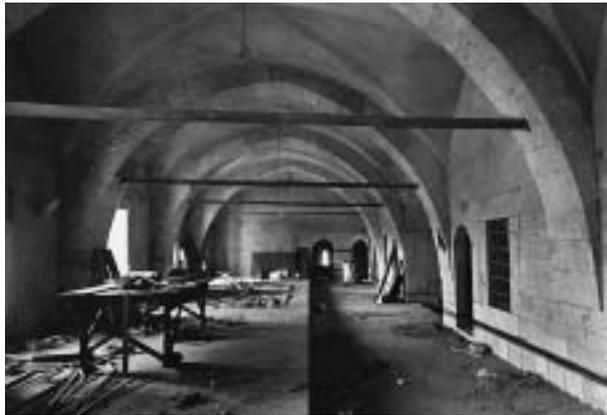
**Figure 10.** Caravansary, Safranbolu, Turkey, showing timber *hatil* in bearing wall masonry, which is the black line visible on right at base of wall, 2000. © Randolph Langenbach, 2007.

interrupting the continuity of the masonry construction. In addition to the lower floor of houses, some of the more prestigious monuments were made of dressed stone construction with *hatillar* throughout, as in the caravansary of Safranbolu, Turkey (Figure 10).

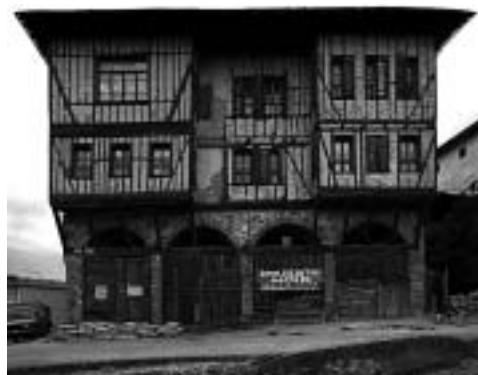
**Figure 11.** House over shops in Safranbolu Turkey, showing *humuş* construction of upper stories, 2004. © Randolph Langenbach, 2007.

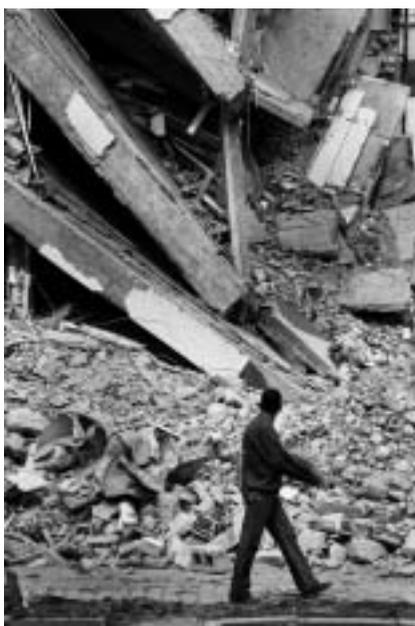
**Figure 12.** Collapsed reinforced concrete infill-frame in Gölcük, Turkey, after 1999 Kocaeli earthquake. © Randolph Langenbach, 2007.

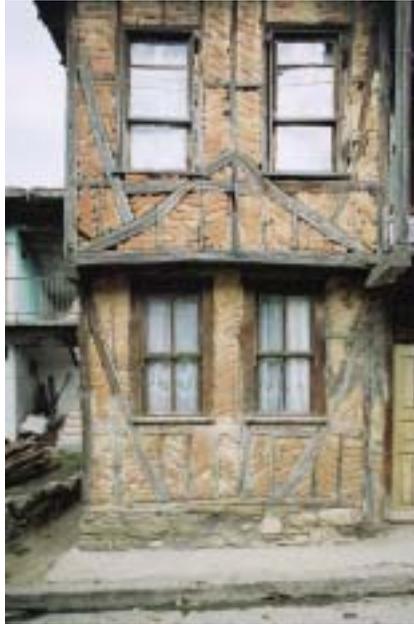
**Figure 13.** House, circa 1940 of *hums* construction in heart of damage district of Gölcük, Turkey, after the 1999 Kocaeli earthquake with no visible damage. © Randolph Langenbach, 2007.

century. The Kocaeli earthquake of August 17, 1999, killed approximately 30,000 people (Kandilli Earthquake Research Institute, 2000). The epicenter was only about 100 kilometers east of Istanbul. In some areas of Gölcük and Adapazari, the earthquake destroyed more than one third of all housing units, almost all of them in reinforced concrete buildings (Figure 12) (Kandilli Earthquake Research Institute, 2000) While the laced bearing wall type was rare, there were clusters of *humuş* buildings in the heart of these districts. The houses were constructed of *humuş* from the ground up. These houses, mostly dating from the early part of the twentieth century, pre-dated the ruined reinforced-concrete apartment blocks nearby. Many of the older *humuş* houses remained intact, with only a few that were heavily damaged (Figures 13–16).

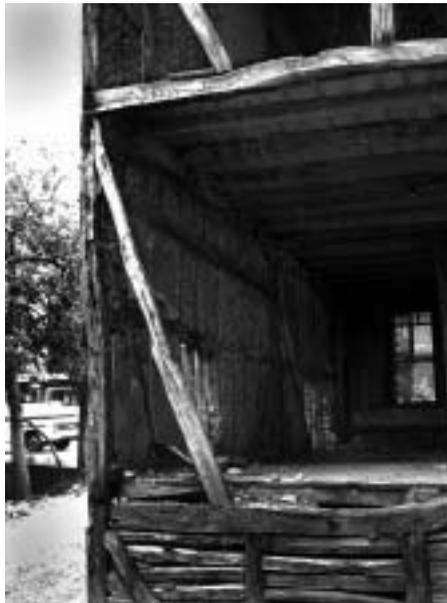
**Figure 14.** An abandoned early twentieth-century house, Gölcük, Turkey, showing the thin walls and light framing characteristic of *hums* construction. The damage here was not caused by the earthquake. Instead, the house, even in its partially dismantled state, survived the earthquake with little additional damage. © Randolph Langenbach, 2007.

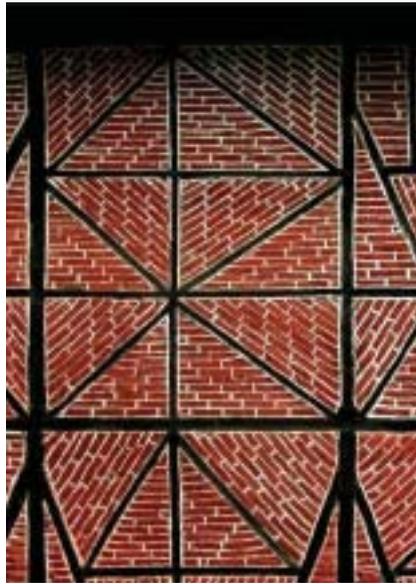
**Figure 15.** Detail of exterior wall of early twentieth-century *humuş* construction near Düzce, Turkey. Sometimes the brick infill is deliberately arranged into decorative patterns. © Randolph Langenbach, 2007.

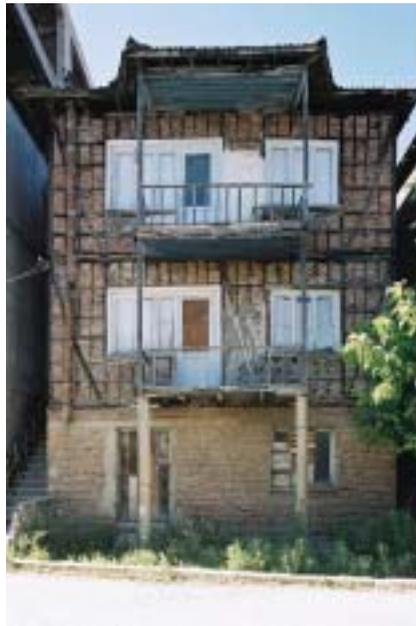
**Figure 16.** Three-story mid-twentieth-century *humuş* house in heart of the Gölçük, Turkey, damage district less than 0.5km from the fault trace. Whereas the unfinished reinforced concrete building to the left survived, several other occupied buildings in adjacent blocks collapsed. © Randolph Langenbach, 2007.

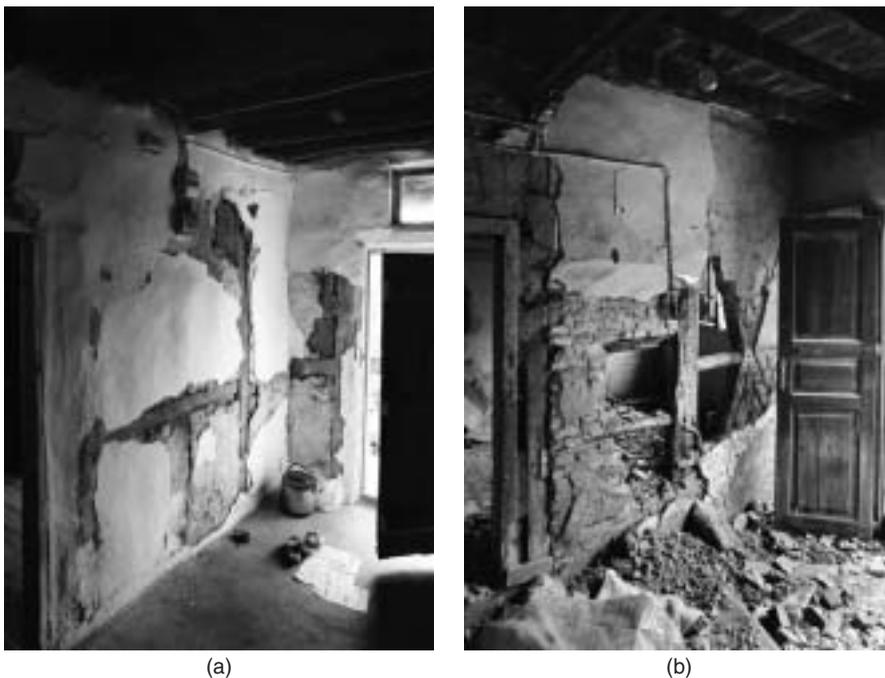
**Figure 17.** (a) Interior of *huniş* house in Orta, Turkey, after 2000 earthquake showing plaster shedding from working of the frame. (b) Interior of *huniş* house in heart of damage district in Adapazari, Turkey, after 1999 earthquake, showing how heavy masonry damage did not jeopardize its stability. This particular house was abandoned and in a more advanced state of decay than the house in Orta, Turkey, and the shaking from the 1999 earthquake in Adapazari was far greater. Most well-maintained *huniş* houses had even less wall damage from the 1999 earthquakes. © Randolph Langenbach, 2007.

A smaller earthquake (M 6.1) that struck the rural town of Orta, Turkey, on June 6, 2000, provided an interesting comparison with the damage caused by the Kocaeli and Düzce earthquakes the previous year. In this smaller earthquake, the damage to the *huniş* structures was similar to those affected in the larger earthquakes, whereas the damage to reinforced concrete (RC) structures was much less. This finding may explain why in Turkey there is a false, but widespread, perception that RC buildings are safer. A comparison of the RC buildings affected by this earthquake with those in the 1999 earthquakes has revealed that the common RC buildings in Turkey have very little reserve capacity. They go very quickly from exhibiting little damage, as seen after the Orta earthquake, to collapse, as shown by the 1999 events. What appeared as small cracks at the beam/column intersections in Orta was evidence of the leading edge of what in the larger earthquake proved to be a rapid degradation to collapse. This observation contrasts with the performance of the traditional *huniş* buildings shaken by the same earthquakes. Even though the onset of damage is at low levels of shaking, the small difference in the damage caused by the smaller and larger earthquakes demonstrates their ability to absorb the much increased shaking with little increase in damage (Figures 17a and 17b).

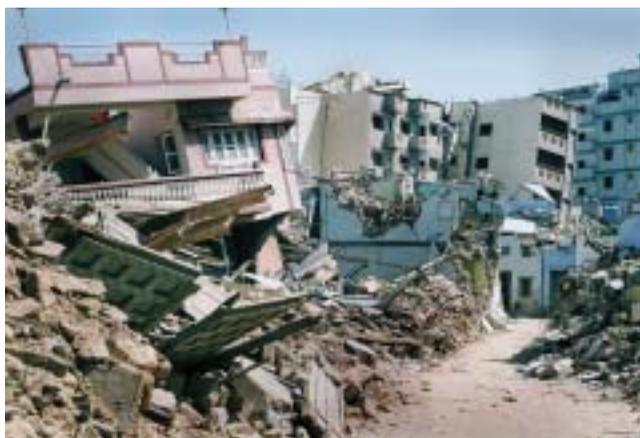
**Figure 18.** Bhuj, India, after the 2001 earthquake showing widespread collapse of both reinforced concrete and unreinforced masonry buildings. © Randolph Langenbach, 2007.

After a devastating earthquake struck western Gujarat, India, on Republic Day, January 26, 2001, the scene of devastation was as appalling as that after the Turkish earthquakes in 1999. Whole towns were completely leveled. In Bhuj, Anjar, and Bachau, the building stock was divided almost equally between older stone masonry buildings and reinforced concrete structures. Many older masonry buildings were surmounted with upper floors of RC construction, which proved to be an unsafe combination. The masonry consisted mainly of rubble stone laid in mud or weak lime-mud mortar. The newer construction was of reinforced concrete with infill masonry walls. There was no evidence of RC shearwall construction (Figures 18 and 19).

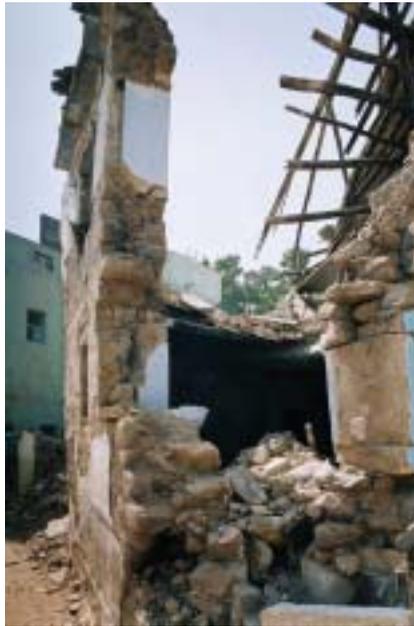
**Figure 19.** Collapsed masonry building, in Bhuj, India, after the 2001 earthquake, showing top-heavy thick walls lacking timber lacing and with shallow joist pockets. © Randolph Langenbach, 2007.

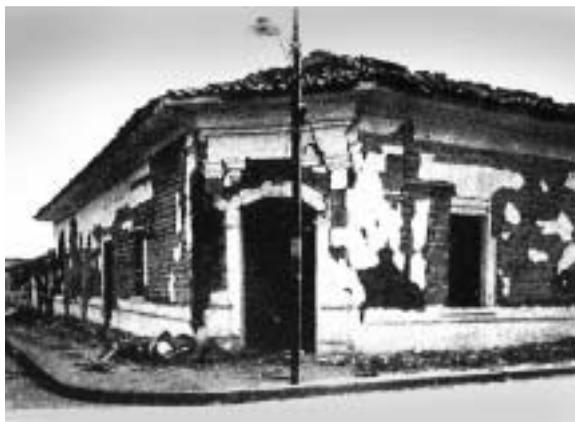
**Figure 23.** Photograph by American engineer J.R. Freeman of *Taquezal* building in Managua, Nicaragua, after 1931 earthquake used to illustrate his observation that damage to the building was limited the shedding of exterior plaster. © Randolph Langenbach, 2007.

In 1931, Freeman observed that “the only serious damage was the shaking off of . . . practically all of the plaster” (Freeman, 1932) (Figure 23). Likewise, in San

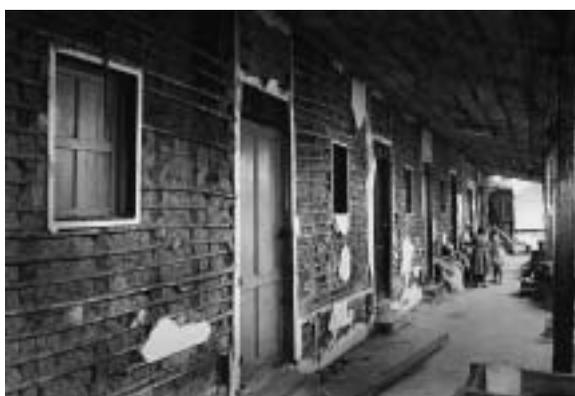
**Figure 24.** *Bahareque* building in San Salvador, El Salvador, after 1986 earthquake showing a similar shedding of plaster from otherwise undamaged walls. © Randolph Langenbach, 2007.

Salvador in 1986 there were many *Bahareque* buildings on which the plaster had fallen off with no evidence of damage to the underlying walls (Figure 24). The dislodging of the plaster from nearly the entire surface of the walls is evidence of the distribution of the earthquake stress throughout the wall, which is indicative of good behavior. It draws attention to the fact that the earthquake stress is dissipated throughout the wall with small movements between the masonry and wood of what is inherently a flexible structure. As a result, there is no single major destructive crack, and the energy of the earthquake is dissipated by the friction from the microcracking of the substrate that is confined between the studs.

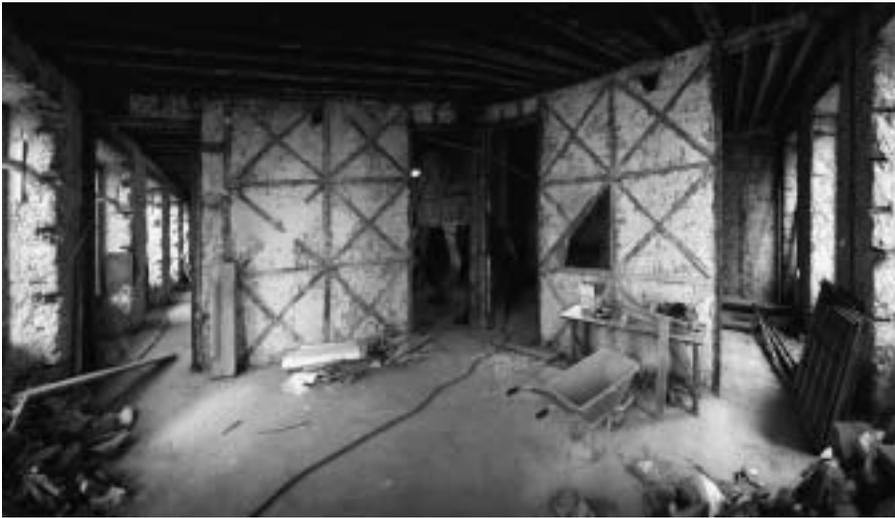
**Figure 25.** Interior of eighteenth-century building in central Lisbon, Portugal, showing *Pombalino gaiola* construction, 2003. © Randolph Langenbach, 2007.

central area, Chief Minister Sebastiao Jose de Carvalho e Melo (who later became the Marquis of Pombal), gathered a group of military engineers led by Manuel da Maia to determine the best manner of earthquake-resistant construction to use for the rebuilding. For this, they developed the *gaiola* (“cage”), which has become known as *Pombalino construction*. The *gaiola* essentially is a well-braced form of half-timber construction. After testing a prototype, they made its incorporation into the reconstructed buildings a requirement (Penn, et al, 1995). Many of the new buildings with the *gaiola* were five and six stories in height, and most of these remain standing today, 225 years later (Figure 25).

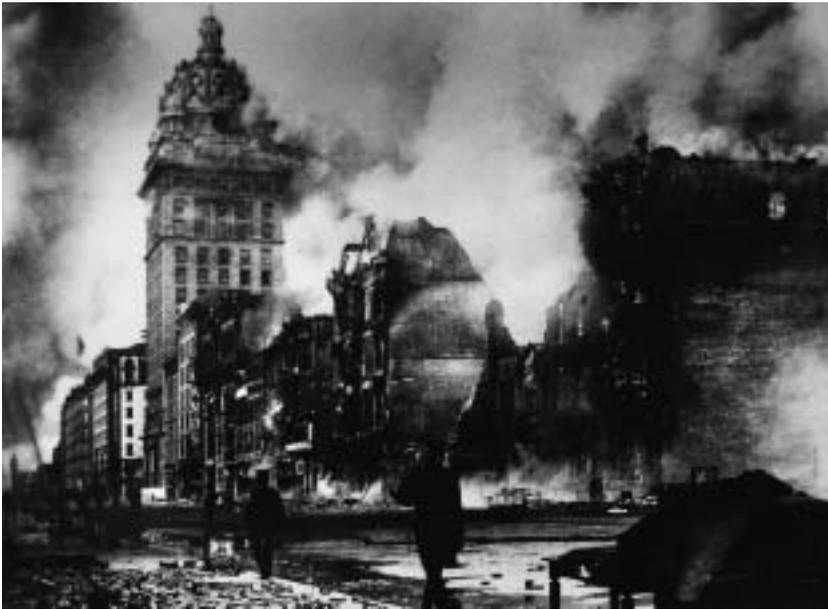
**Figure 27.** Market Street, San Francisco, United States, during the post-earthquake fire of 1906, showing how even the new skyscraper of fireproof construction, the Hearst Building, caught fire from the wood windows and interior finishes (Photograph courtesy of Bancroft Library, University of California, Berkeley, Berkeley CA). In 2006, this building remains extant in a remodeled state.

Like the 1755 Lisbon earthquake, the 1906 San Francisco (United States) earthquake triggered fires that destroyed the entire central business district and many of the surrounding residential areas (Figure 27). Ironically, the fire burned the brick, steel, and concrete parts of the city, leaving intact the buildings in many other areas that were built entirely of wood. The early steel skeleton frame skyscrapers that burned were constructed within two decades after the first skeleton frame office buildings in Chicago (United States), to which the term *skyscraper* was first applied. The walls of these first skyscrapers were of brick masonry — masonry that infilled the frame which in turn carried the weight to the ground. It is the masonry infill that places these

Since even today a “design level” earthquake is expected to cause structural damage, it is remarkable that there was such a low level of earthquake damage found in the San Francisco skeleton frame buildings after the 1906 earthquake. This finding is especially important because that earthquake clearly met or exceeded a design-level event. The lack of serious earthquake damage is demonstrated by the simple fact that a large percentage of these buildings were restored to use not only after the earthquake, but even after the fire which caused far more substantial damage than did the earthquake shaking. Many prominent landmark structures have also survived redevelopment pressures to remain in existence to this day, having recently marked the hundredth anniversary of the 1906 earthquake (Figures 27–29).

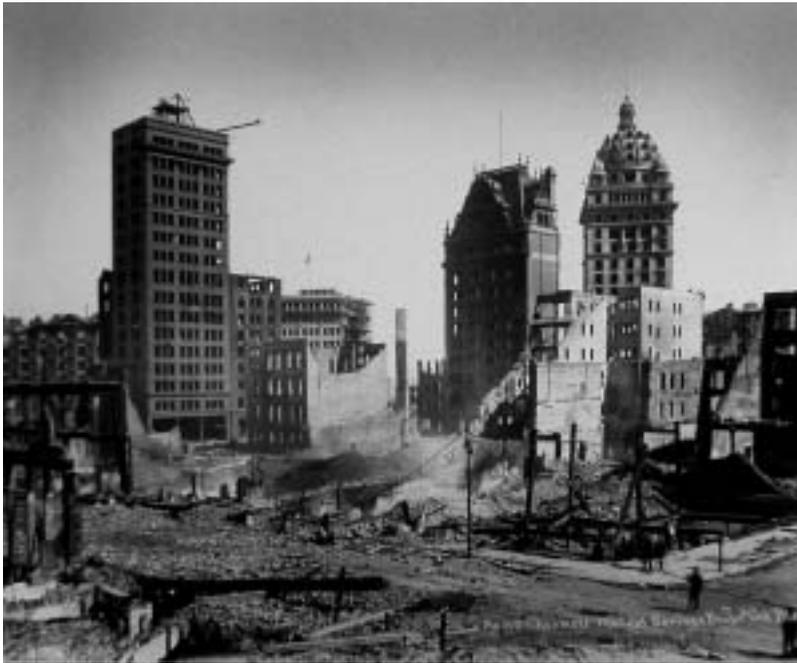
**Figure 28.** 1906 view showing several of the steel skeleton “Chicago frame” buildings in burned-out condition. All of these buildings are still extant in 2007 (Photograph courtesy of Bancroft Library, University of California, Berkeley, Berkeley, CA).

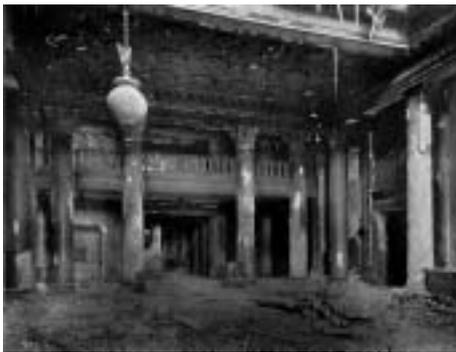
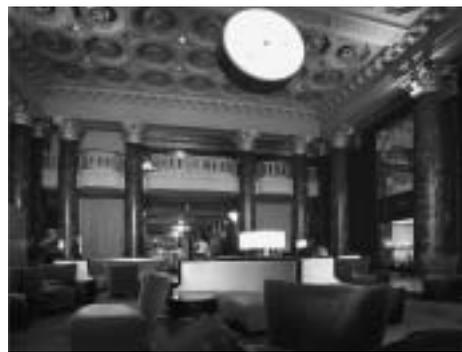
**Figure 29.** (a) Lobby of the steel frame St. Francis Hotel after the San Francisco earthquake and fire of 1906 (Photograph, Roebing, 1906). (b) Same view as Figure 29a, 100 years later. © Randolph Langenbach, 2007.

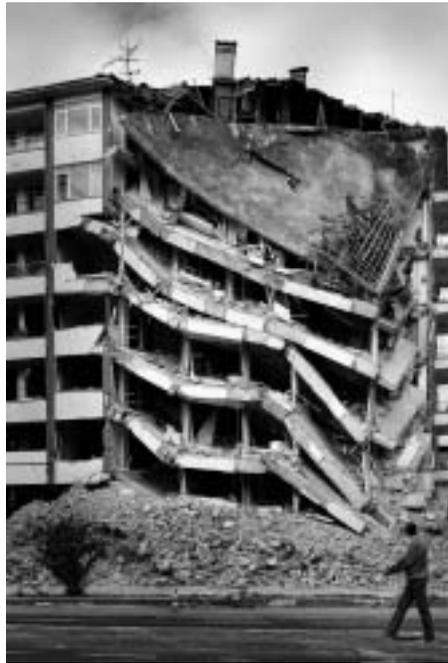
**Figure 31.** Partially collapsed reinforced concrete infill-frame building in Gölcük, Turkey, 1999. The initial stiffness and subsequent rapid degradation and collapse of the infill masonry walls, fragments of which are visible in the photograph, contributed to the collapse of many of the Gölcük concrete frame buildings. © Randolph Langenbach, 2007.

The fundamental flaw with this approach is that this method of standard analysis is based on linear elastic behavior, which conflicts with the fact that buildings are expected to deflect into the nonlinear range in earthquakes. This flaw has been recognized in codes through the use of ductility factors, but such factors are unresponsive to the conditions that exist when stiff and brittle membrane of “non-structural” infill masonry is added to the system, as this masonry is contained and restrained by the frame in a way that changes the behavior of the frame, sometimes with catastrophic results (Figure 31 and 32a).

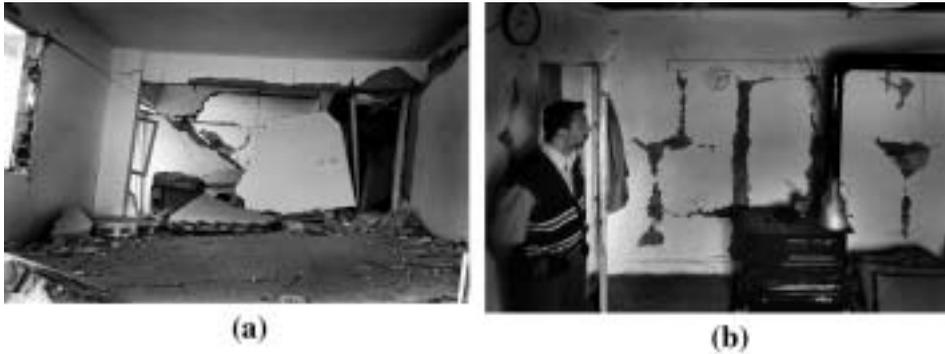
**Figure 32.** (a) Ruptured frame and collapsed hollow block masonry infill wall in a Gölcük, Turkey concrete building after the 1999 earthquake. © Randolph Langenbach, 2007. (b) Interior of house in Orta, Turkey after the 2000 earthquake, showing the working of the confined masonry panels of *humuş* construction. © Randolph Langenbach, 2007.

In reinforced concrete buildings, if the infill walls are subdivided into panels, as stresses on the individual masonry panels increase, the shifting and cracking begins first along the interface between the panels and the sub-frame members, and then in the panels themselves (Figure 32b). If the mortar is kept weaker, rather than stronger than the masonry units, cracking occurs along the mortar joints. This helps to avoid the concentration of destructive loads onto small sections of the reinforced concrete frame, which can lead to sudden catastrophic failure, especially when the RC frame has hidden faults, which has often proved to be the case. Ensuring that the mortar is weaker than the masonry units avoids the cracking of the bricks or blocks themselves, which is of critical importance in maintaining the stability of the masonry panel (Langenbach, 2003b).
